# NORTH PACIFIC HALL

## SOUTH FACADE RESTORATION

HISTORIC RESTORATION TEAM | Summer 2015

Sitka Fine Arts Camp | Sheldon Jackson Campus, Sitka, Alaska

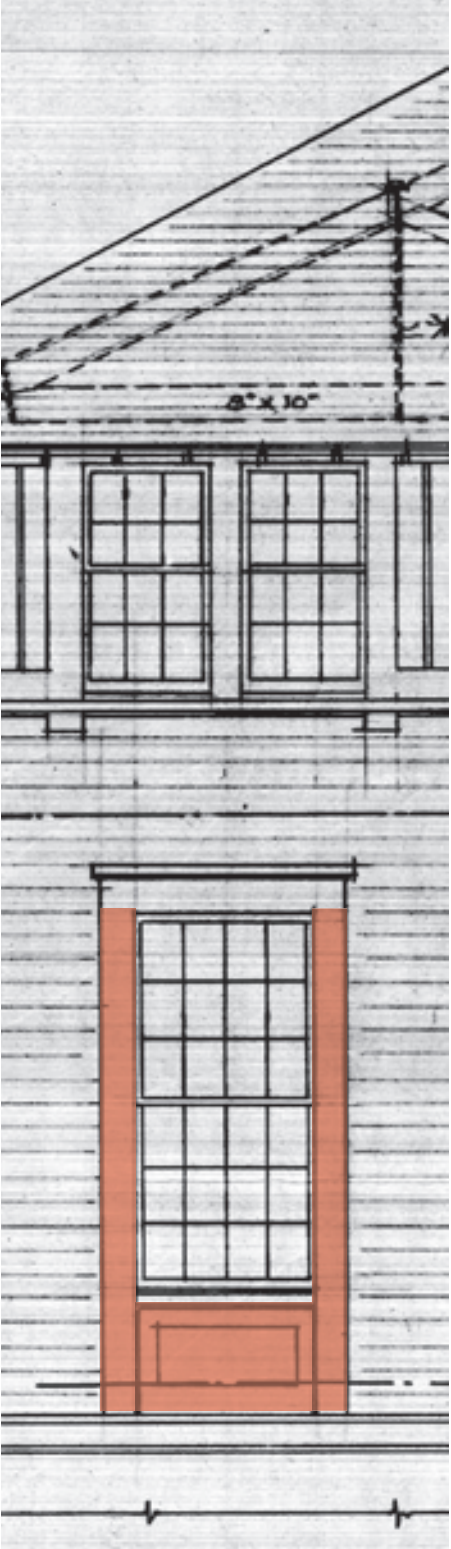
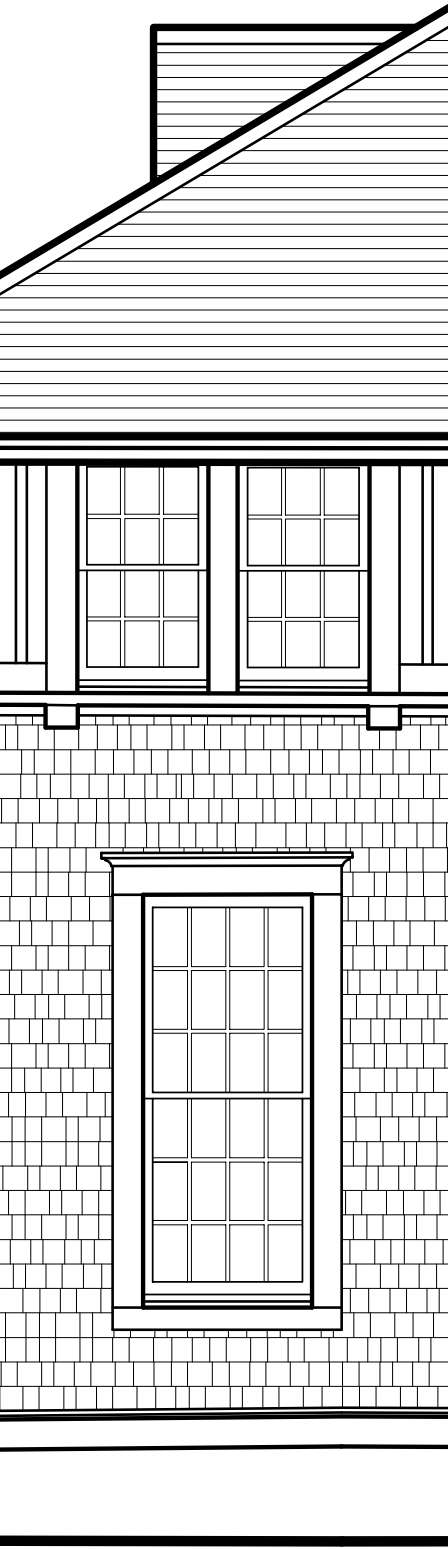
On the left is the original first floor window design with casings extending to belly beam and panel below the sill. In red are the restored components.

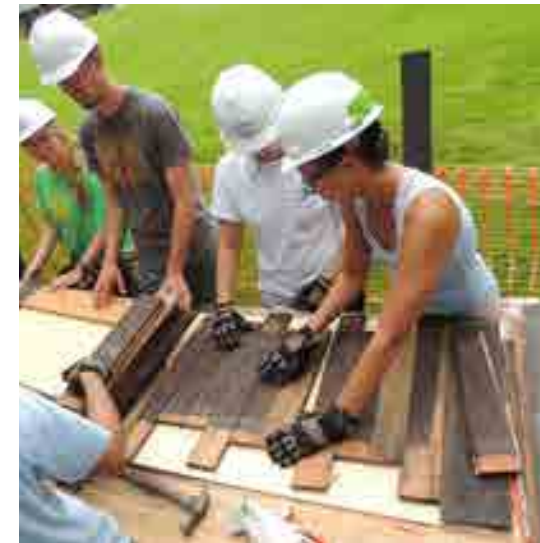
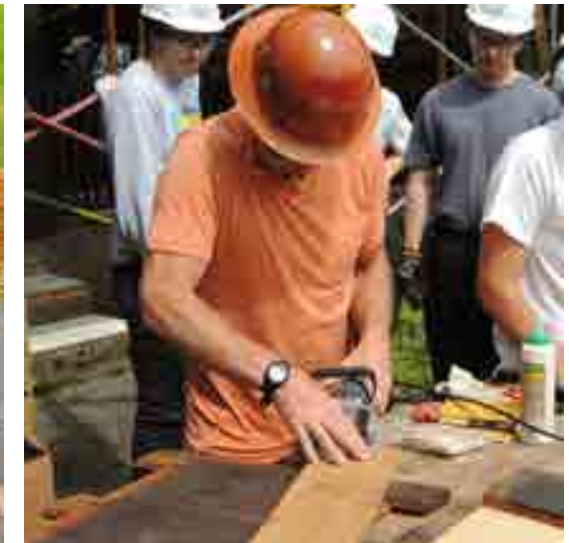
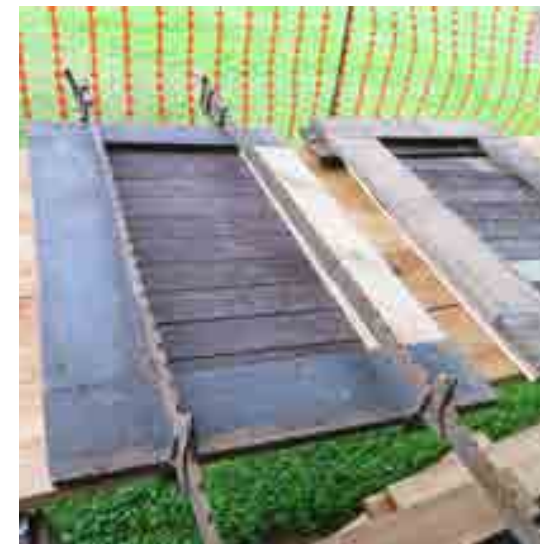
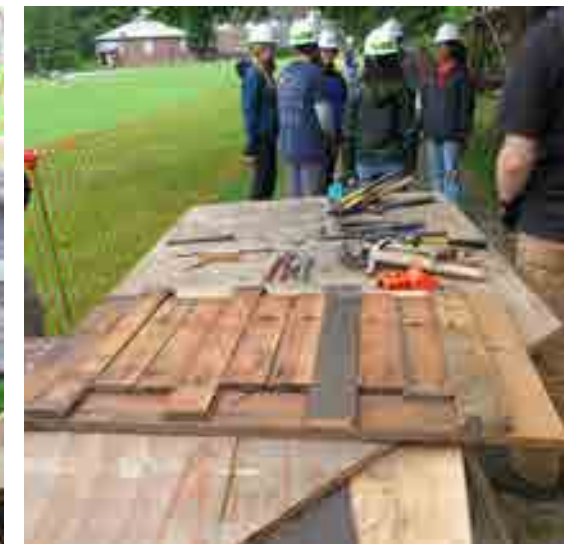
CLOCKWISE FROM TOP LEFT: PANEL REASSEMBLY ONSITE; HOLES ARE CUT INTO THE FRAMES FOR BISCUIT AND GLUE ASSEMBLY; PANELS ARE PIN NAILED TO THE FRAME; PANELS ARE FLIPPED AND CLAMPED IN PLACE DURING DRYING

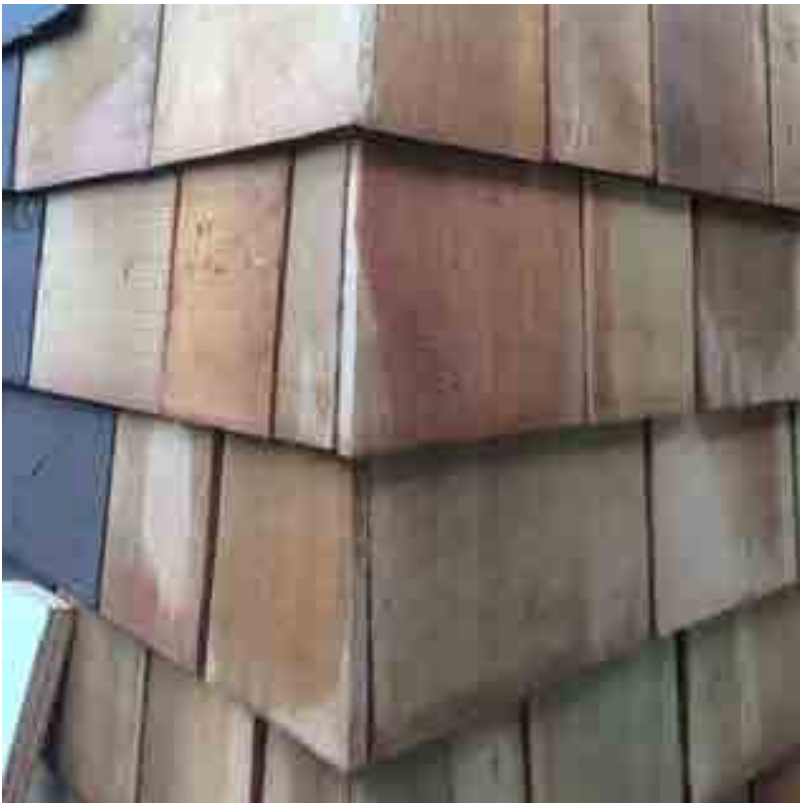
CORNER WEAVING

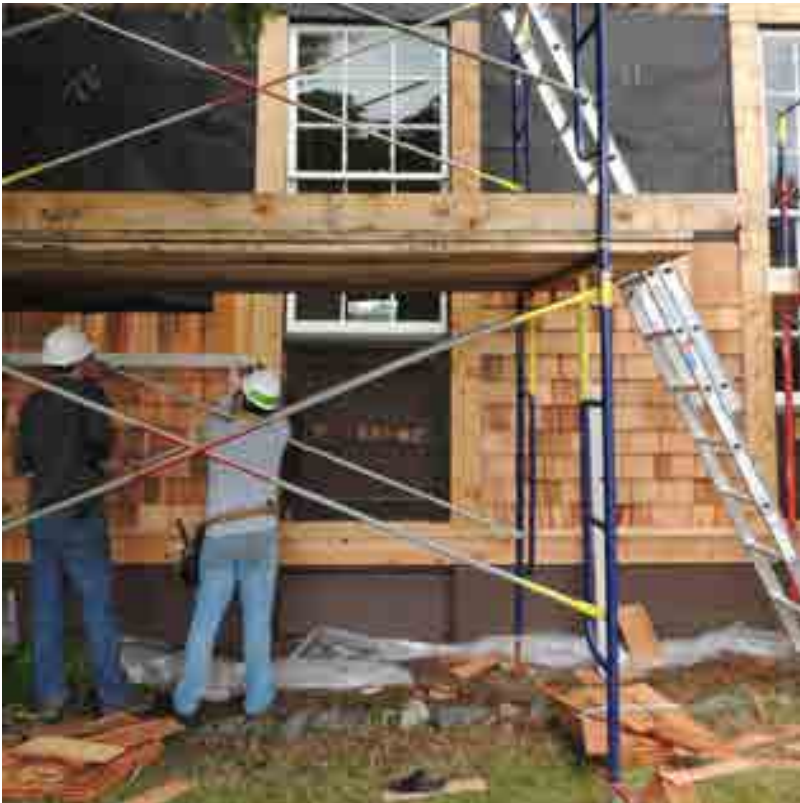
SHINGLE INSTALLATION

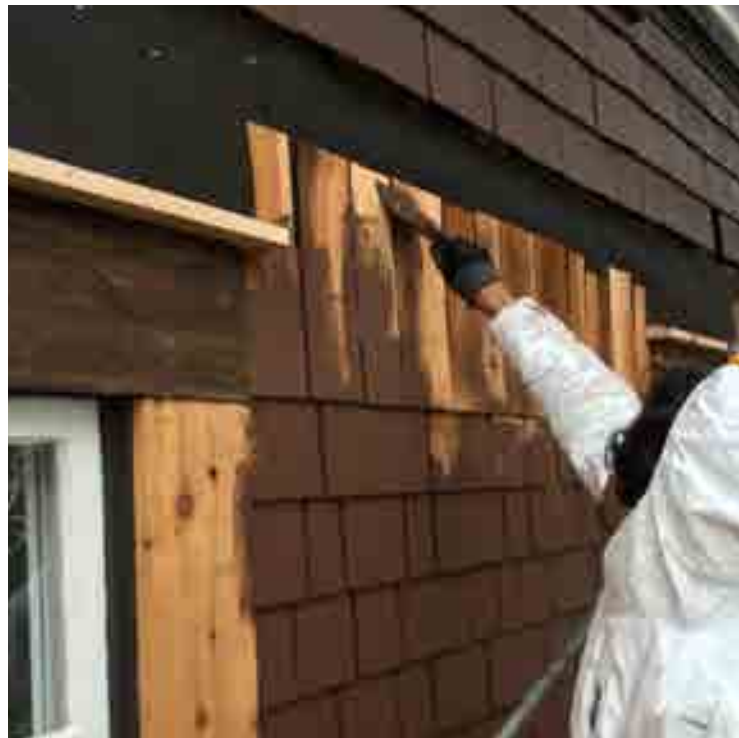
PAINTING SHINGLES

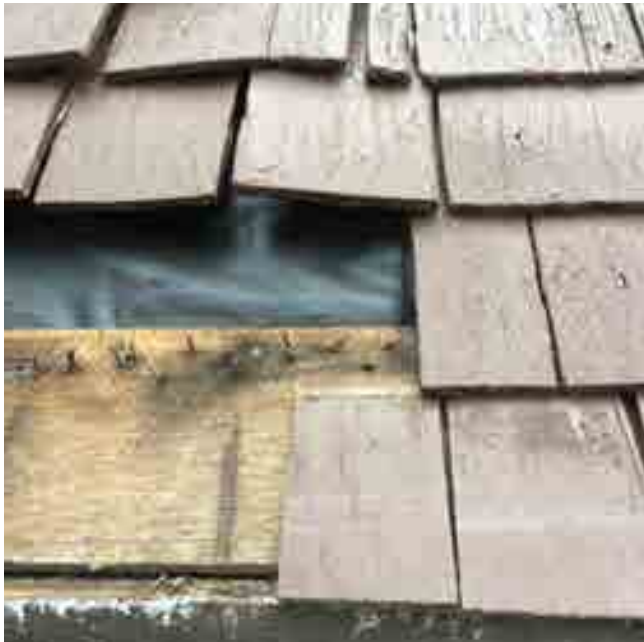
SHIMS AND SHORTENED SHINGLES

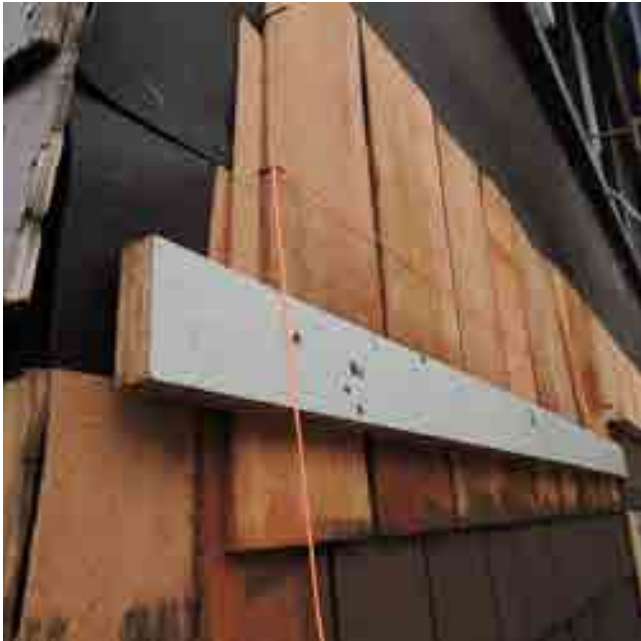
STRING GUIDE LINES ABOVE THE WINDOW SILL UNIFY THE SHINGLE LINES ACROSS THE ENTIRE FACADE

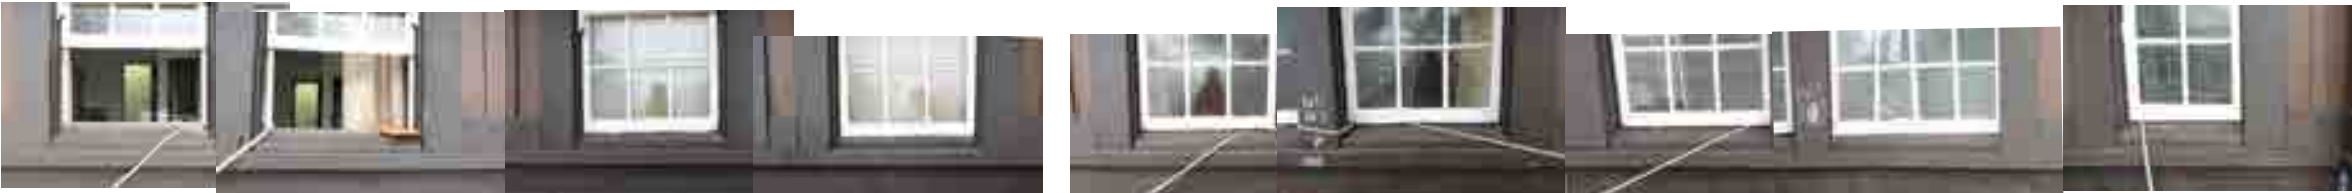
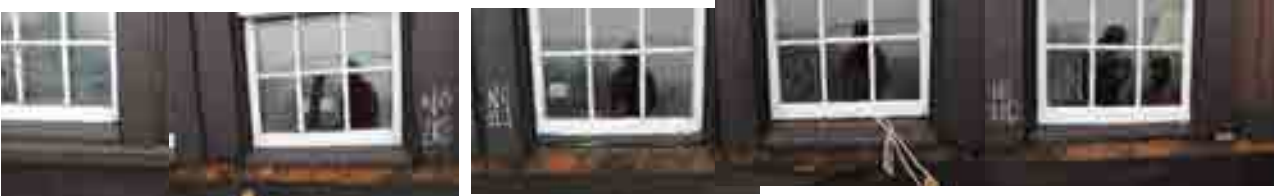
SECOND STORY WINDOWS, SHINGLES REMOVED AND TAR PAPER STAPLED ON

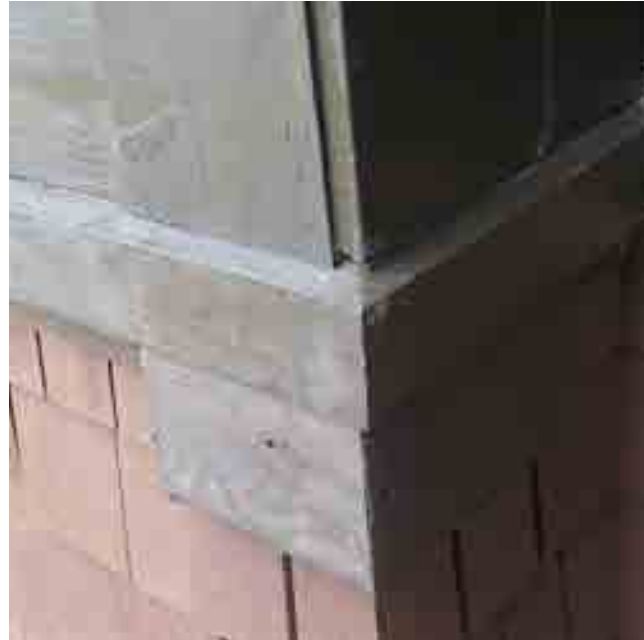
FRESHLY PAINTED, WITH NEWLY FABRICATED BLOCKS BENEATH, THE OLD AND NEW TRIM ARE SEAMLESSLY CONSTRUCTED TOGETHER

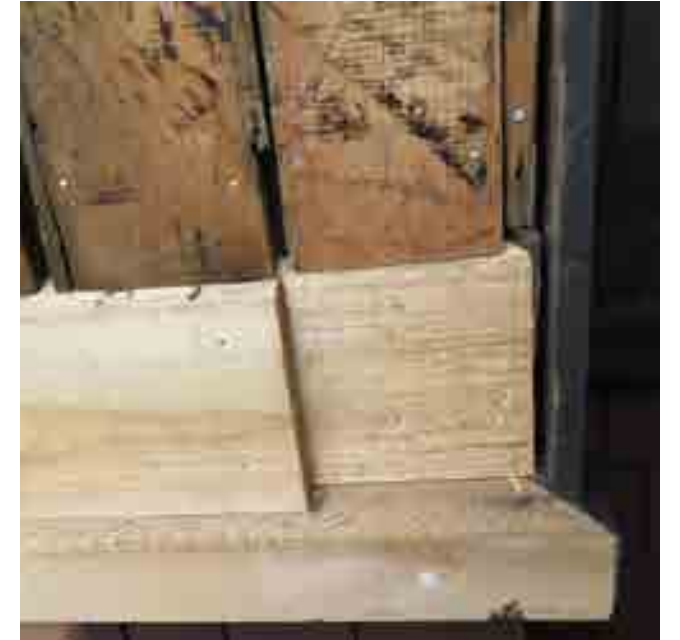
NEWLY FABRICATED TRIM
