# Old Stone House

## Historic Structure Report FINAL DRAFT

Rock Creek Park  
Washington, DC

April 2013

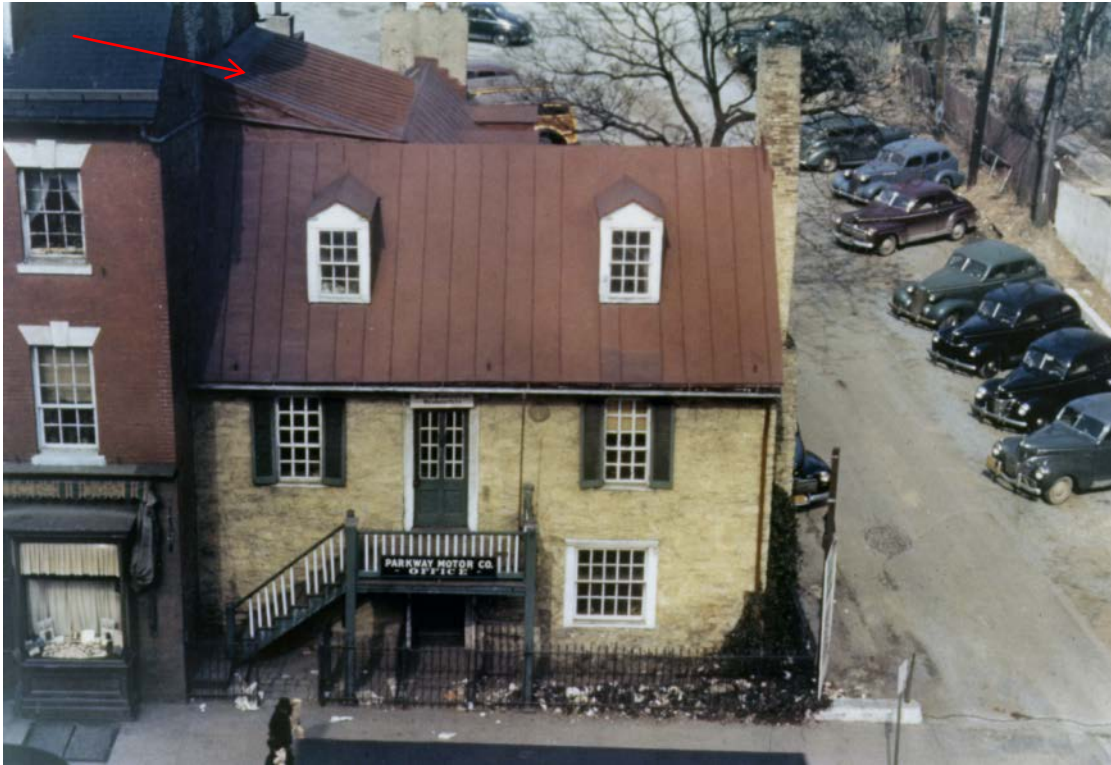
**Figure 15.** Old Stone House in 1951. Note the shed roof addition of between the adjacent building's exterior wall and the gable roof of the north addition (red arrow). (NPS)

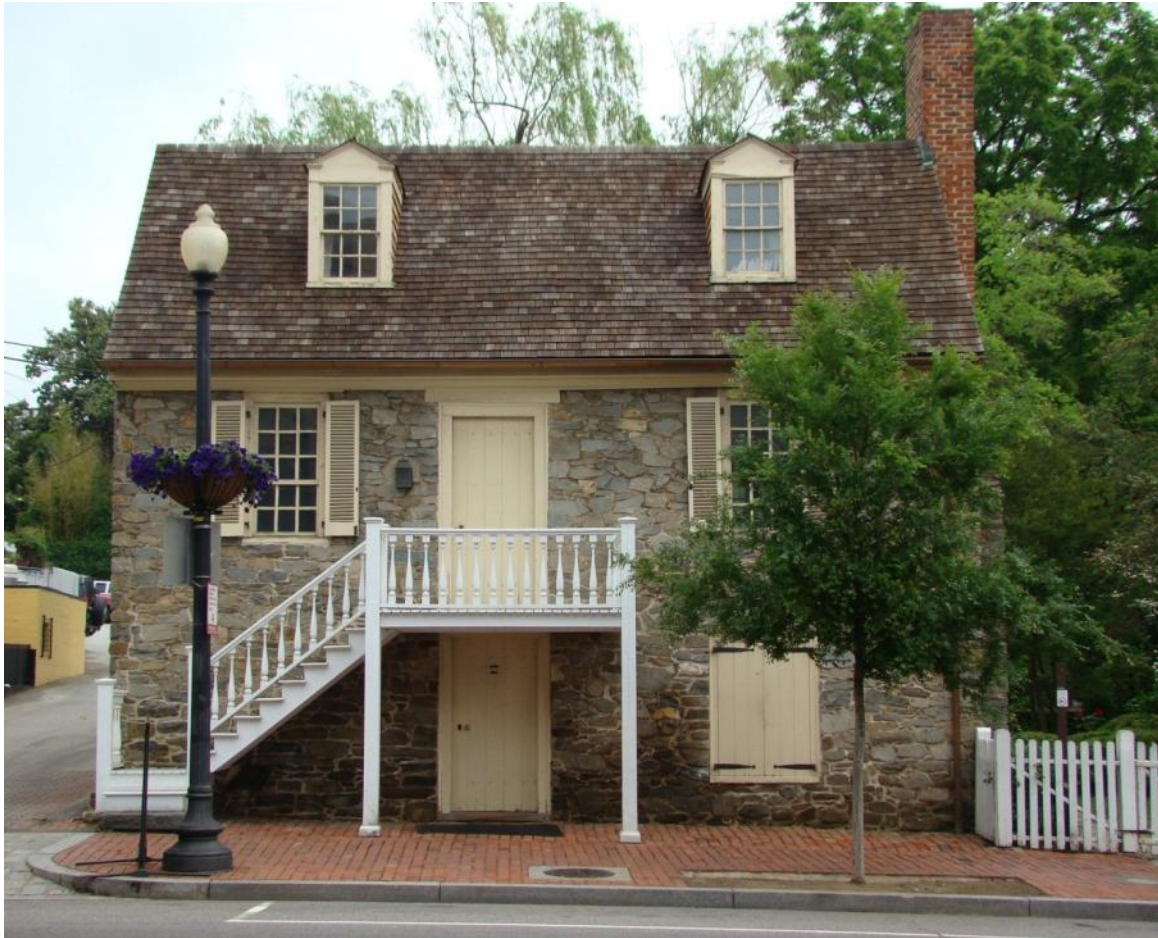
During, or soon after, the renovation, necessitated by the construction of the building to the west, the main block roof was replaced. The dormers were placed symmetrically on the roof based on the relationship to the newly constructed building and the east chimney. As a result, the dormers do not line up vertically with the second-floor windows (fig. 28).

**Figure 28.** The dormer windows are symmetric, but do not align with the windows on the second floor. (NPS)

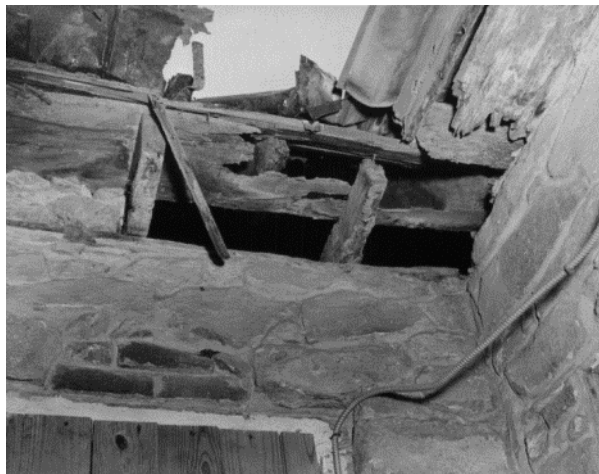
**Figure 29.** The cornices of the house were in disrepair when the NPS acquired the property, as seen in this 1955 photograph. (NPS)

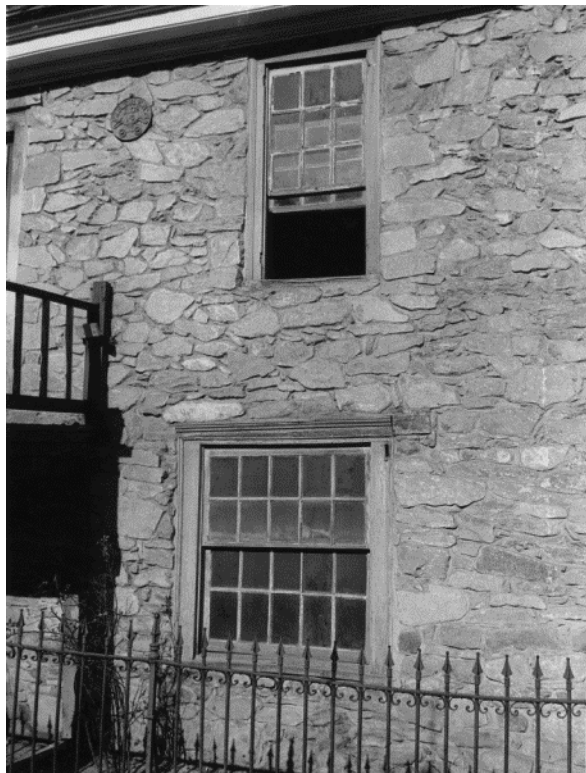
**Figure 43.** The south elevation and windows in 1956. (NPS)

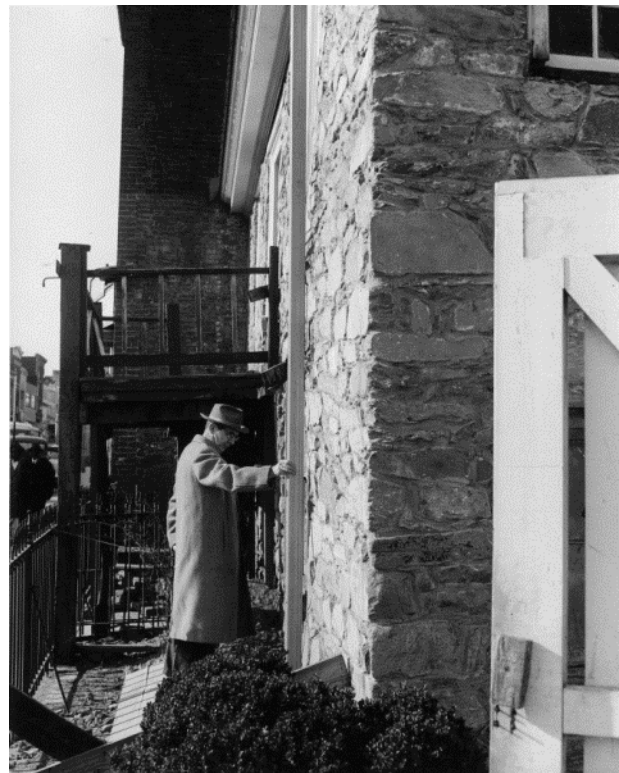
**Figure 44.** The south elevation, with former front porch and replacement downspout, in 1956. (NPS)

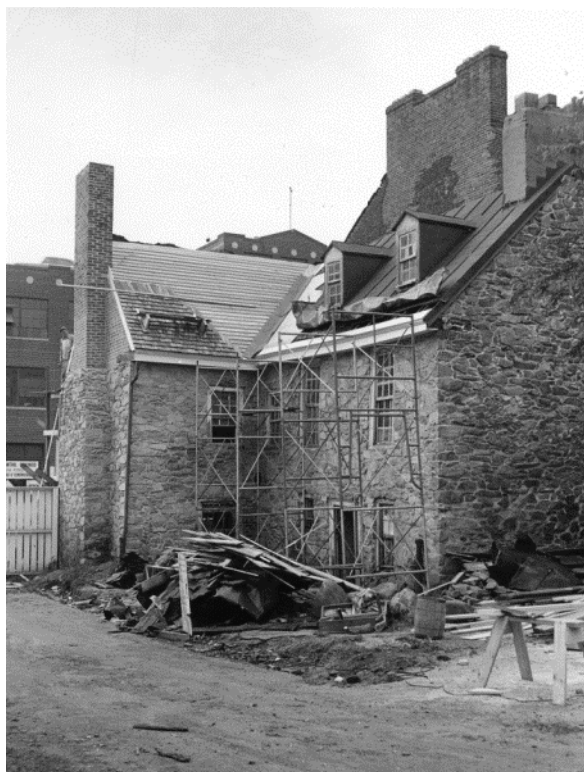
**Figure 45.** The north and east elevations during restoration in 1956. (NPS)

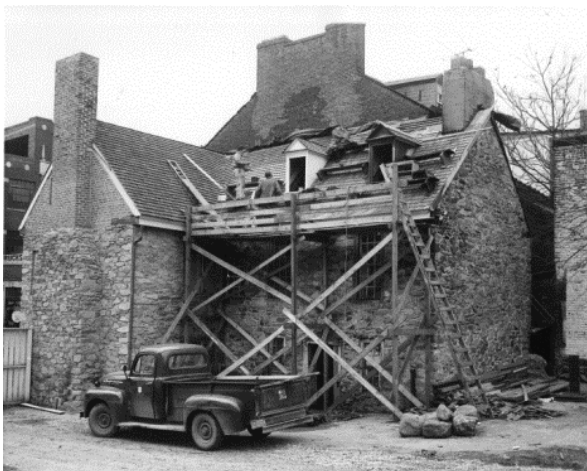
**Figure 57.** The north addition dormers being restored in 1957. (NPS)

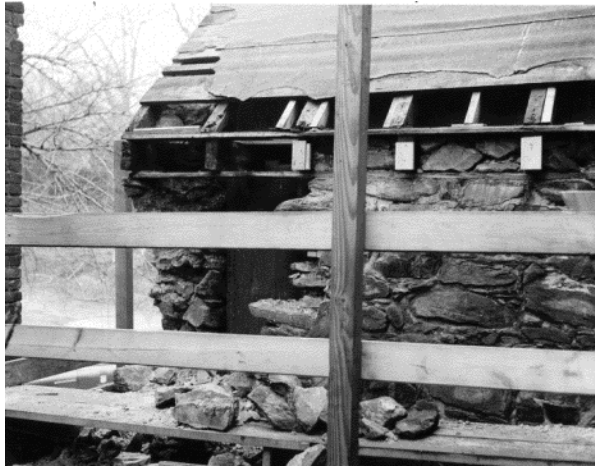
**Figure 59, above.** During the restoration of the west corner of the north addition roof line. (NPS, 1957)

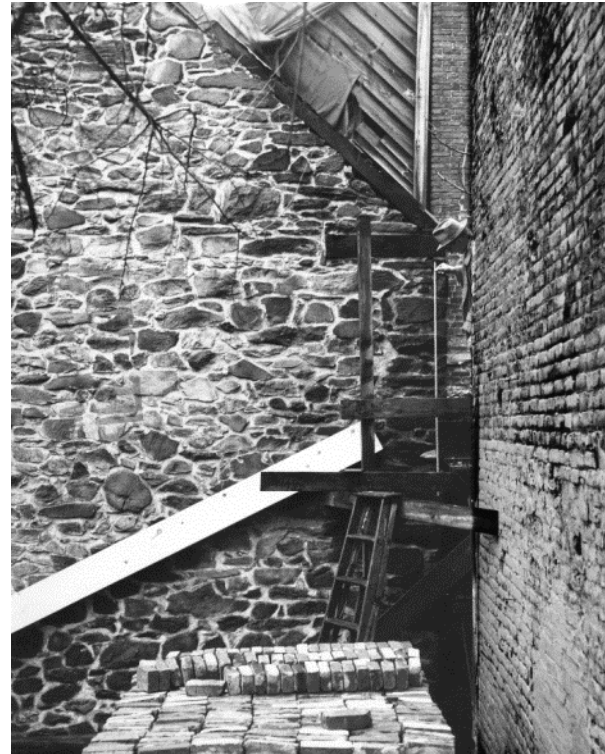
**Figure 60, right.** After the restoration of the west corner of the north addition roof line. (NPS, 1957)

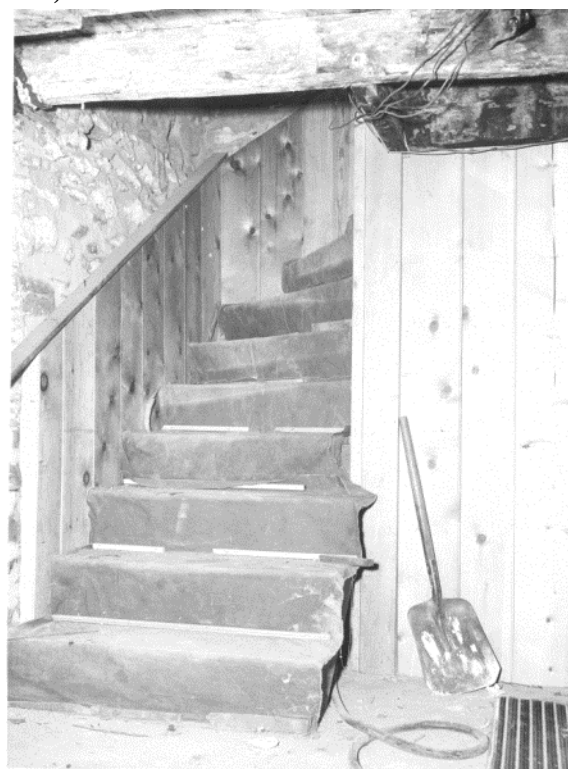
**Figure 66, right.** Reconstructed Stair 1 in Room 102 in 1957. (NPS)

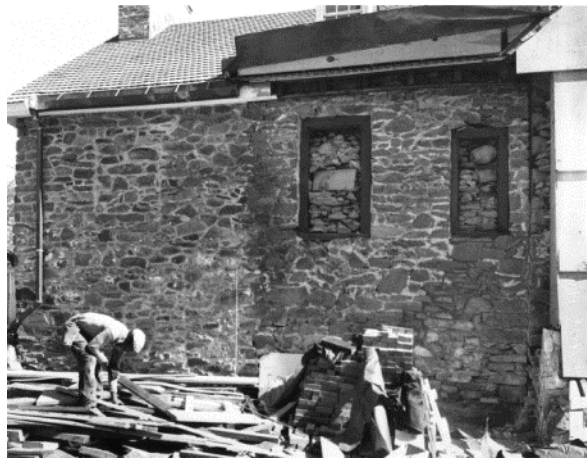
**Figure 75.** Window details of the west elevation after the removal of the shared wall. (NPS, 1958)

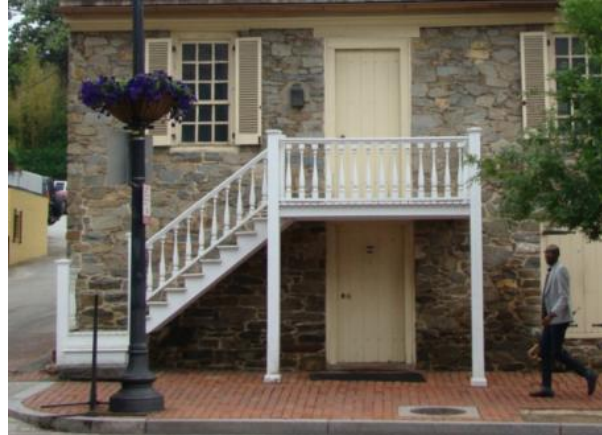
**Figure 83.** The front porch and stair after reconstruction. (NPS, 2011)

Since the major renovations throughout the 1950s, the National Park Service has made some changes to the house. These changes include the installation of new roofs in 2009 (figs. 80-81), the construction of a replacement front porch in 2011 (figs. 82-83), and selected repointing to exterior stonework on south, east, and north elevations in 2012 (fig. 84-91).

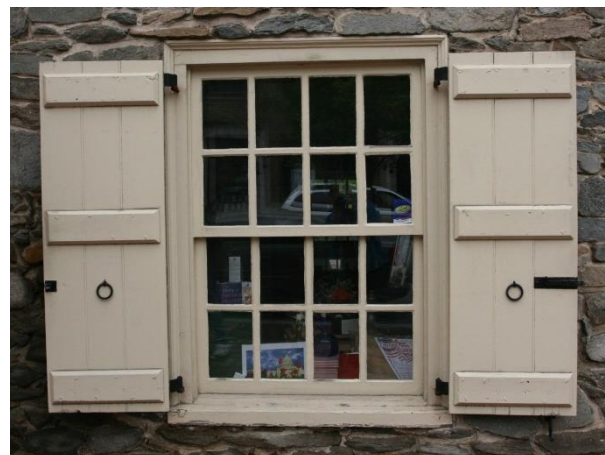
**Figure 130.** Type B – W101. (NPS)

There is one Type B window: W101, located on the first floor of the south elevation. It is an 8/8 double-hung, wood window with 0'-0-1/4" mullions (fig. 130). It was installed in 1956 and designed to replicate the Colonial style of the house. When the NPS purchased the house, they removed a 10/10 sash window from this location. This window also has a battened shutter, installed in 1957.

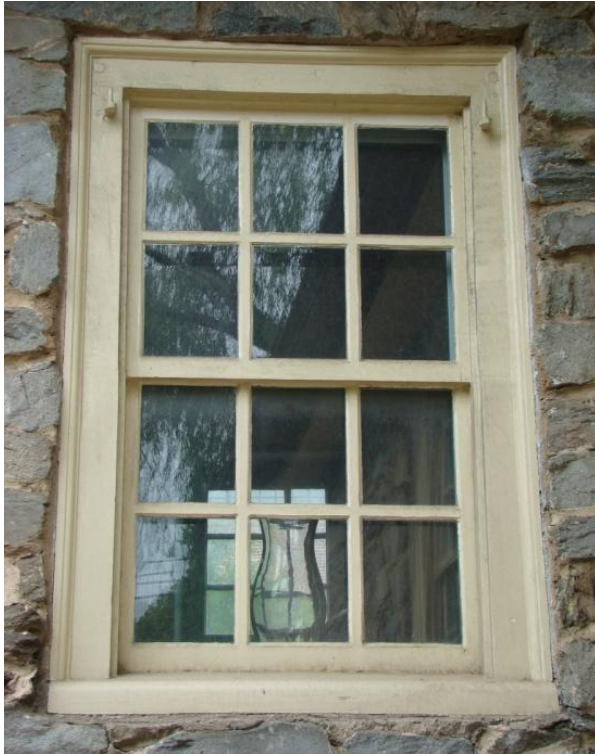
**Figure 131.** Type C – W204. (NPS)

There are three Type C windows: W103, W204, and W205. W103 and W204 are located on the north elevation of the main block, on the first and second floors respectively. W205 is located on the second floor of the east elevation of the north addition. Type C is a 6/6 double-hung, wood window with 0'-0-3/4" mullions. W103 and W204 are replica windows modeled after W205, which is original (fig. 131). The sill and upper left corner of W205 were restored in 1957. W103 was proposed to be a batten door in the 1957 drawings.

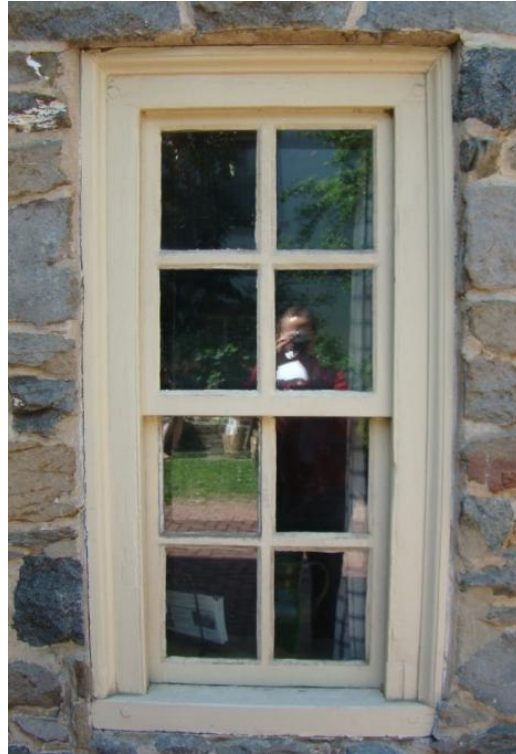
**Figure 132.** Type D – W104. (NPS)

There are two Type D windows: W104 and W105, located on the first floor of the east elevation of the north addition. Type D is a 4/4 double-hung, wood window (fig. 132). It is similar to Type F, but has narrower window panes. Type D windows are 2'-5" wide and 4'-4" tall. Both W104 and W105 are new replication windows installed in 1957. The original sills were restored at the same time. The 1934 HABS drawings depict 4/4 windows, proving that the NPS replaced these windows accurately.

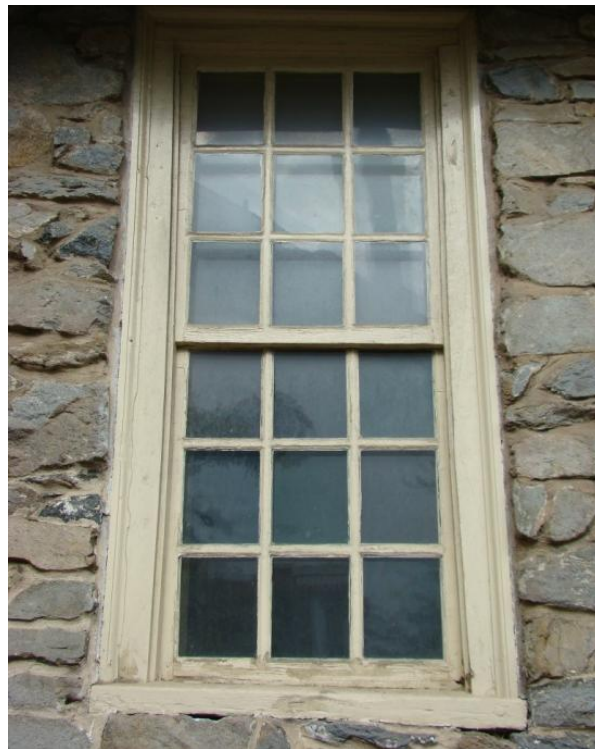
**Figure 133.** Type E – W206. (NPS)

There are two Type E windows: W206 and W207, located on the second floor of the east elevation of the north addition. Type E windows are 9/9 double-hung, wood windows (fig. 133). They are original to the house. They were in good condition at the time the NPS acquired the property, and are the least-altered original windows.

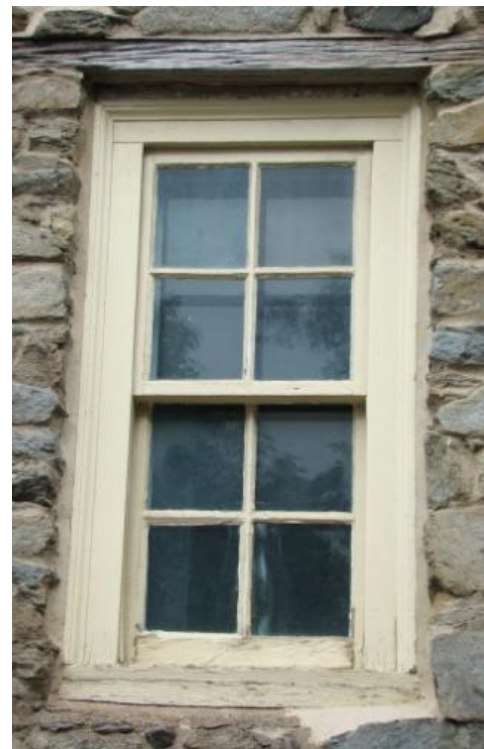
**Figure 134.** Type F – W203. (NPS)

There are two Type F windows: W102 and W203, located on the first and second floors of the east elevation of the north addition. Type F is a 4/4 double-hung, wood window (fig. 134). HABS drawings depict W203 as a 6/6 sash window (replacement date unknown). The replacement date is unknown.

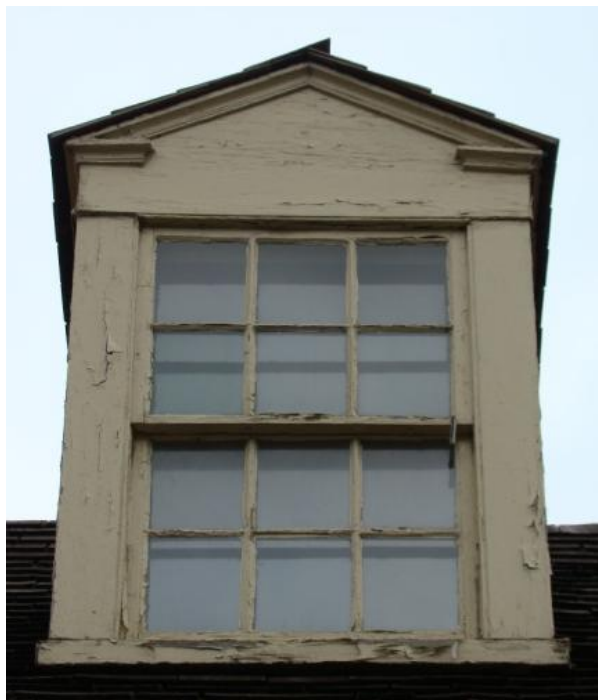
**Figure 135.** Type G – W302. (NPS)

There are two Type G windows: W301 and W302, located in the third-floor dormers of the south elevation of the main block. They are 6/6 double-hung, wood windows in pedimented gable dormers (fig. 135). Type G differs from Type I in that the base of the horizontal cornice is broken in the middle. These dormers were rebuilt during the 1957 renovations.

Dormers have evidence of water infiltration and rot. The new roof, installed in 2009, appears to have resolved the water infiltration, but damage should be repaired. Interior storm windows have trapped moisture, exacerbating mold and rot.

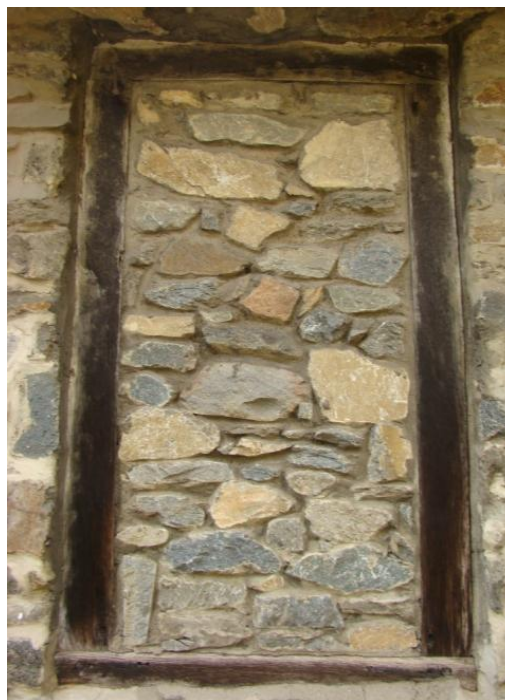
**Figure 136.** Type H – FW01. (NPS)

There are two Type H former window openings: FWO1 and FWO2, located on the second floor of the west elevation of the north addition. Only the window frames remain, likely original to the ca. 1775 construction (fig. 136). The former window openings have been infilled with stone to match the west elevation wall stone. There were plans in the 1950s to install reproduction Colonial-style sash windows.

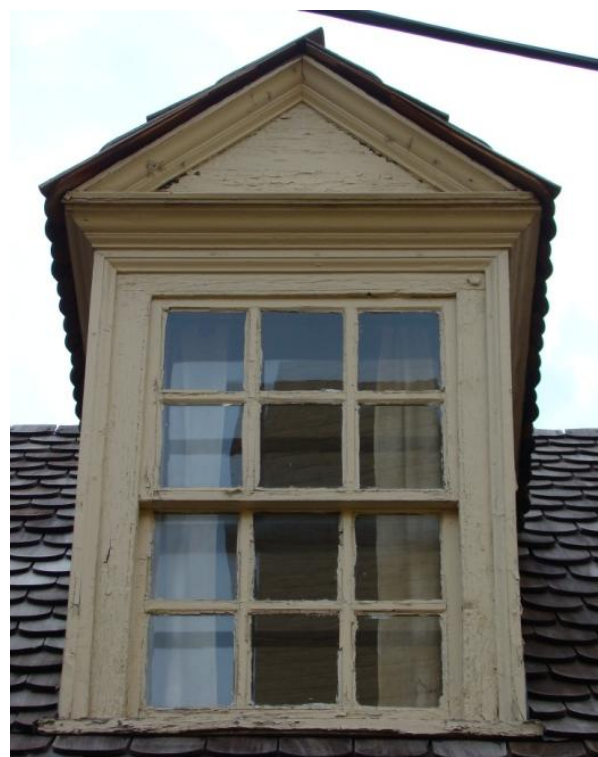
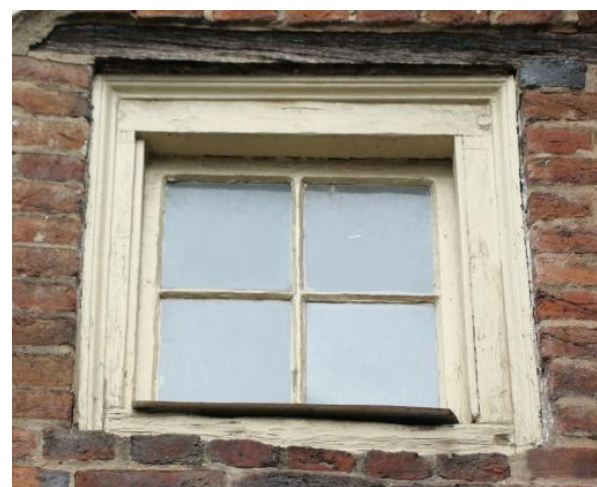
There are three Type I windows: W304, W305, and W306. W304 and W305 are located in the third-floor dormers of the east elevation of the north addition; W306 is located in the third-floor dormer of the west elevation of the north addition. They are 6/6 double-hung, wood windows in pedimented gable dormers (fig. 137).

There is one Type J window: W303, located on the third floor of the east elevation of the main block. It is a four-lite square casement window (fig. 138). There were significant repairs done to this window in 1957, including the installation of a new frame.

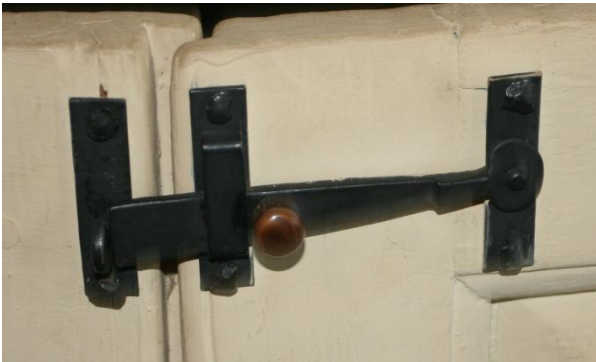
All of the extant, installed hardware is in good condition.

**Figure 175.** Cupboard latch located in Room 204. (NPS).

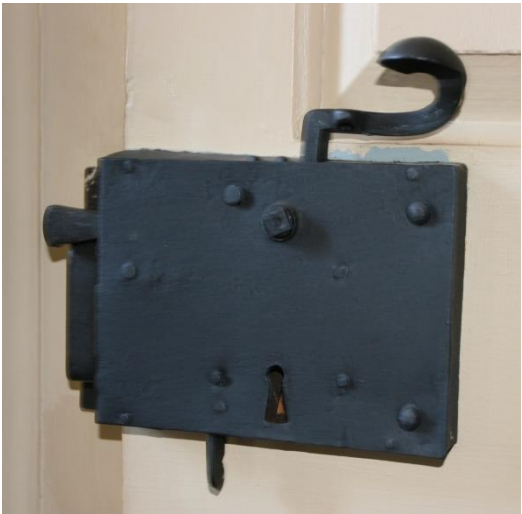
**Figure 176.** Door latch located in Room 203 (dating to ca. 1957). (NPS)

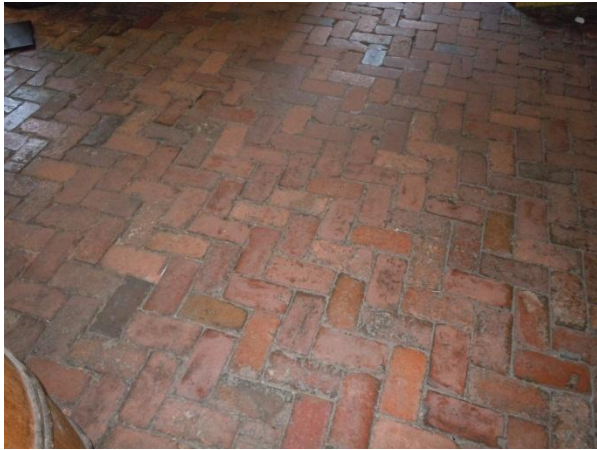
The herringbone brick floor is in good condition.

**Figure 208, above.** The herringbone brick floor of Room 102. (NPS, 2013).
