Manassas National Battlefield Park  
Manassas, Virginia

# The Stone House—Historic Structure Assessment Report

## *Manassas National Battlefield Park*

2015

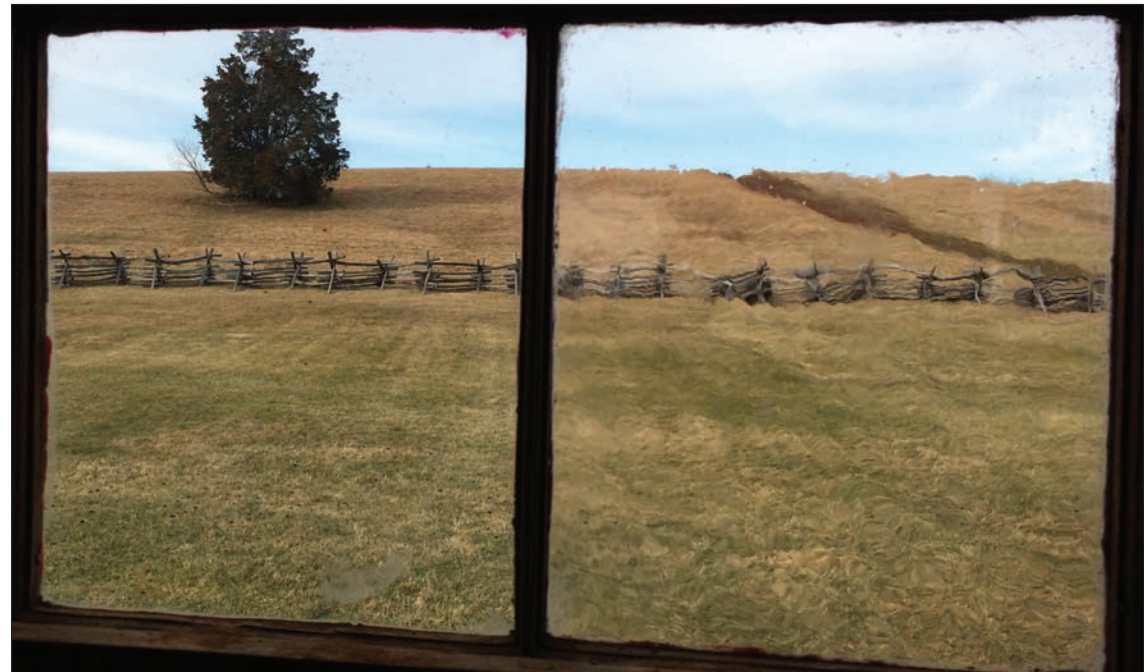
Figure 39: Reproduction (left) vs. antique (right) glass.

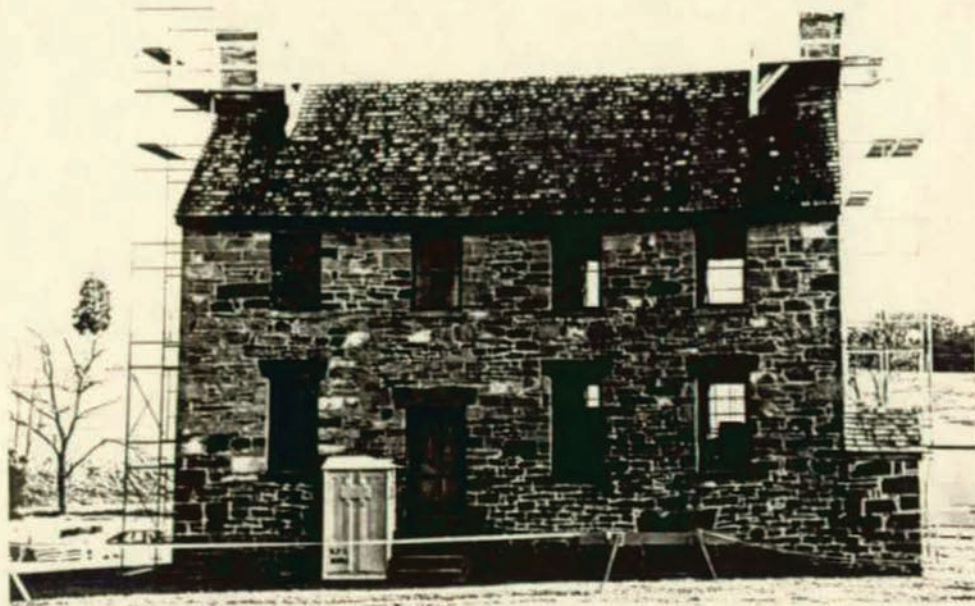
Figure 41: (left) Old Stone House chimney repair and reroofing project report, 1993; (above) Stone House west chimney prior to installation of blue stone chimney cap.

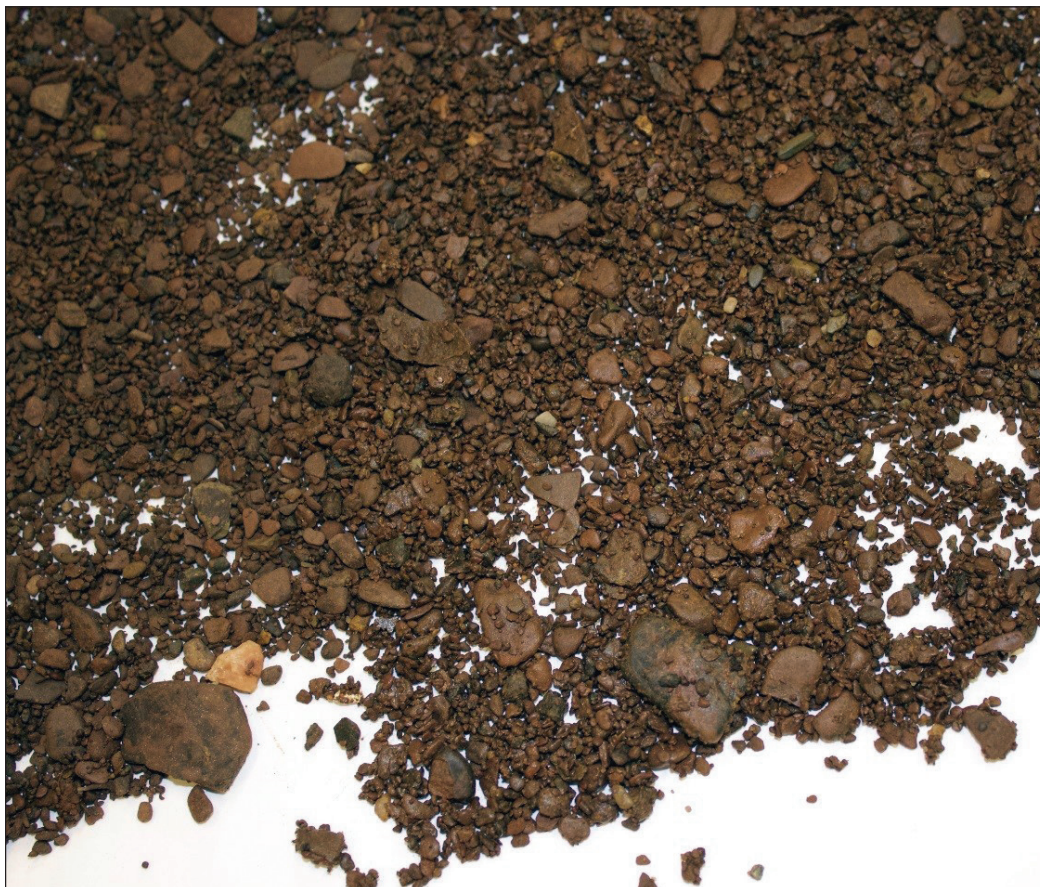
Figure 51: Decomposed sandstone from the nearby Youngs Branch.

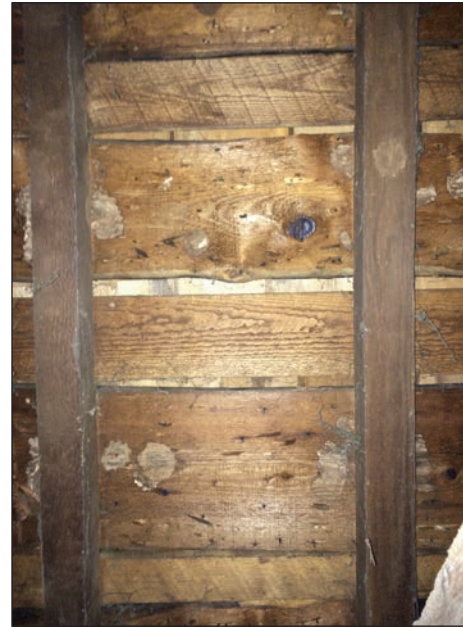
Figure 60: Sheathing and shingles.

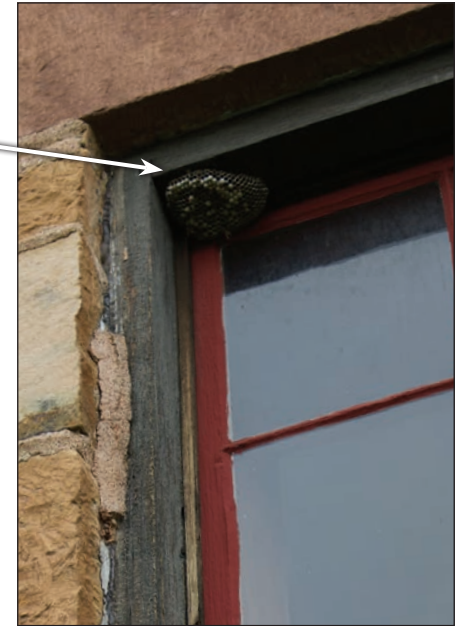
Figure 95: Window 102 insect nest detail.

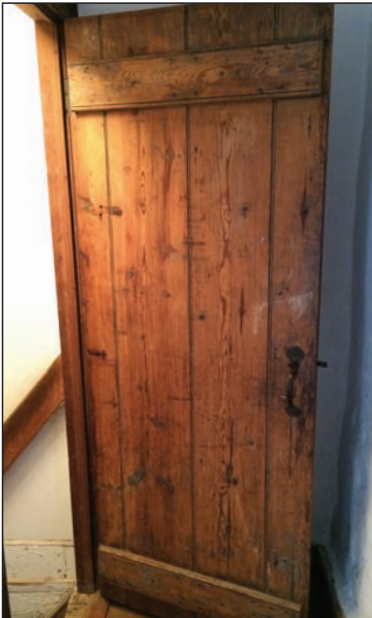
Figure 117: Basement door 002.

The doors on the interior of the Stone House are not original to the construction of the house but were in place at the time of the 1960 Historic Structure Report by Orville Carroll. The first floor doors to the two east rooms are four-paneled. The basement door and tavern room door are board and batten. All four doors are stained walnut and have walnut casings. The hardware found in the house consists of T-strap hinges on the board and batten doors and butt hinges on the paneled doors. Earlier use of T-strap hinges on all doors is evident by the markings left

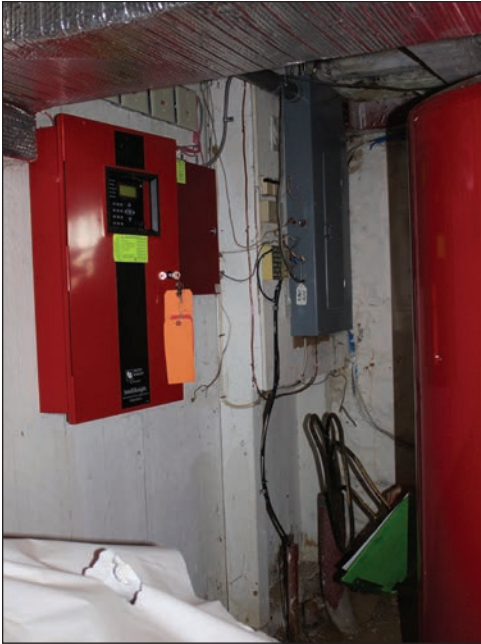
Figure 130: Electrical overview.

The electrical service in the Stone House is fed via underground cable that enters the basement at the south elevation. There is an overhead light on both the east and west sides of the basement and in the stairwell leading to the first floor. The main electrical distribution panel (MDP) is located on the partition wall of the east side of the basement. The fire alarm enunciator panel is also located on the partition wall, as are the thermostats. All of these services are in excellent condition.
