# DANFORTH MEMORIAL LIBRARY | PRESERVATION PLAN

SEPTEMBER, 2018

## I. EXECUTIVE SUMMARY

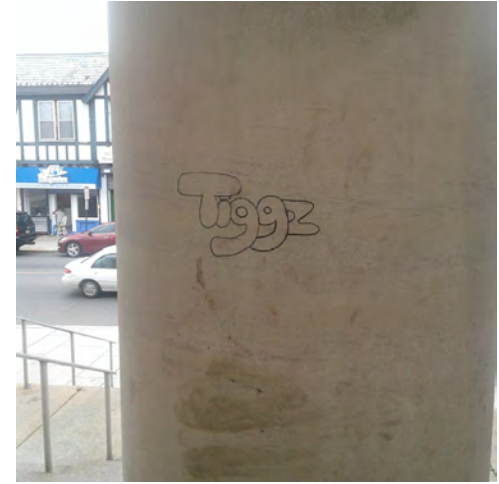
| Feature | Description | Period | Condition | CDF | Priority and Recommendation |
|---|---|---|---|---|---|
| LIMESTONE ELEVATIONS<br>P39-P42 | Limestone | Original | Good to Fair: Stone requires cleaning and repointing, some small cracks and spalling some locations. Occasional graffiti | Yes | Long Term - Clean and repoint stone. Carefully repair cracks to match existing stone. |

P39: Marker graffiti on back of column.

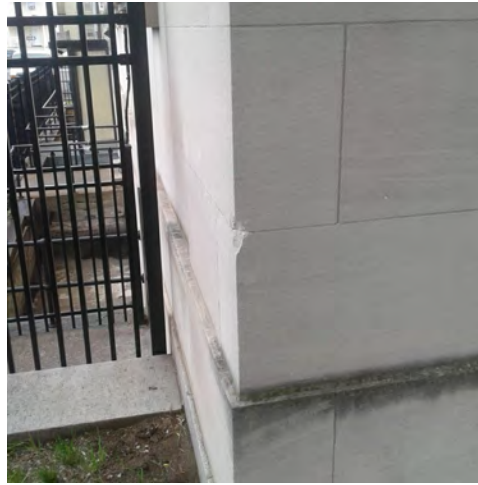
| Feature | Description | Period | Condition | CDF | Priority and Recommendation |
|---|---|---|---|---|---|
| LIMESTONE ELEVATIONS P49-P51 | Limestone | Original | Good to Fair: Stone requires cleaning and repointing, some small cracks and spalling some locations. | Yes | Long Term - Clean and repoint stone. Carefully repair cracks to match existing stone. |

P50: Chipped stone, NE corner

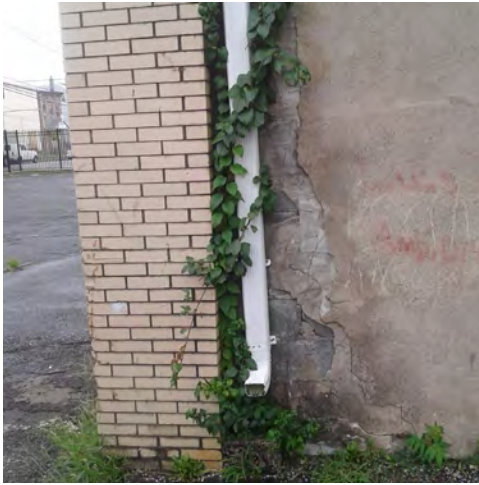
| Feature | Description | Period | Condition | CDF | Priority and Recommendation |
|---|---|---|---|---|---|
| WALLS AT REAR GARAGE P55, P56 | CMU & Stucco | Likely 1967 | Fair to Poor with water infiltration, cracked stucco and some damage to CMU. | No | Immediate - Stop water infiltration at roof, remove vegetation, patch and repair stucco. This building will likely be replaced during a later phase. |

P55: Vegetation on the garage addition.

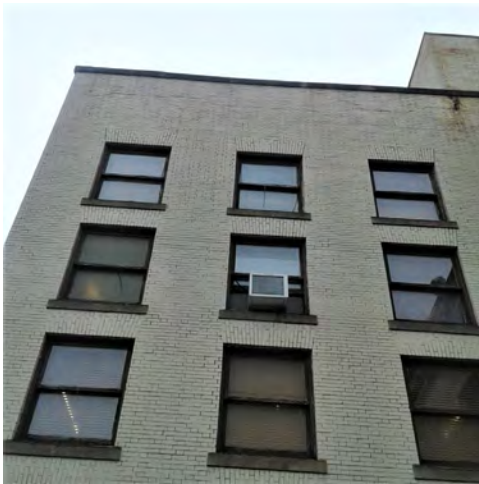
| Feature | Description | Period | Condition | CDF | Priority and Recommendation |
|---|---|---|---|---|---|
| GLAZED BRICK ELEVATIONS P57-P60 | Glazed Brick | Original | Fair - Staining, missing mortar, some cracking | Yes | Long Term - Clean and repoint brick. Carefully repair cracks to match existing brick. |
| WINDOWS P57- P59 | Painted Wood | Replacement windows from the mid-1980's | Fair to Poor: Paint is peeling leaving bare wood exposed and rotting in some areas. 20% of windows have been blocked up. There is water and air infiltration in many locations. | Yes (replacement) | Short Term - Replace most windows with new, historically appropriate windows that are insulated and function properly. |

P58: Rear wing.

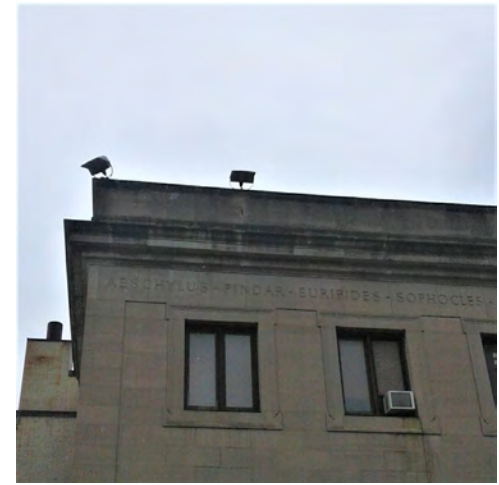
P75

| Feature | Description | Period | Condition | CDF | Priority and Recommendation |
|---|---|---|---|---|---|
| LIMESTONE CORNICE P75, P76, P78 | Limestone | Original | Good to Fair: Stone requires cleaning and repointing, some small cracks and spalling some locations. | Yes | Long Term - Clean and repoint stone. Carefully repair cracks to match existing stone. Remove lighting from top of coping. |

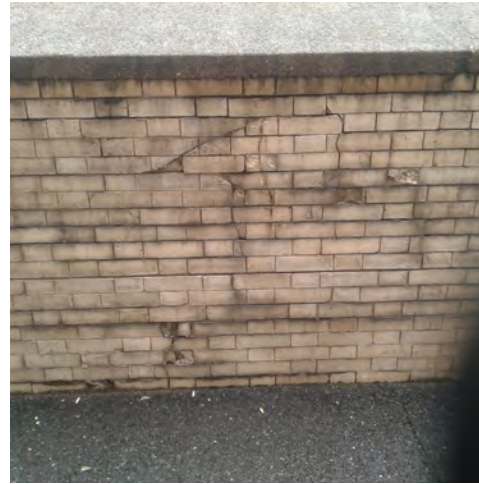
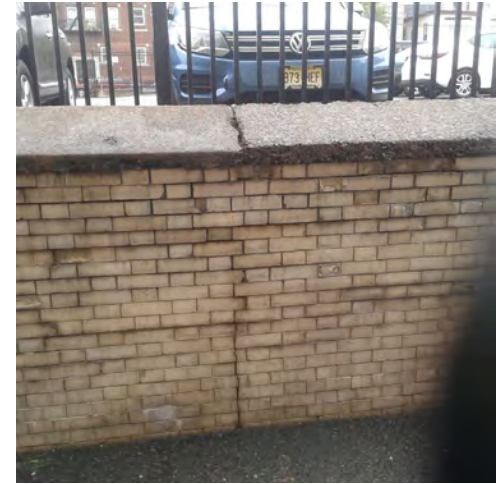
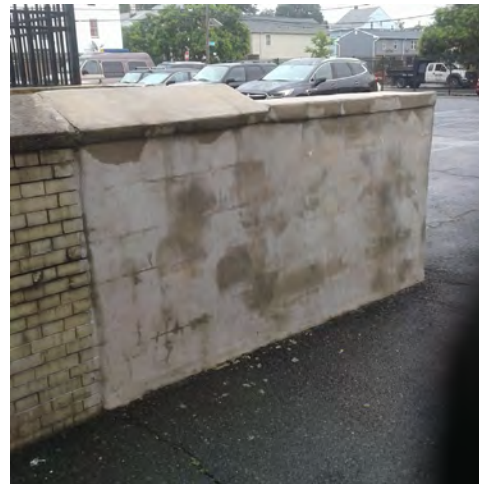
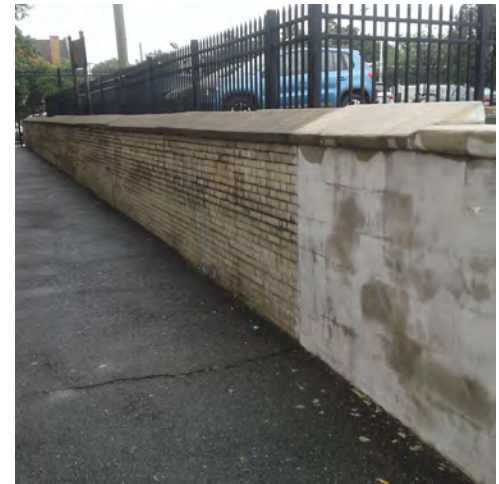
| Feature | Description | Period | Condition | CDF | Priority and Recommendation |
|---|---|---|---|---|---|
| RETAINING WALLS<br>(parallel to East Elevation) P85 - P90 | Glazed Brick with Concrete Coping | Original | Poor - Structural failure and severely damaged coping. | No | Immediate - Stabilize and reconstruct all retaining walls. |

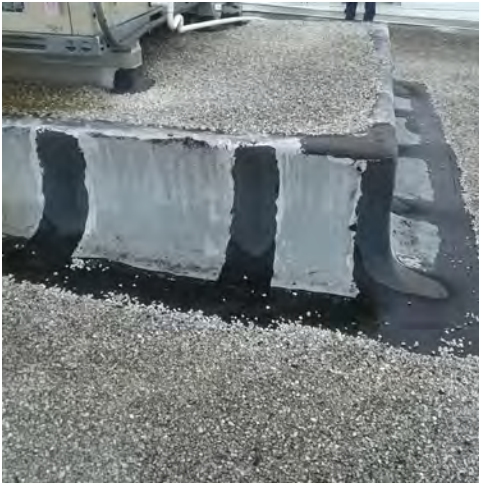
| Feature | Description | Period | Condition | CDF | Priority and Recommendation |
|---|---|---|---|---|---|
| ROOFING P121 | Ballasted built-up roofing with metal flashings and copings. Aluminum siding is used to protect walls and parapets. | 10-25 years old | Fair to poor: Evidence of periodic leaking inside and patching on the roof. Siding that protects the parapets and some walls at the roof is badly damaged, some has blown away. | Yes | Short Term - Install a new, high quality roof that is reflective and that provides adequate insulation to reduce energy usage. Add overflow scuppers and adequate drainage. |

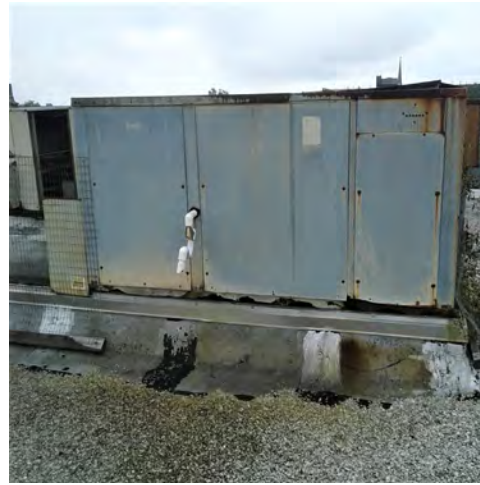
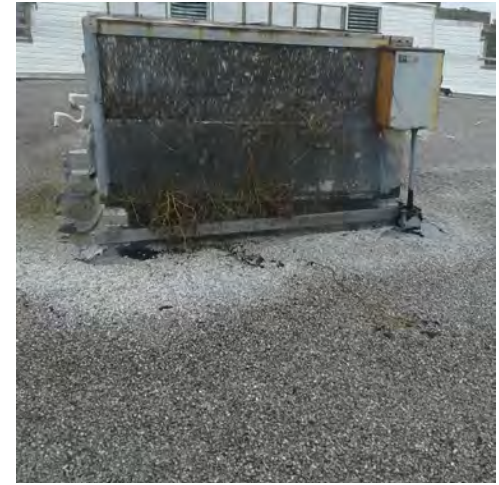
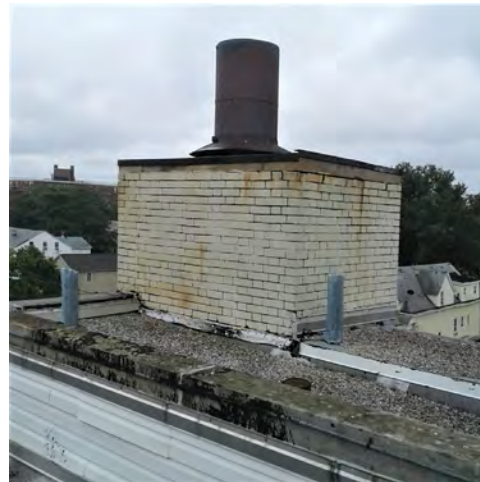
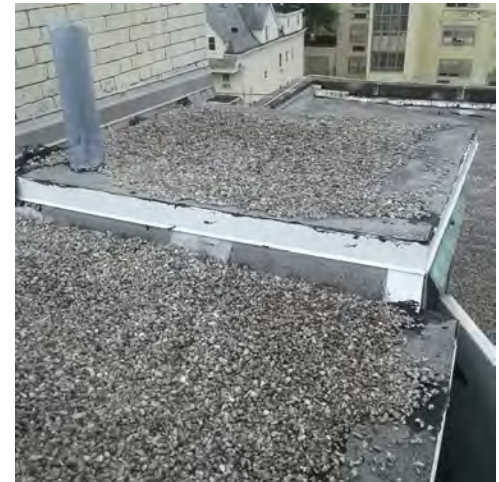
| Feature | Description | Period | Condition | CDF | Priority and Recommendation |
|---|---|---|---|---|---|
| ROOF P127 - P132 | Ballasted built-up roofing with metal flashings and copings. Aluminum siding is used to protect walls and parapets. | 10-25 years old | Fair to poor: Evidence of periodic leaking inside and patching on the roof. Siding that protects the parapets and some walls at the roof is badly damaged, some has blown away. Note the extremely poor condition of the rooftop HVAC equipment | No | Short Term - Install a new, high quality roof that is reflective and that provides adequate insulation to reduce energy usage. Add overflow scuppers and adequate drainage. |

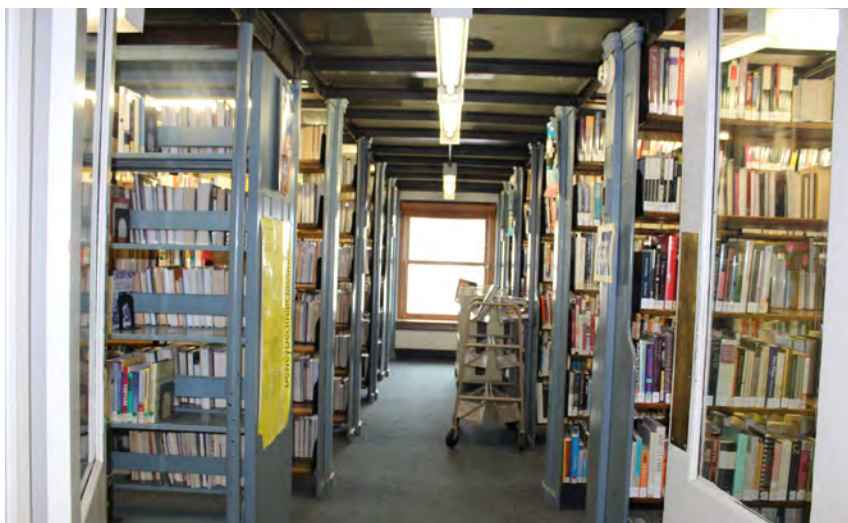
Photo 23: The stacks off the first floor are used for non-fiction. They are the only publicly used stack currently in use

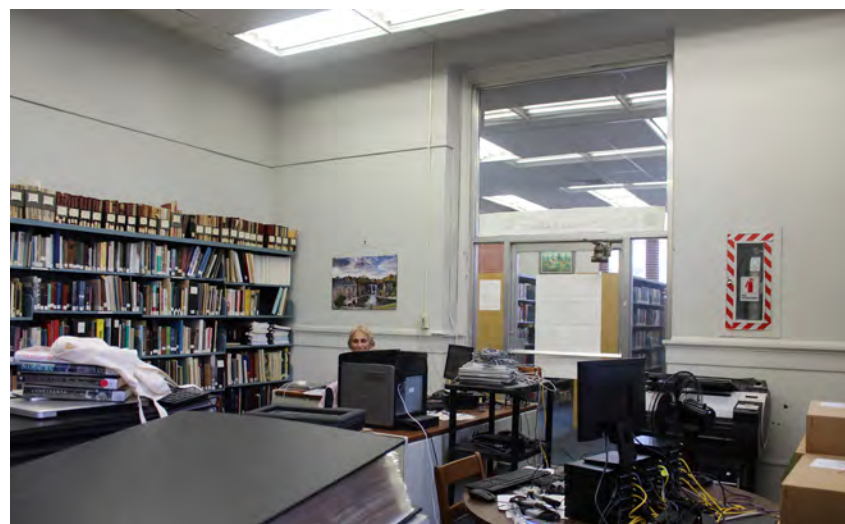
Photo 32: The west wall. Notice the original chair rail

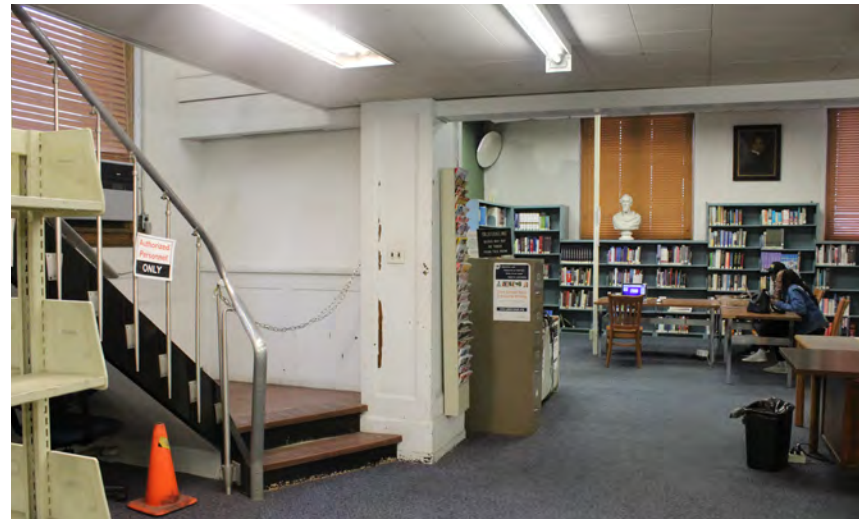
Photo 60: Original wainscot remains at the bottom of the mezzanine stairs

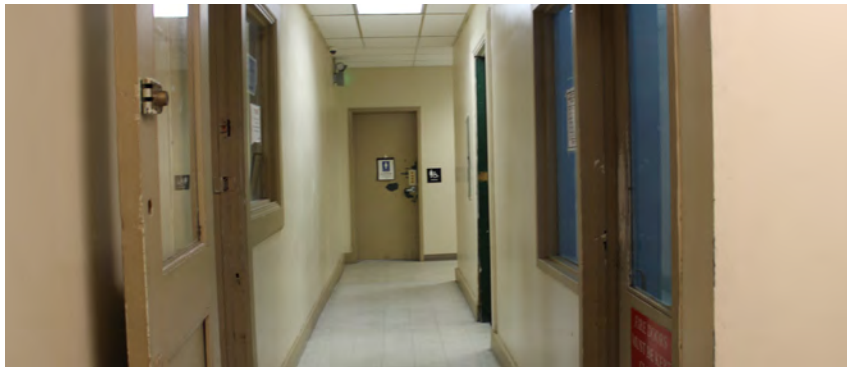
Photo 97: The stair hall runs north south, turns to the east to the main public restrooms are located and at the other end, to the elevator
