# **Big Four Depot** Master Plan Options

for the City of Galion, Ohio

**JULY 20, 2018**

Big Four Depot | 127 North Washington St., Galion, Ohio 44833

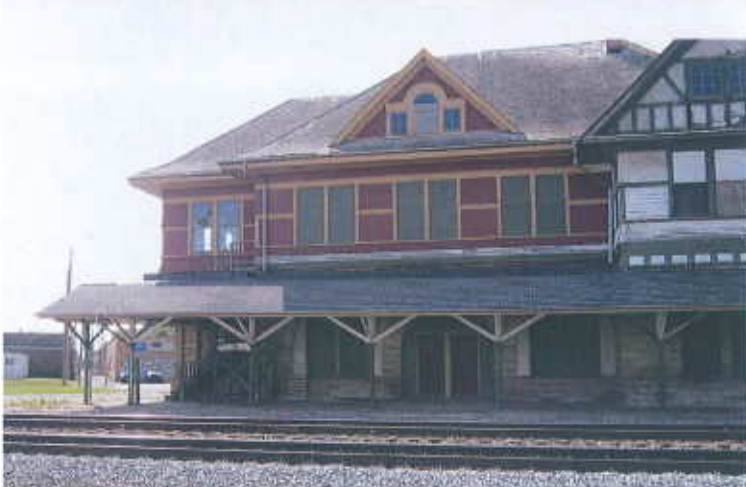
**3.** Partial east elevation, south half.

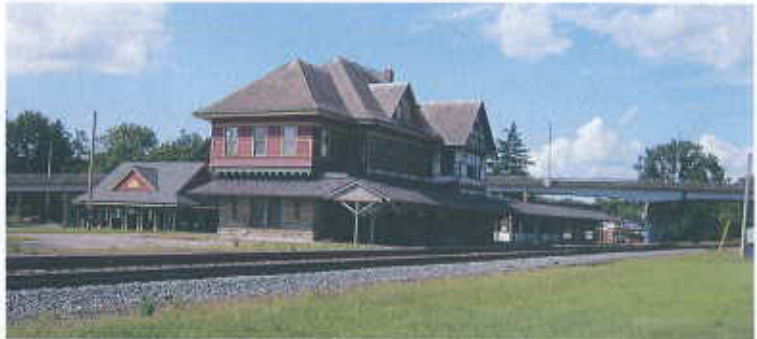
4. Overall site looking to the northwest. The modern pavilion is on the left.

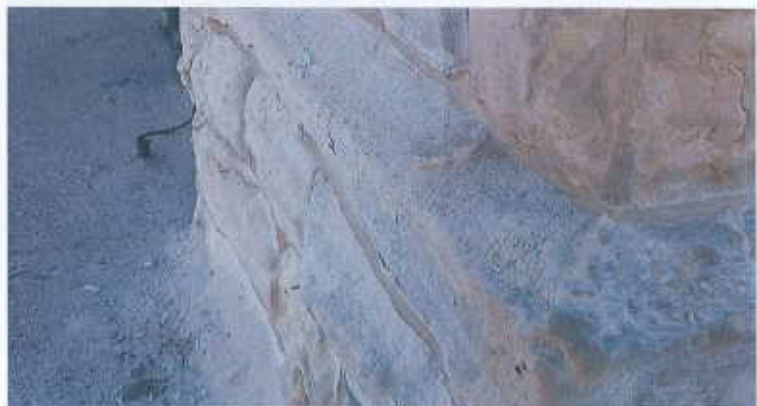
The coursed rusticated stone base (the first floor) with smooth-faced arches is in fair to good condition and was recently repointed 100%. There are isolated locations of deteriorated stone, such as on the north elevation. There is also evidence of salt

7. Rock-faced sandstone base, north elevation.

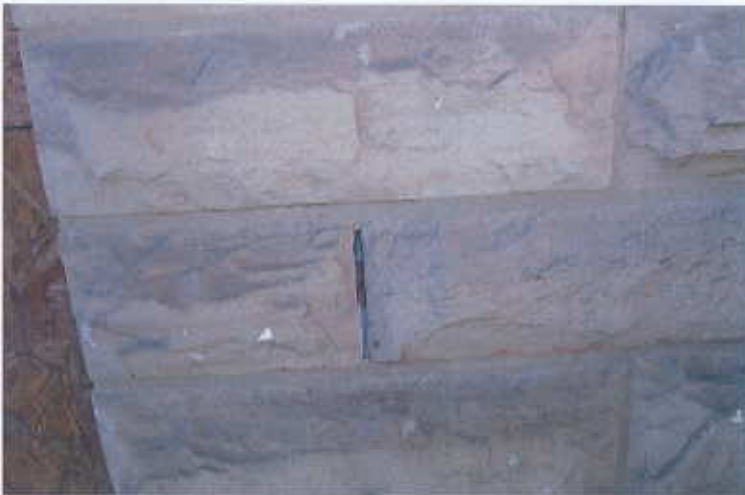
**14.** Detail, east elevation. Open masonry joint.

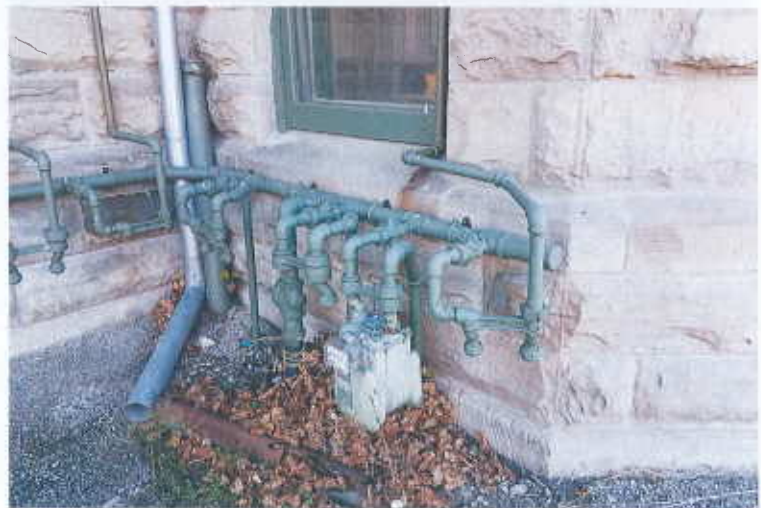
**24.** Detail, gas service at northwest corner of the main part of the depot.

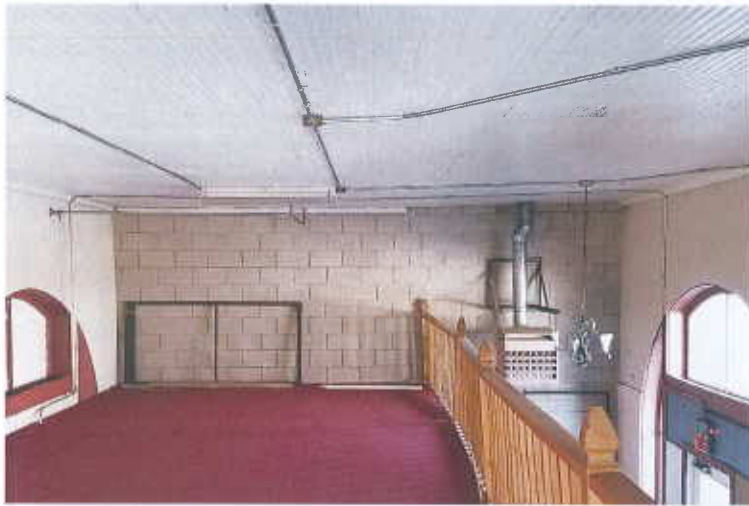
- Room 106 has been greatly altered with an added mezzanine section. The room does retain wood picture rail and crown molding, and wood bead board walls and ceiling that is in fair condition due to worn surface finish. Historically this would have served as a baggage or freight holding area.
- Room 107 is the stair foyer and features a historic wood staircase, beadboard wainscoting and plaster walls in fair condition due to worn surface finish and dirt.
- Rooms 108 and 109 have a non-historic partition wall dividing them but retain beadboard wainscoting in fair condition. The ceilings have been lowered from the original height.
- Rooms 110 and 114 are entrance vestibules and feature crown molding and plaster walls and ceilings in fair condition with hairline cracks, small holes, and peeling paint.

**101.** Room 106, historic beadboard ceiling.

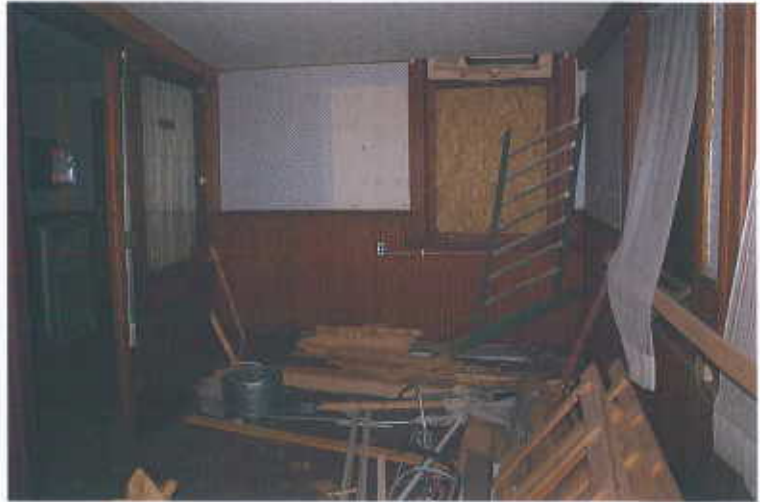
**104.** Room 108, boarded windows, and historic wainscoting.

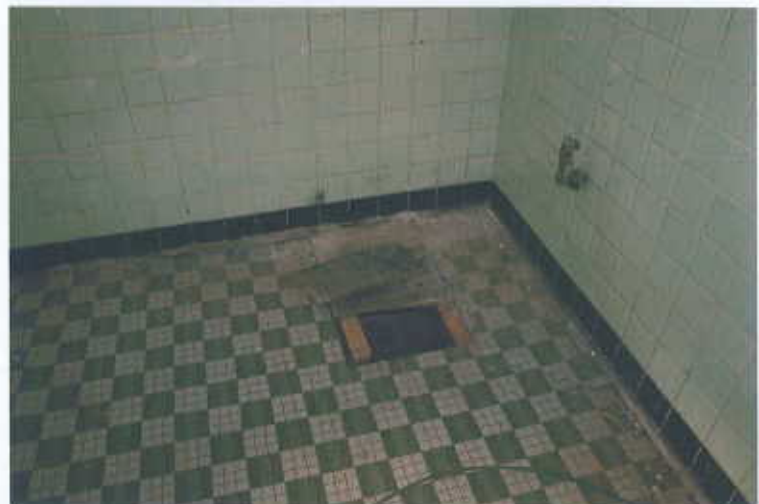
- Rooms 101, 111, and 113 are bathrooms and feature tile wainscoting that likely dates to the 1940s and plaster walls and ceiling. All is in fair to poor condition, with graffiti, dirt, and

111. Room 101, hole in c. 1940s tile flooring.

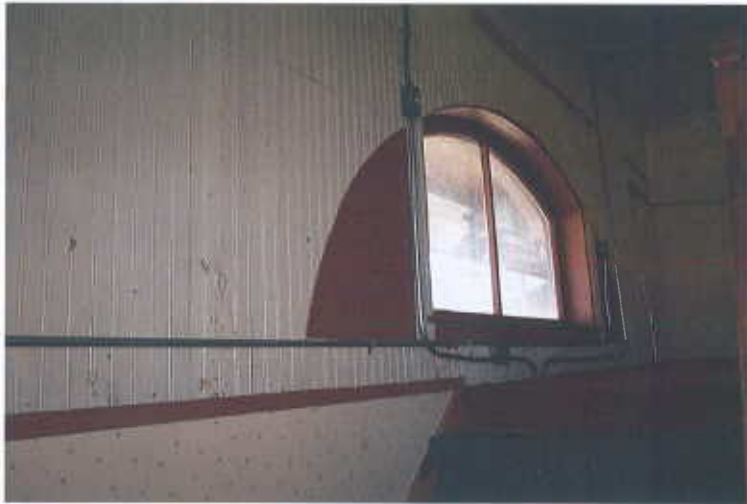
**125.** Room 106, window.

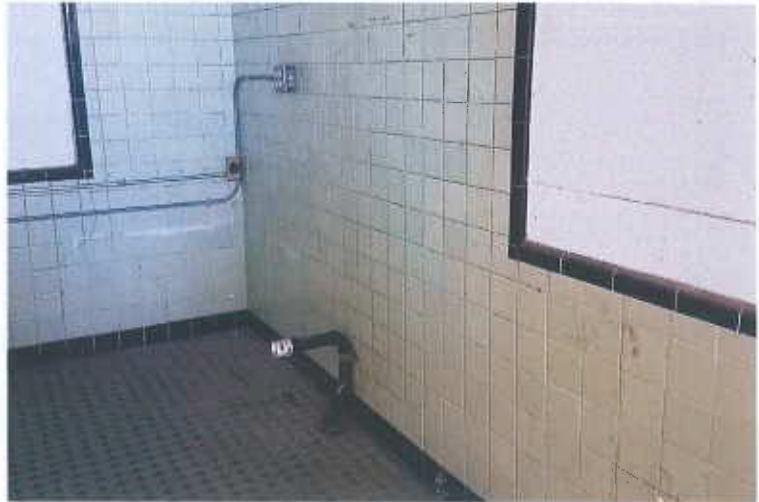
**128.** Plumbing in early restroom, southeast corner of the main wing.

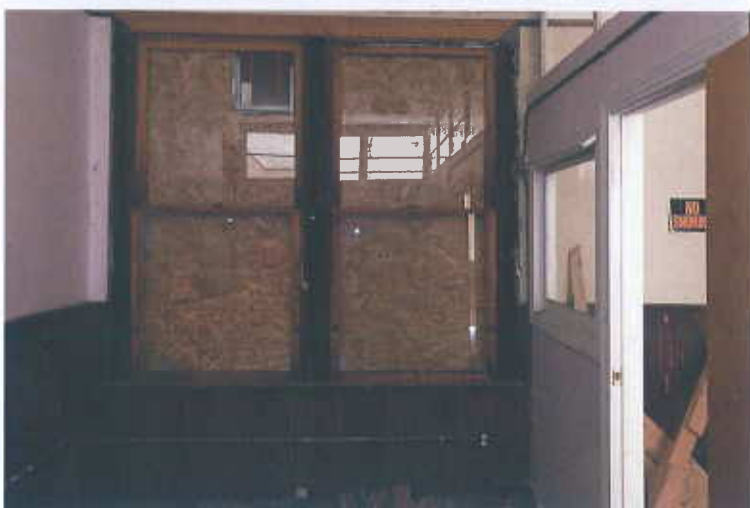
**221.** Room 213, boarded windows and historic wainscoting.

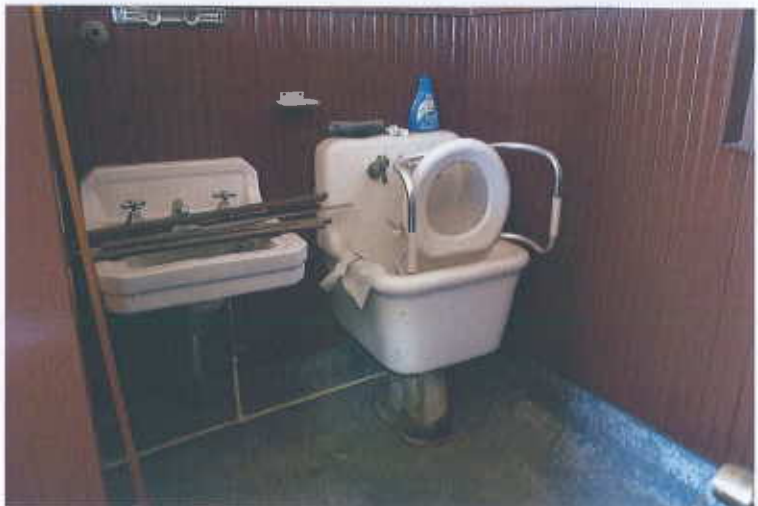
**224.** Plumbing in second floor restroom.
