# HUTCHINSON HOUSE

## Existing Conditions and Recommendations

AUGUST 23, 2019  
FINAL REPORT

Simons Young + associates  
4SE Structural Engineers  
Hillary King, Preservation Consultant

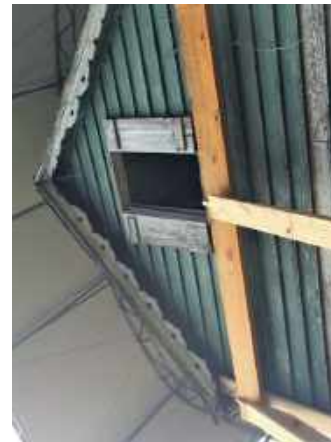
20 East gable end with decorative trim

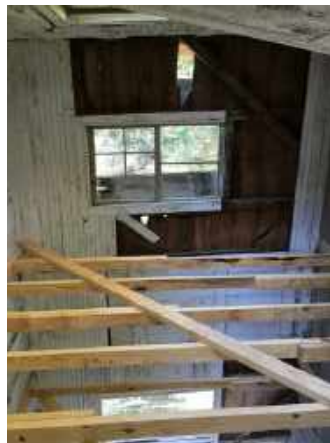
36 First floor - west room looking north. Door has been covered over on the exterior. See northeast elevation photo 8.

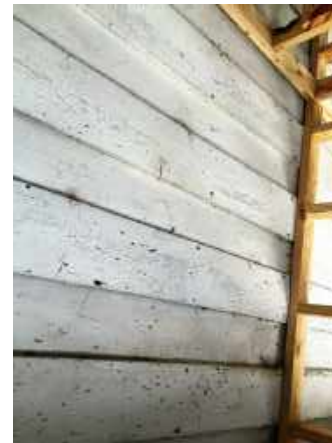
42 Typical ceiling detail

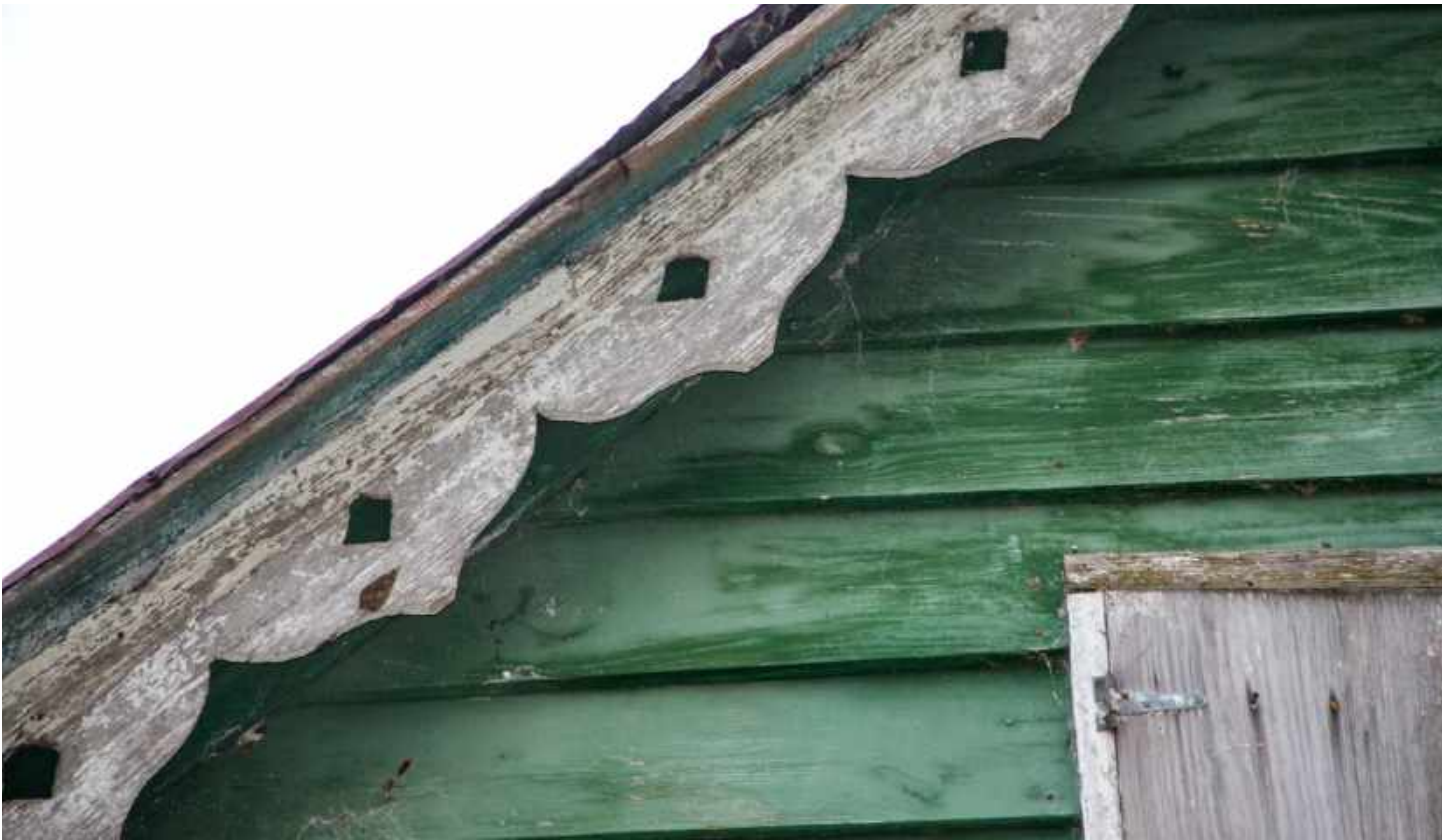
DECORATIVE TRIM AT GABLE END
