# Preservation/Restoration of Moton Field

Tuskegee Airmen  
National Historic Site  
Tuskegee, Alabama

*Historic Structure Report*  
Bath & Locker House

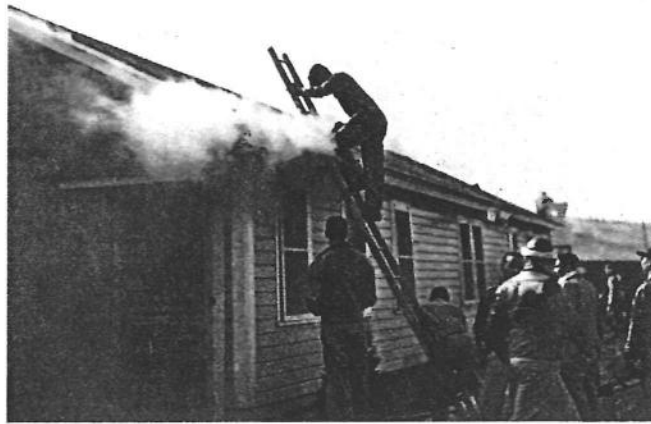
**Figure 3:** Fire in the women's locker room circa 1944. Historic Photograph Collection, Howard University.

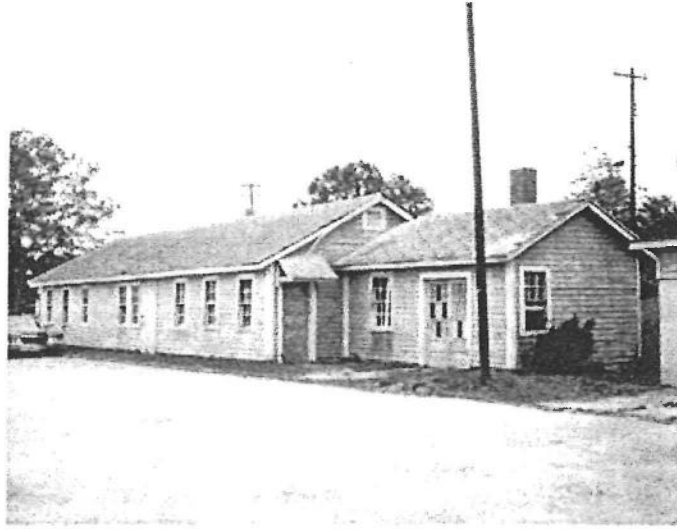
According to Ed Pryce, landscape architect and superintendent of grounds maintenance at Tuskegee Institute from 1955-1969, there was little money to maintain Moton Field during the 1950s and 1960s, and the airfield and its buildings deteriorated.<sup>37</sup> A photograph from the 1970s shows the building to be in fair condition.<sup>38</sup> (See *Figure 5*.)

**Figure 5:** North and west facades on June 14, 1977. Booker Conley's Files, Physical Plant, Tuskegee University.

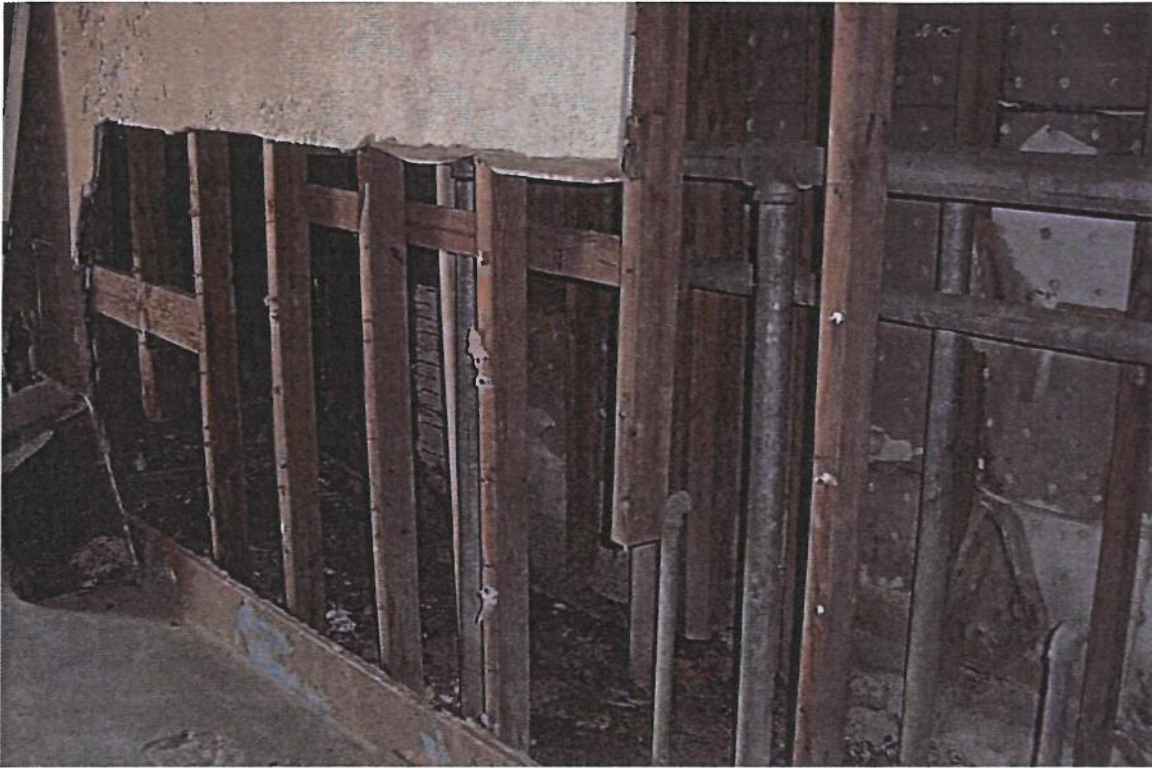
**Figure 11:** View of the plumbing chase that separates the men's and women's facilities.

A small chase 1½ feet wide runs the width of the building between the men's toilet and the women's locker room and toilet. This area contains numerous pipes for plumbing and sewage. (See *Figure 11*.) An access hole has been cut in the wall at the northeast corner of the men's toilet area.

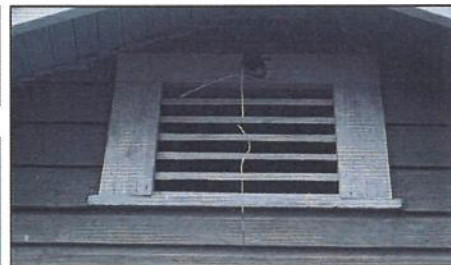
| <b>Deficiency:</b> None |

| <b>Recommendation:</b> Repaint to match original color scheme. |

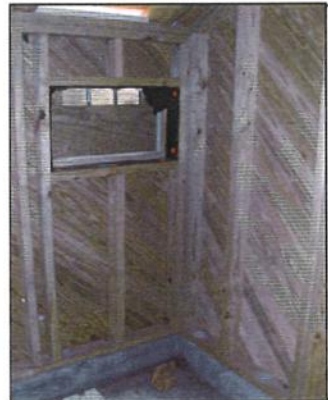
**Deficiency:** Replaced with wood sheathing  
No interior finish material present.

**Recommendation:** Utilize as restored.

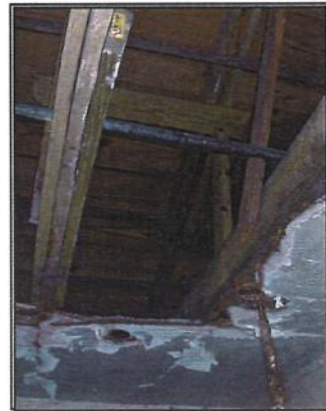
| <b>Deficiency:</b> | Missing portions of ceiling in facility. |

| <b>Recommendation:</b> | Utilize as restored. |

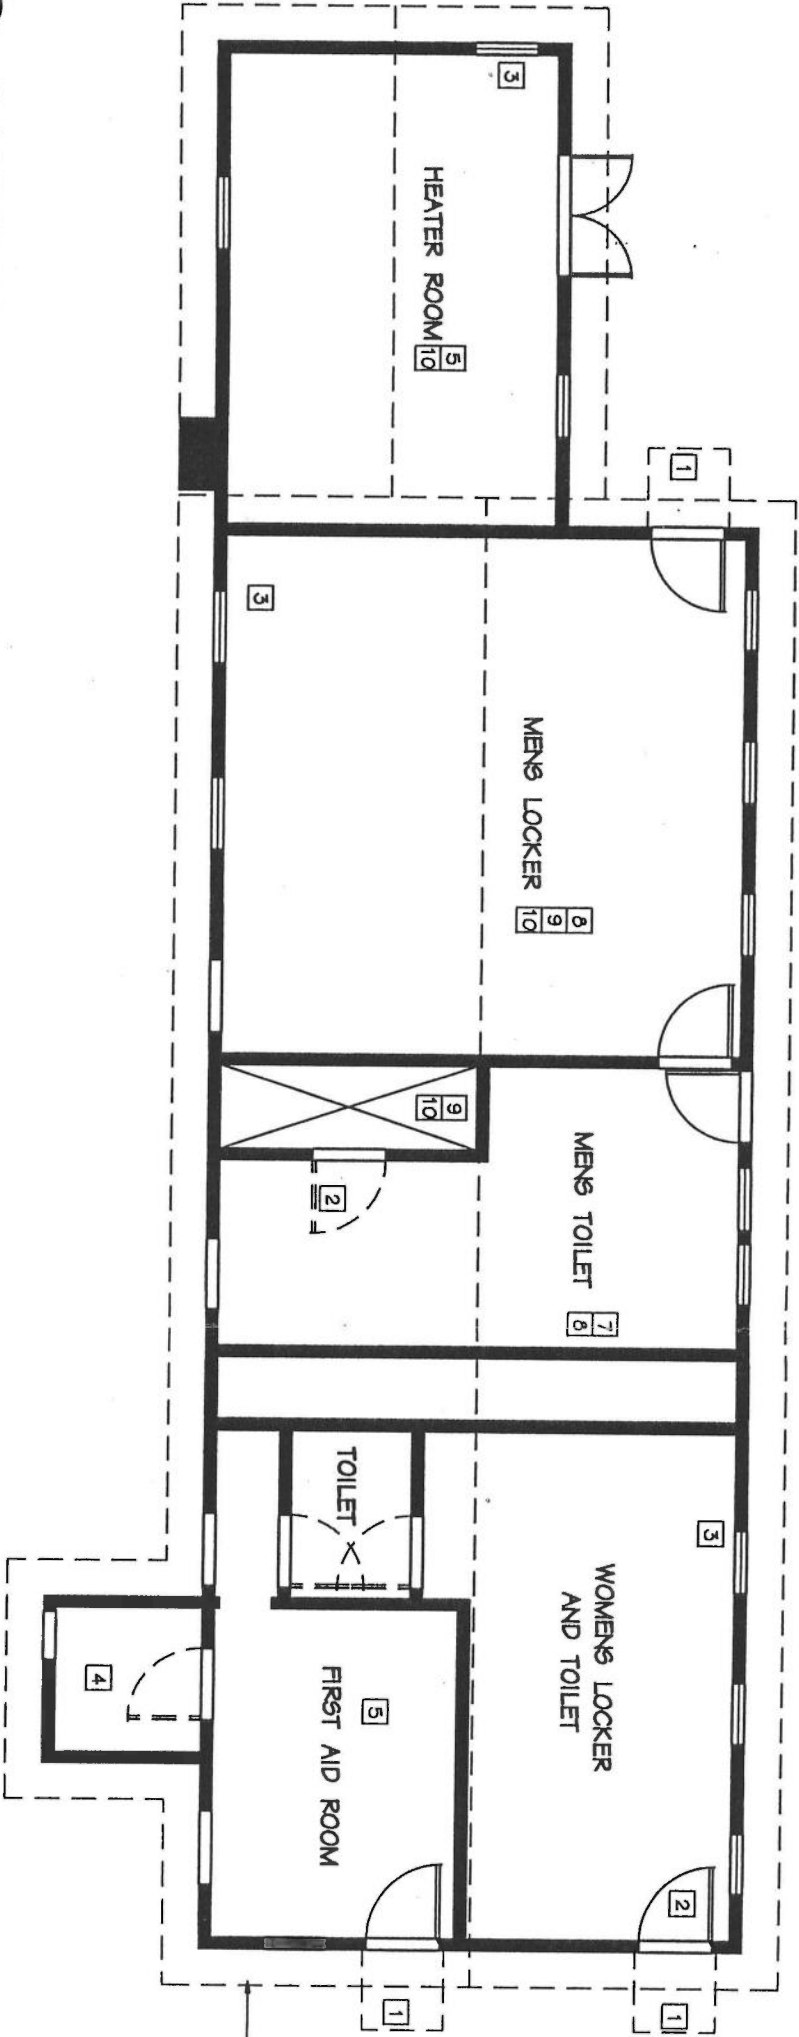
FLOOR PLAN  
SCALE: 1/4" = 1'-0"

- 1 FRAMED AWNING
- 2 WOOD DOOR (TYP)
- 3 WOOD FRAMED WINDOW W/ SCREENS (TYP)
- 4 COMPLETELY REDONE
- 5 FLOOR EXPOSED CONCRETE W/ CONCRETE 8" BASE
- 6 PARTIAL 8" CONCRETE BASE
- 7 PAINT PEELING OFF MOST/ALL WALLS
- 8 PARTIAL STRUCTURE OF WALL IS MISSING/DAMAGED/ROTTED
- 9 WOOD SUPPORT GONE/ROTTED
- 10 CEILING DAMAGED/MISSING

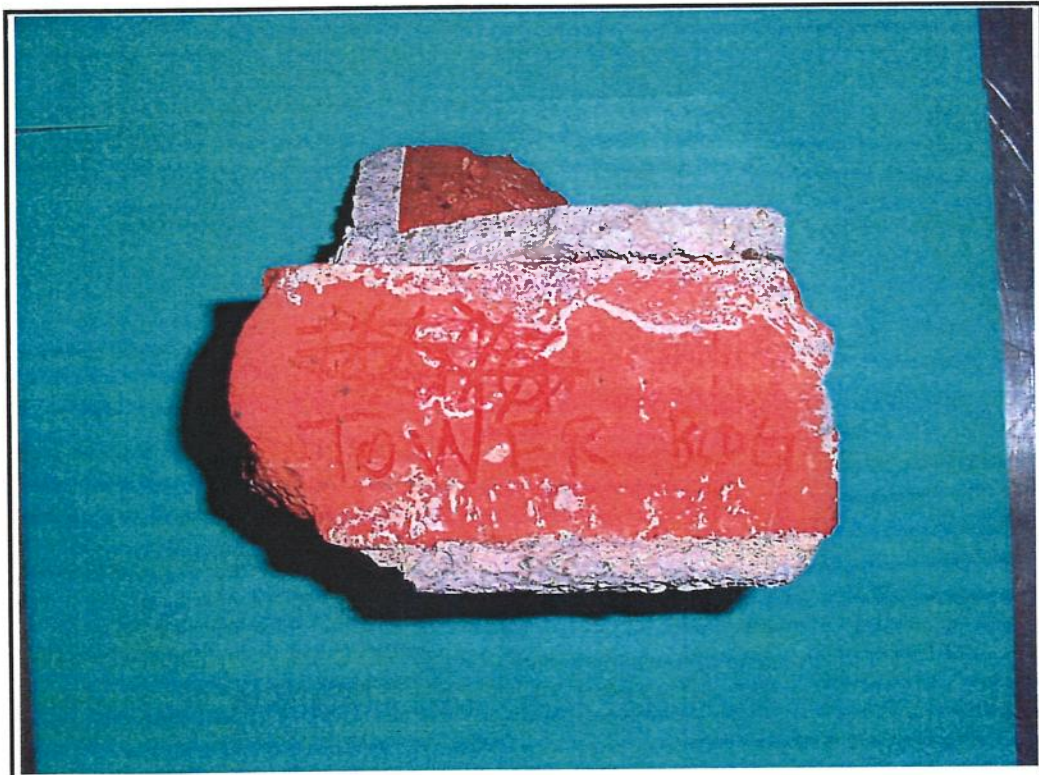
Photo 4. Brick/Mortar sample taken from exterior of Control Tower Building

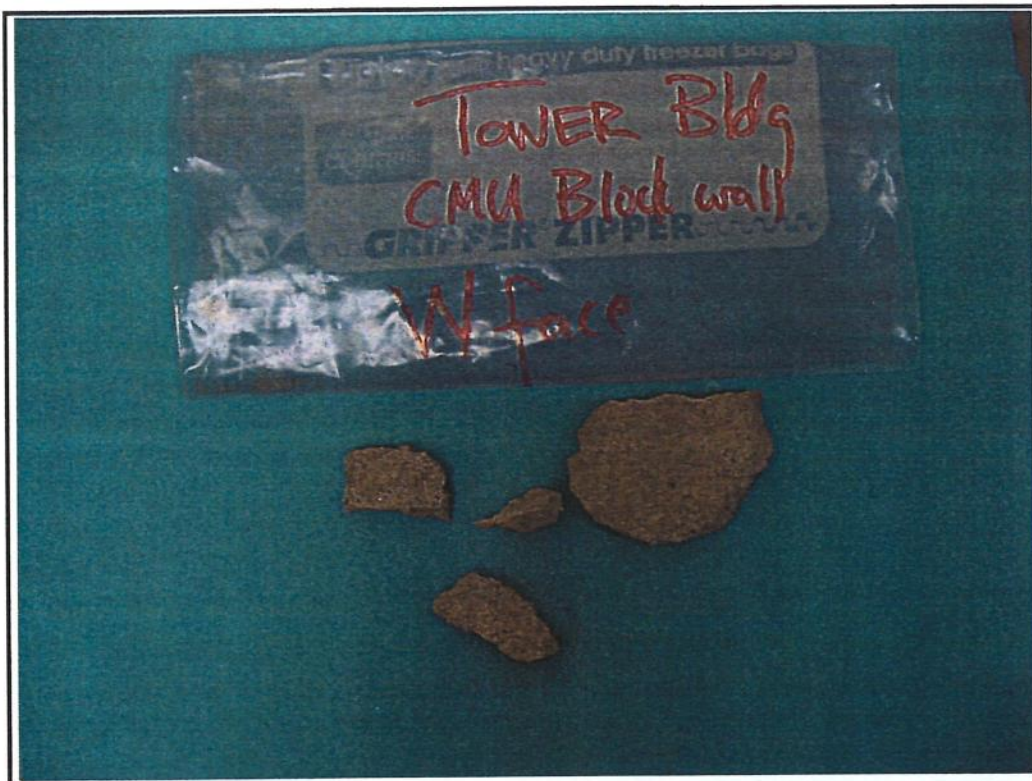
Photo 5. Mortar samples from Control Tower – exterior west face of building

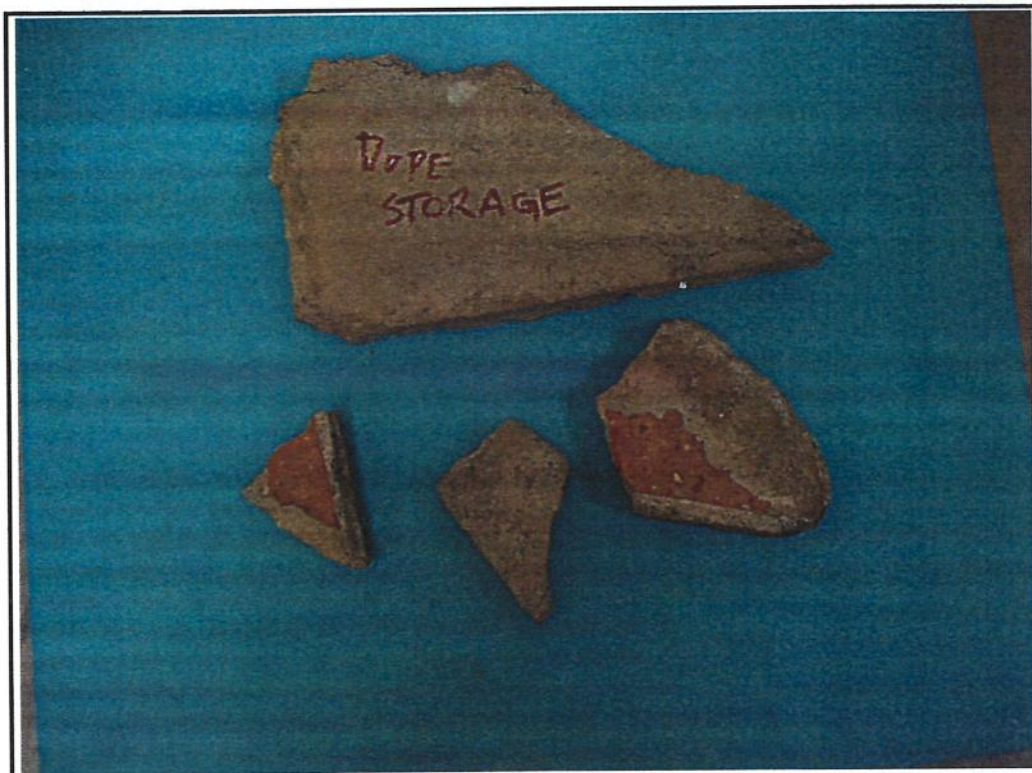
Photo 6. Mortar/Brick samples taken from interior of Dope Storage Shed

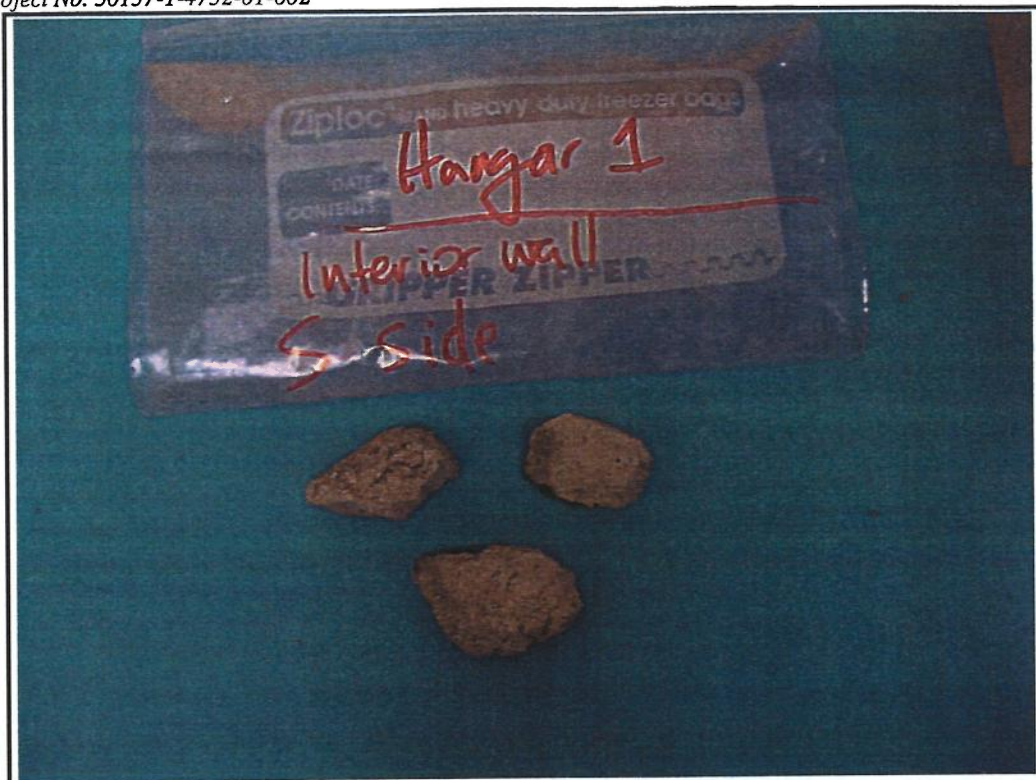
Photo 13. Hangar No. 1, Interior South Side— Mortar taken from brick

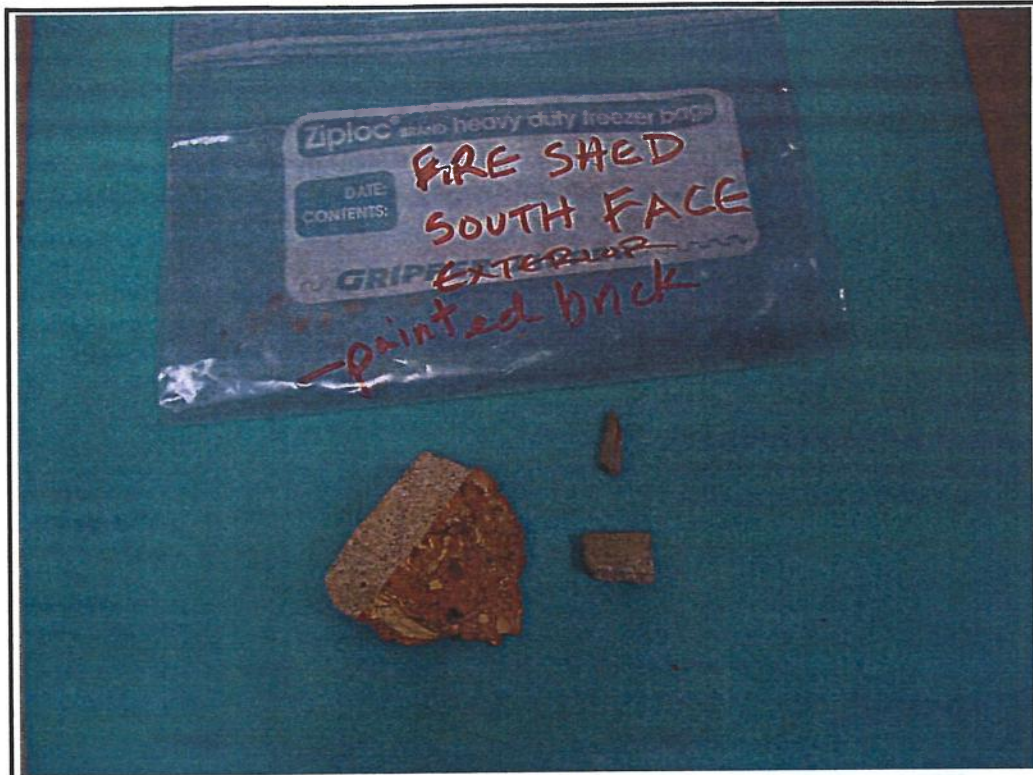
Photo 16. Fire Protection Shed – Mortar/brick samples from south face. Brick painted on side not shown.

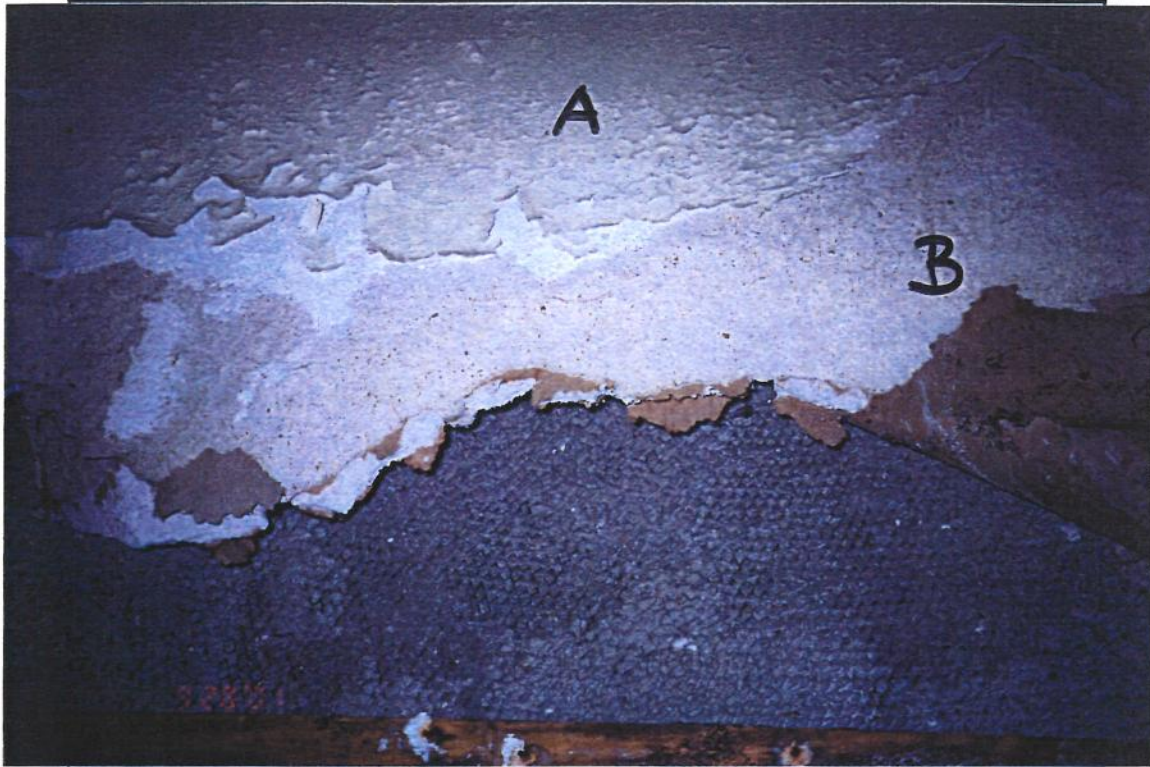
The plaster sample analyzed from the Bath and Locker House was a gypsum-based material (Photos 20 and 21 ). This is typical plaster material. The gypsum board sample was analyzed similar to the mortars. There was an indication that gypsum was present, but it was not quantified.

Photo 20. Bath and Locker House – Interior, Plaster (A) and gypsum board (B)

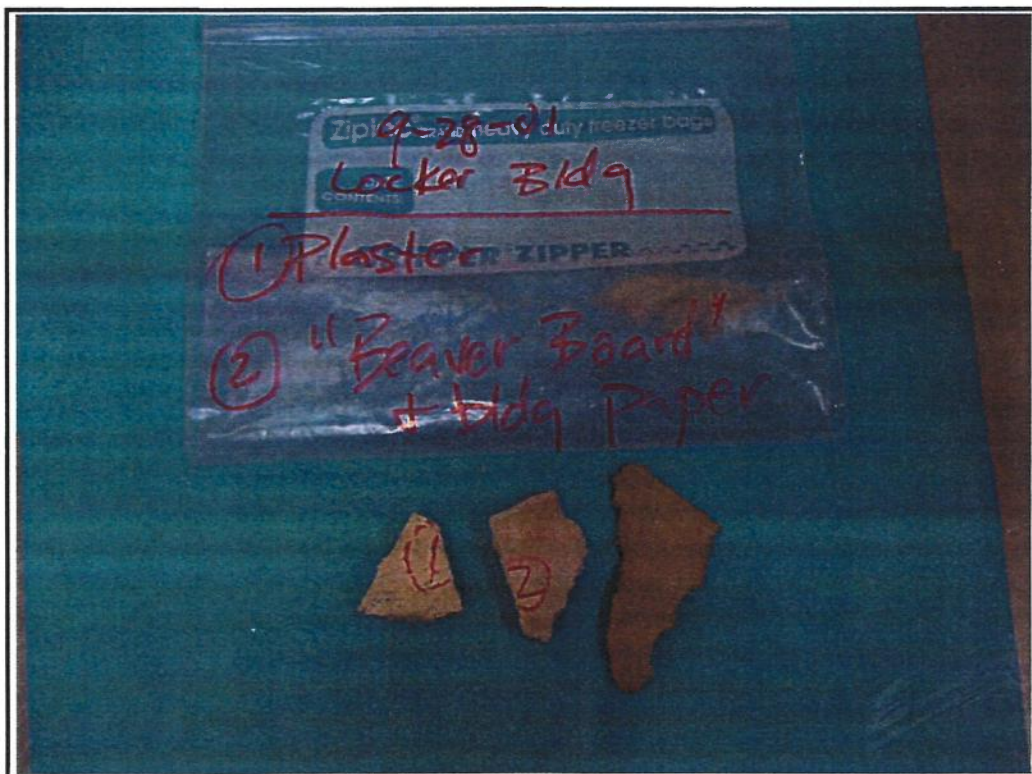
Photo 21. Bath and Locker House – Samples of Plaster (1) and gypsum board (2) with building paper (3)
