# CAHOON MANSION

## ENVELOPE STABILIZATION ASSESSMENT

Entelen Design-Build, LLC. + FFKR Architects

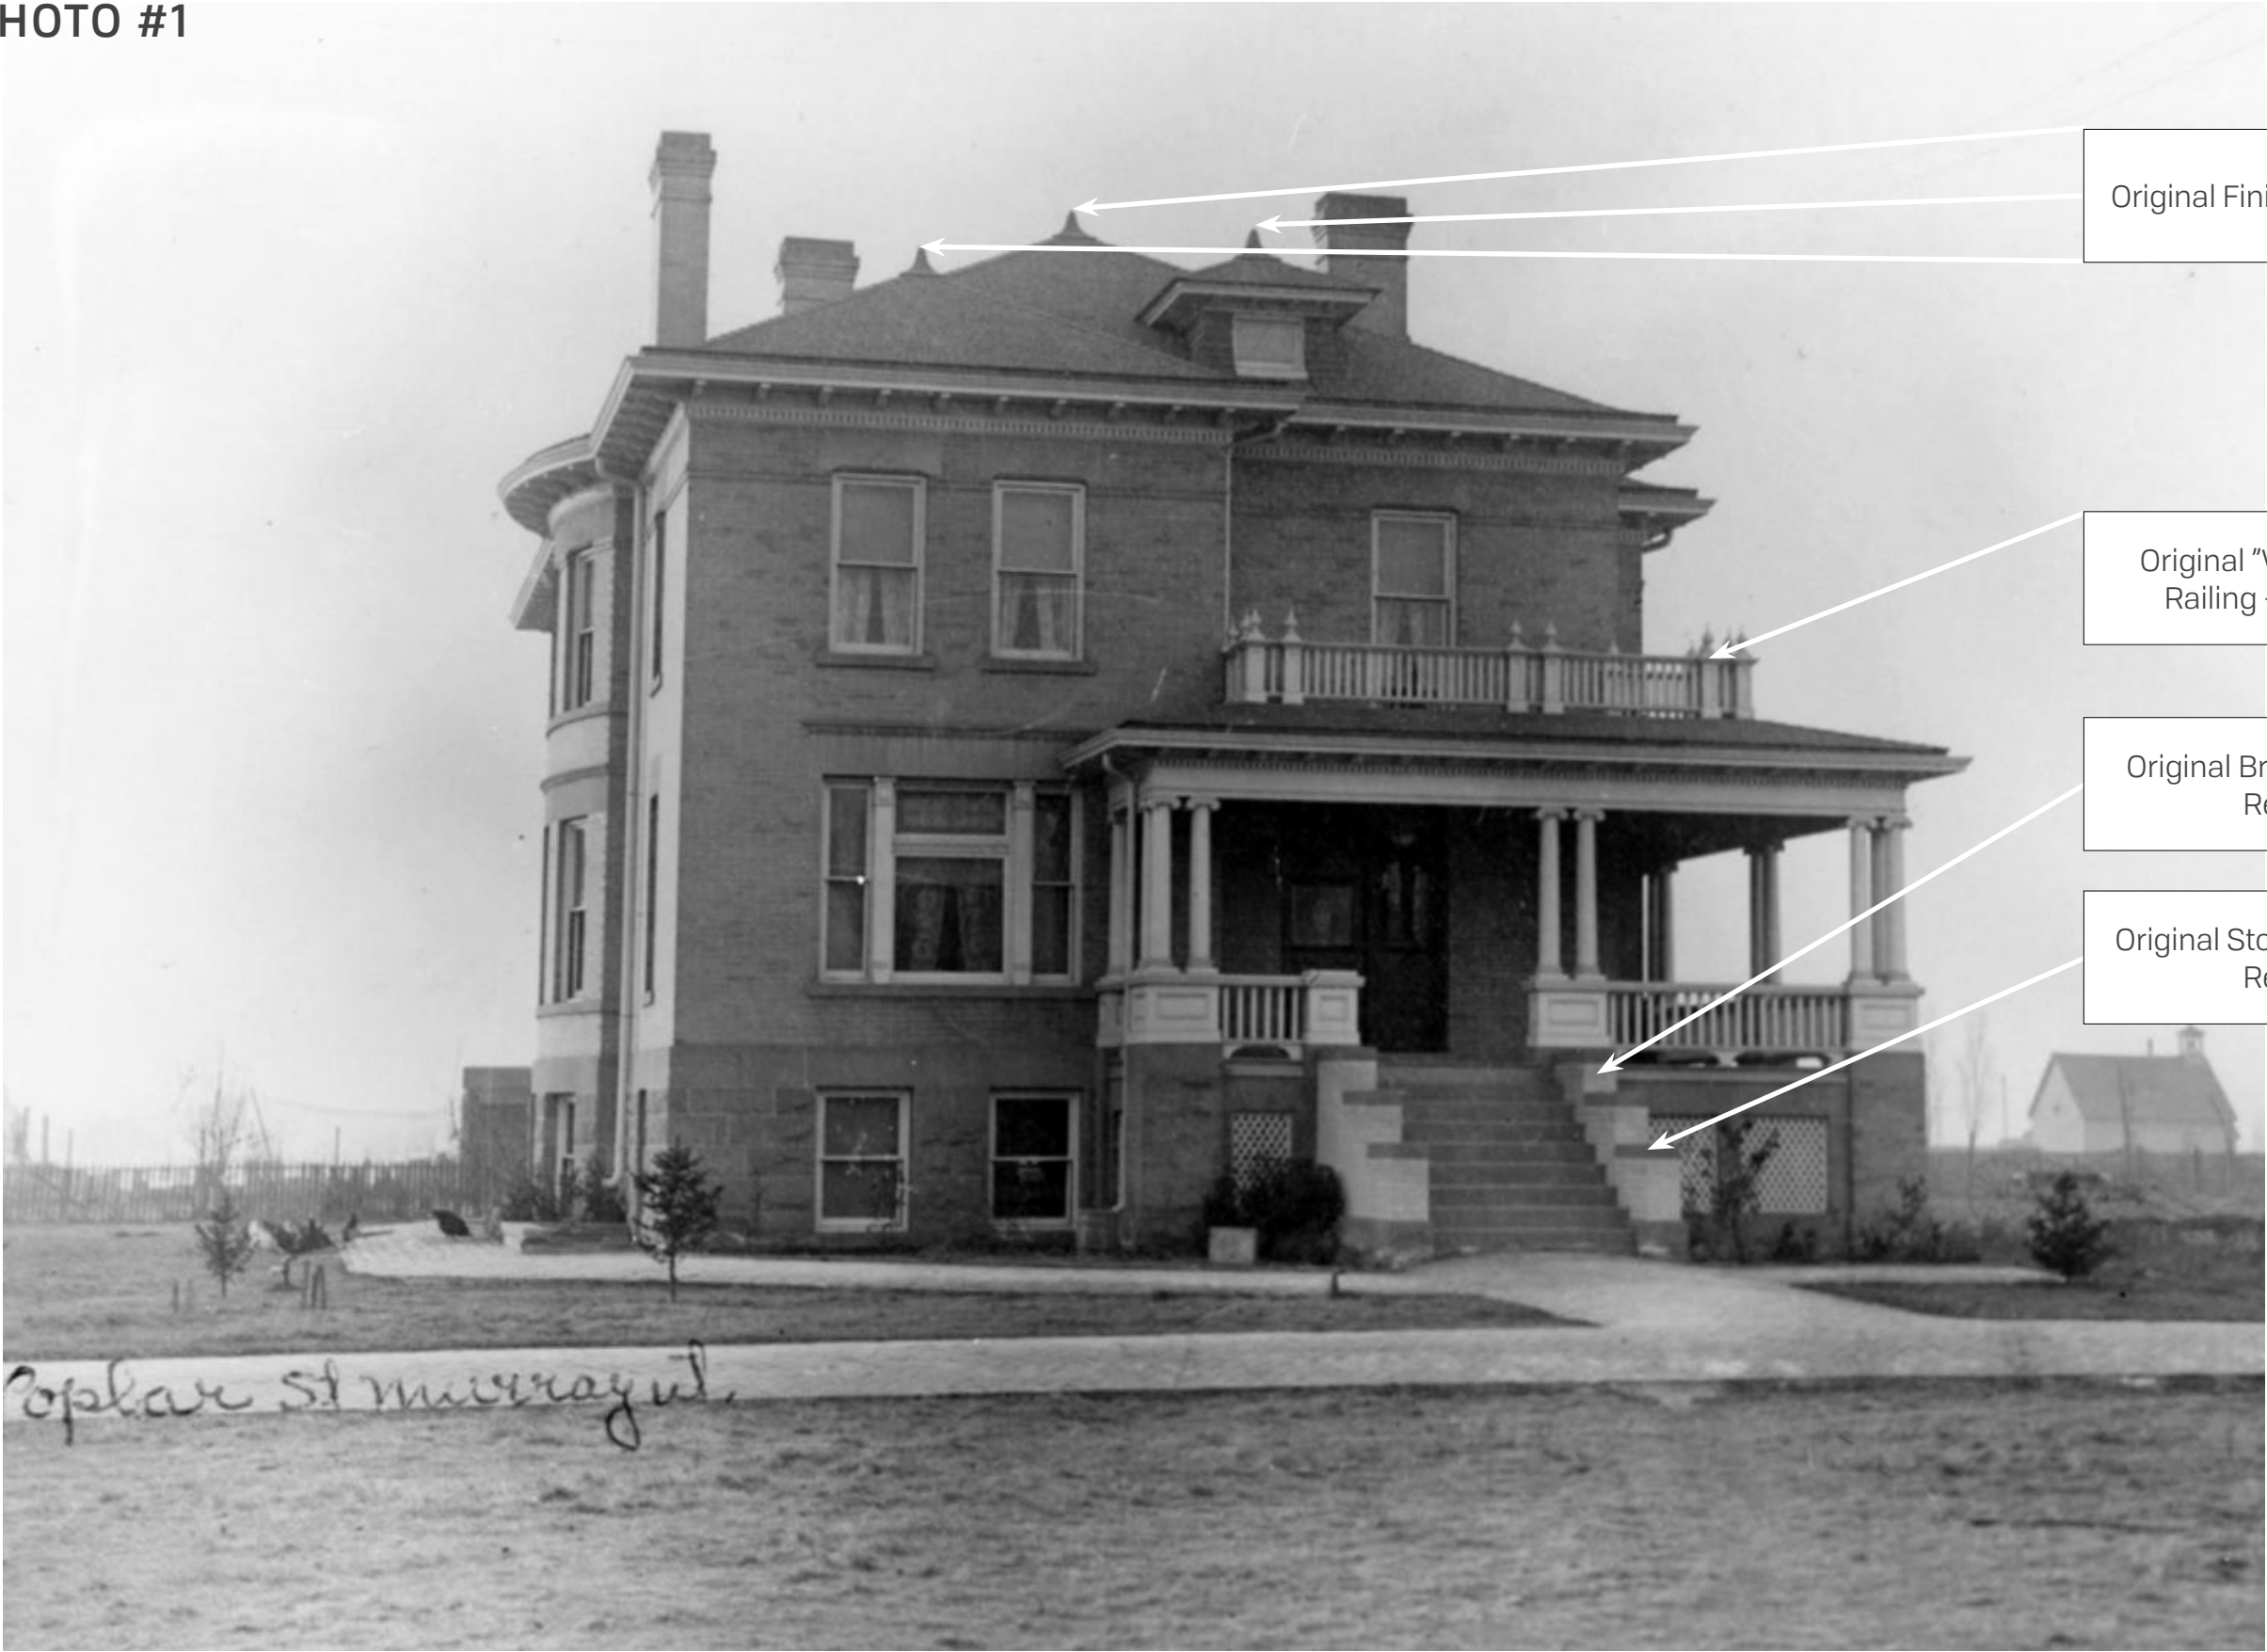
Location of Modern  
Dormer Addition

Remove the plywood soffit and fascia from the large, modern dormer. Install a bracketed wood soffit and detailed fascia to match the historic dormers. Repaint the wood with a high-quality exterior primer and paint.

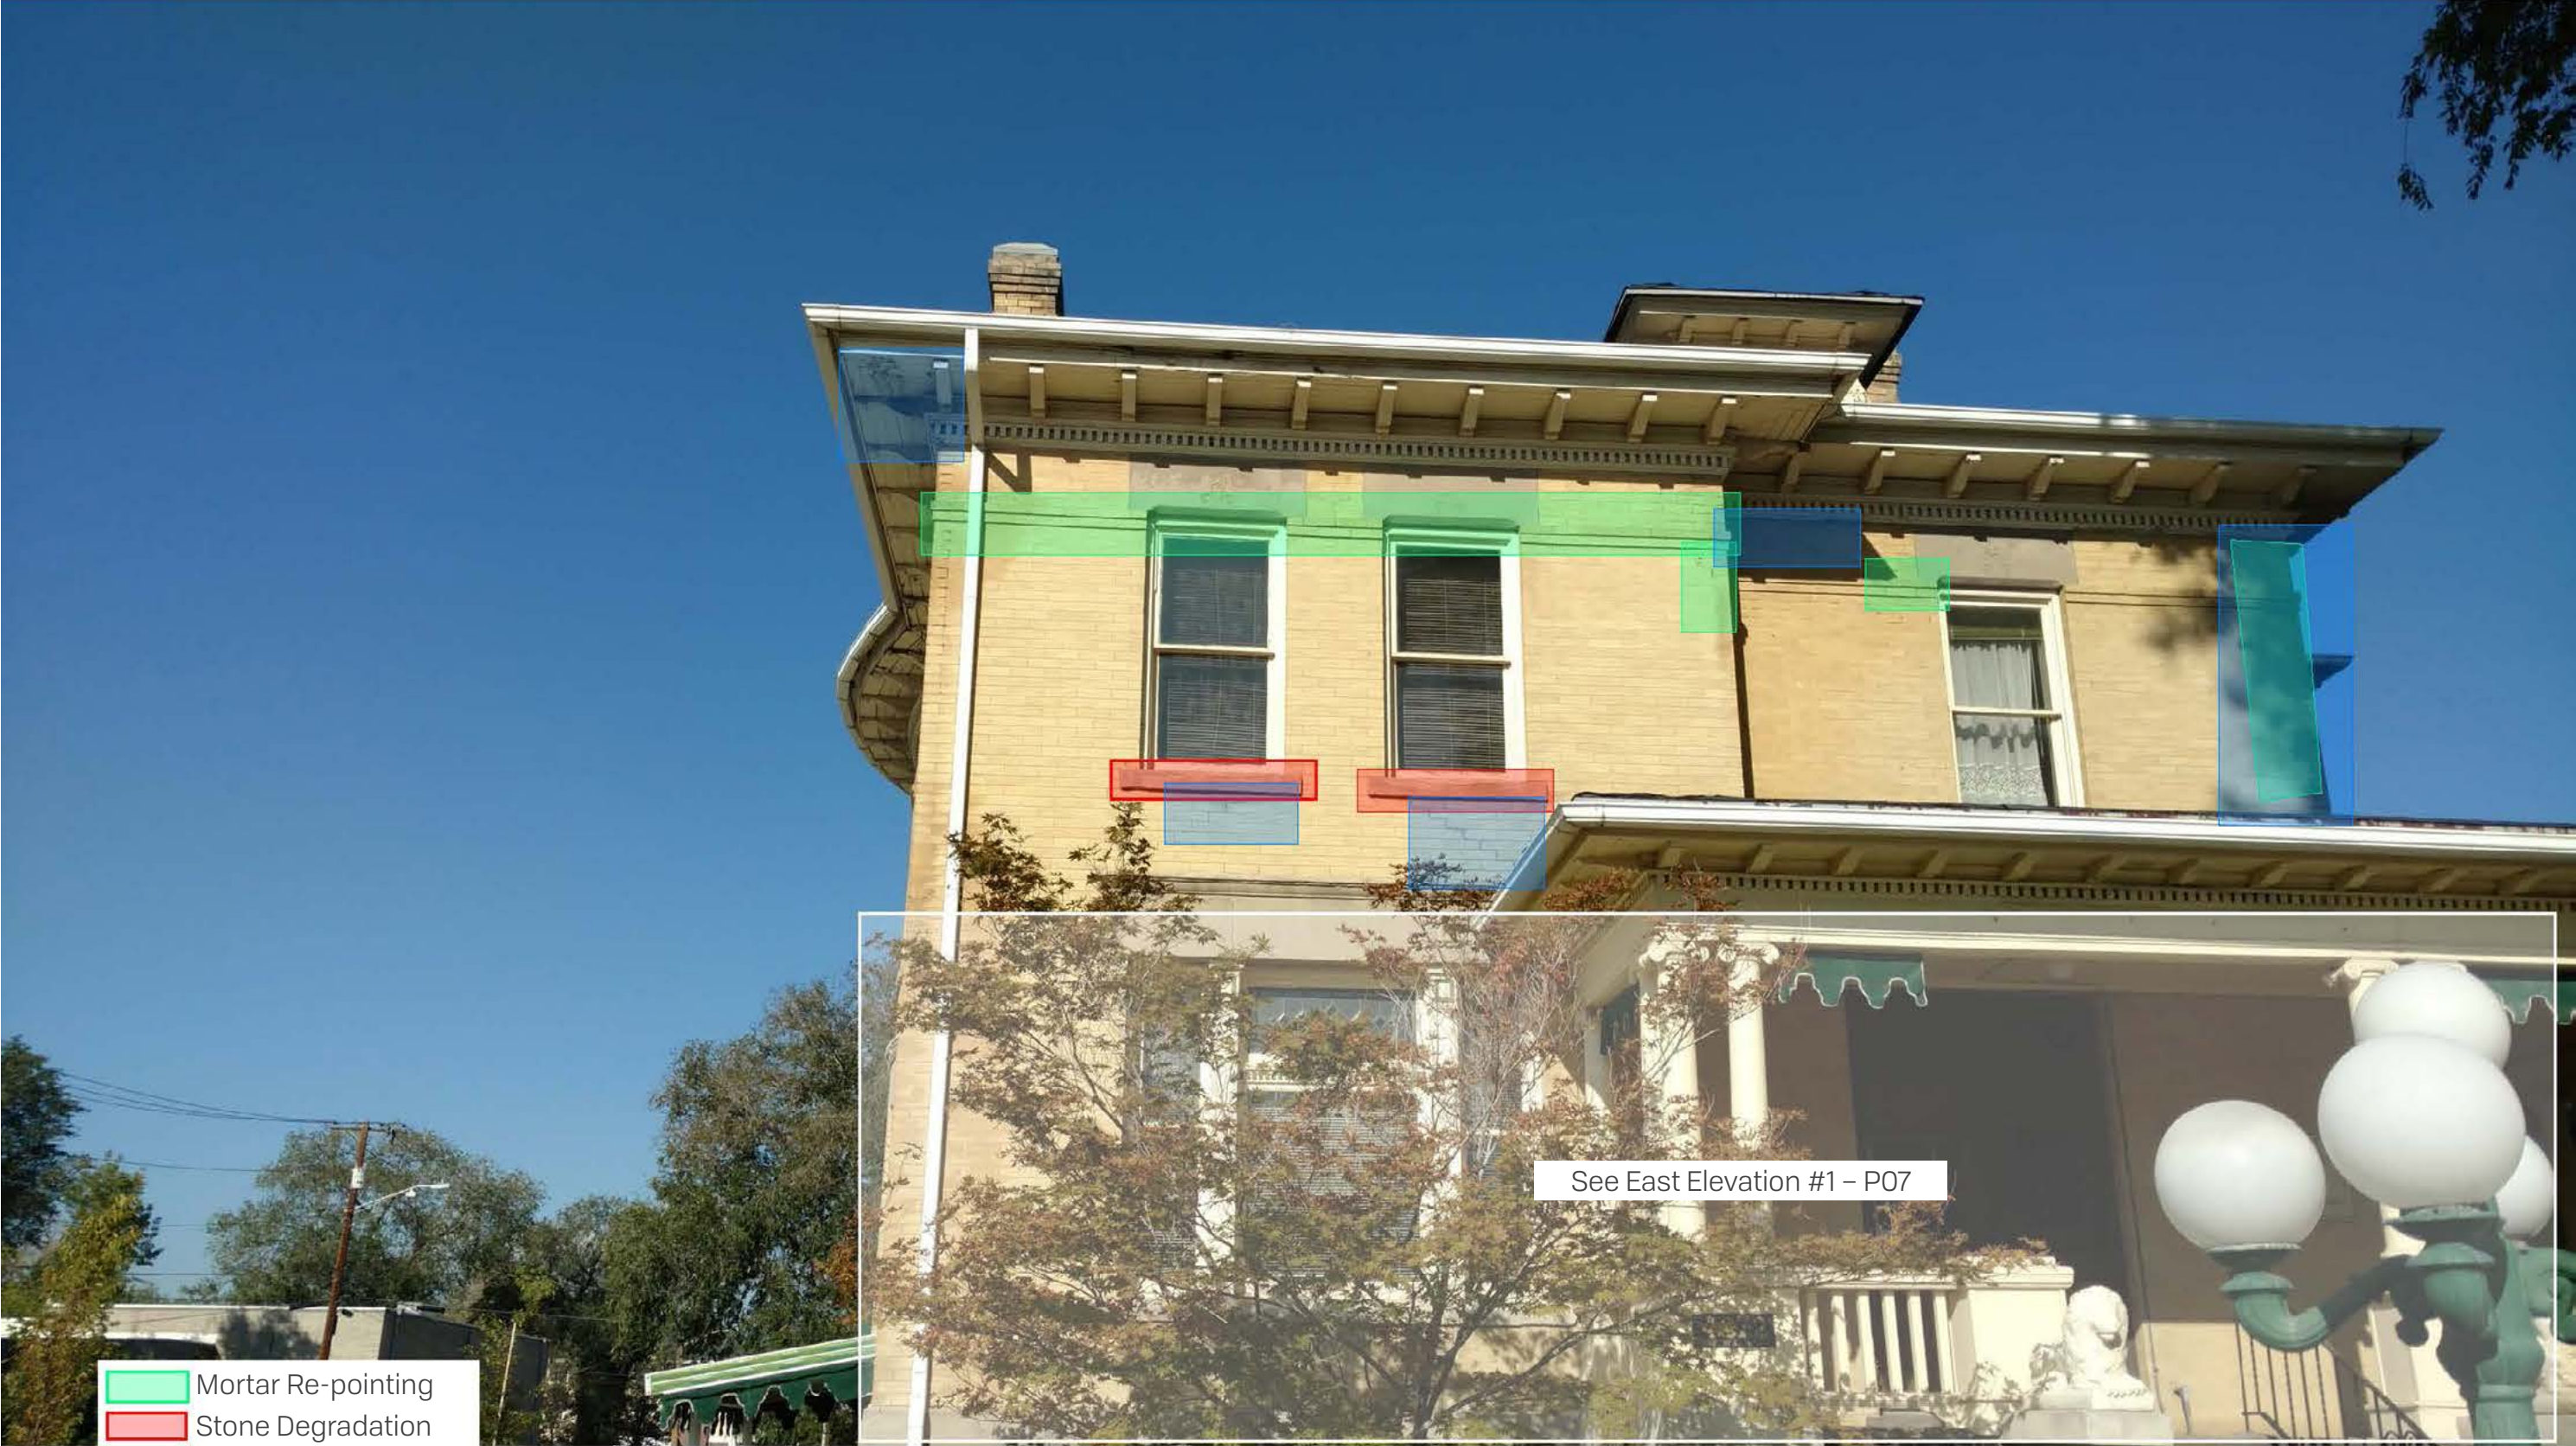
- Mortar Re-pointing
- Stone Degradation
- Water Damage

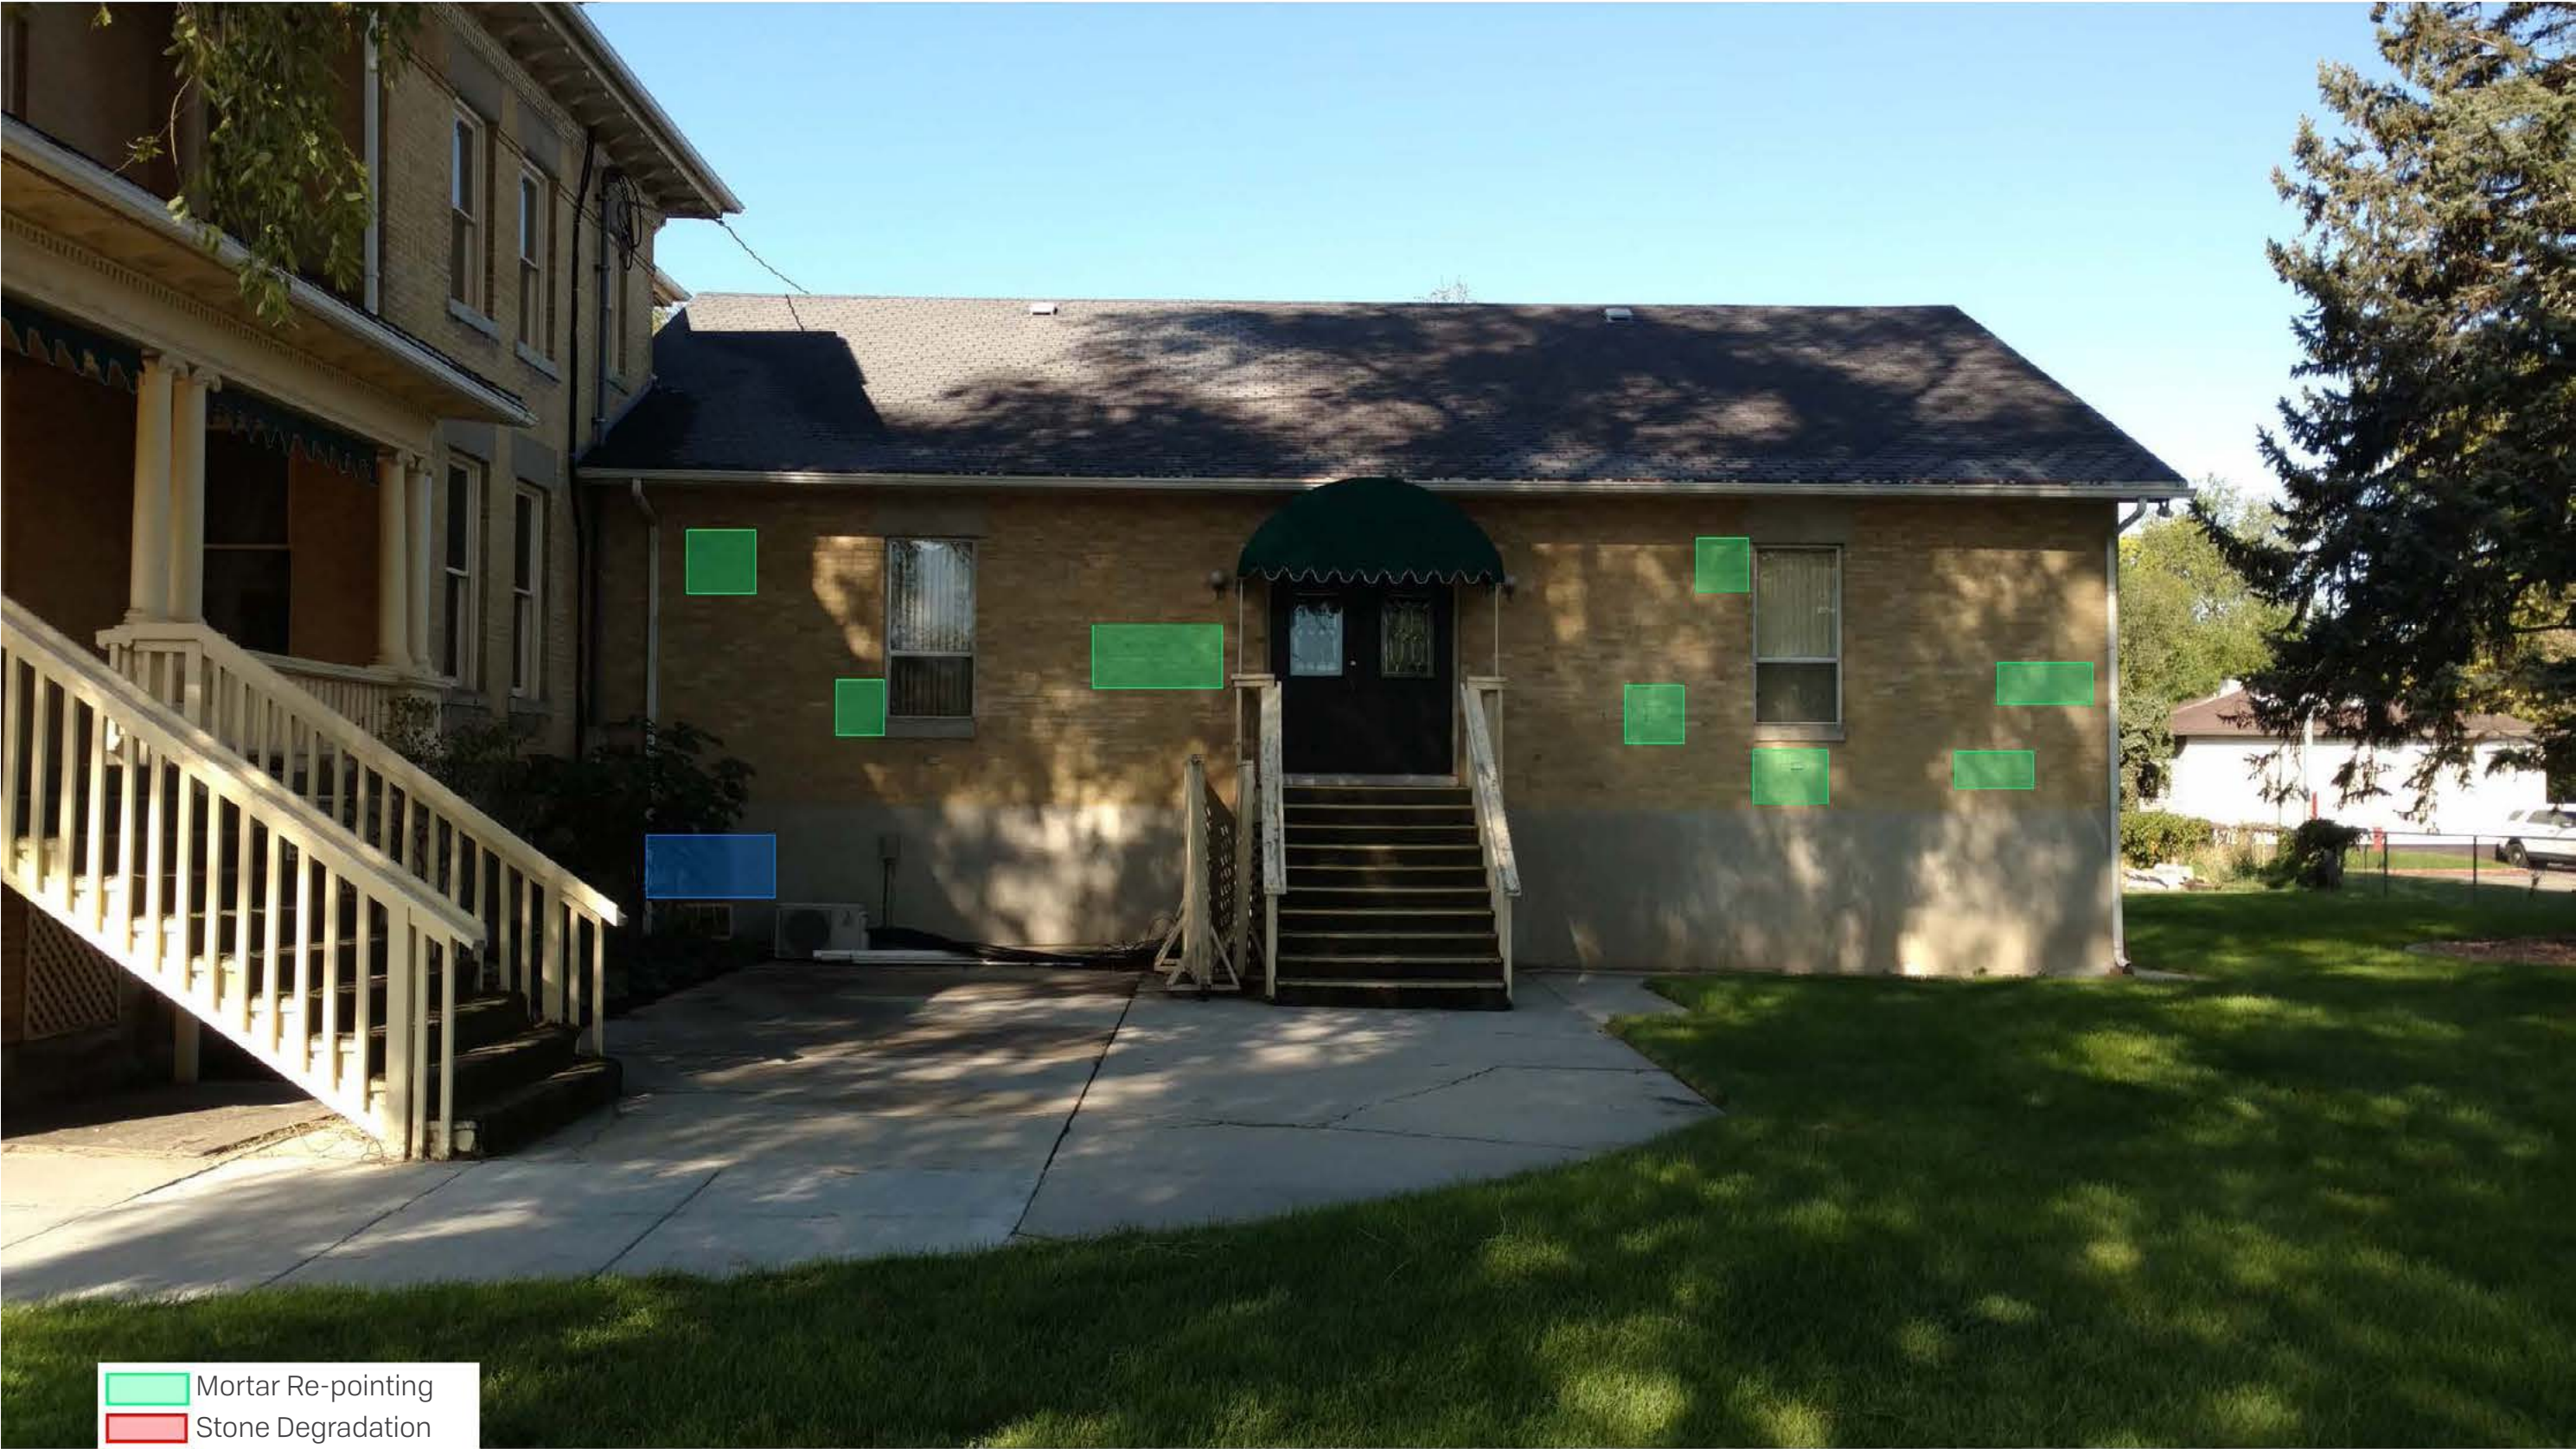
- Mortar Re-pointing
- Stone Degradation
- Water Damage

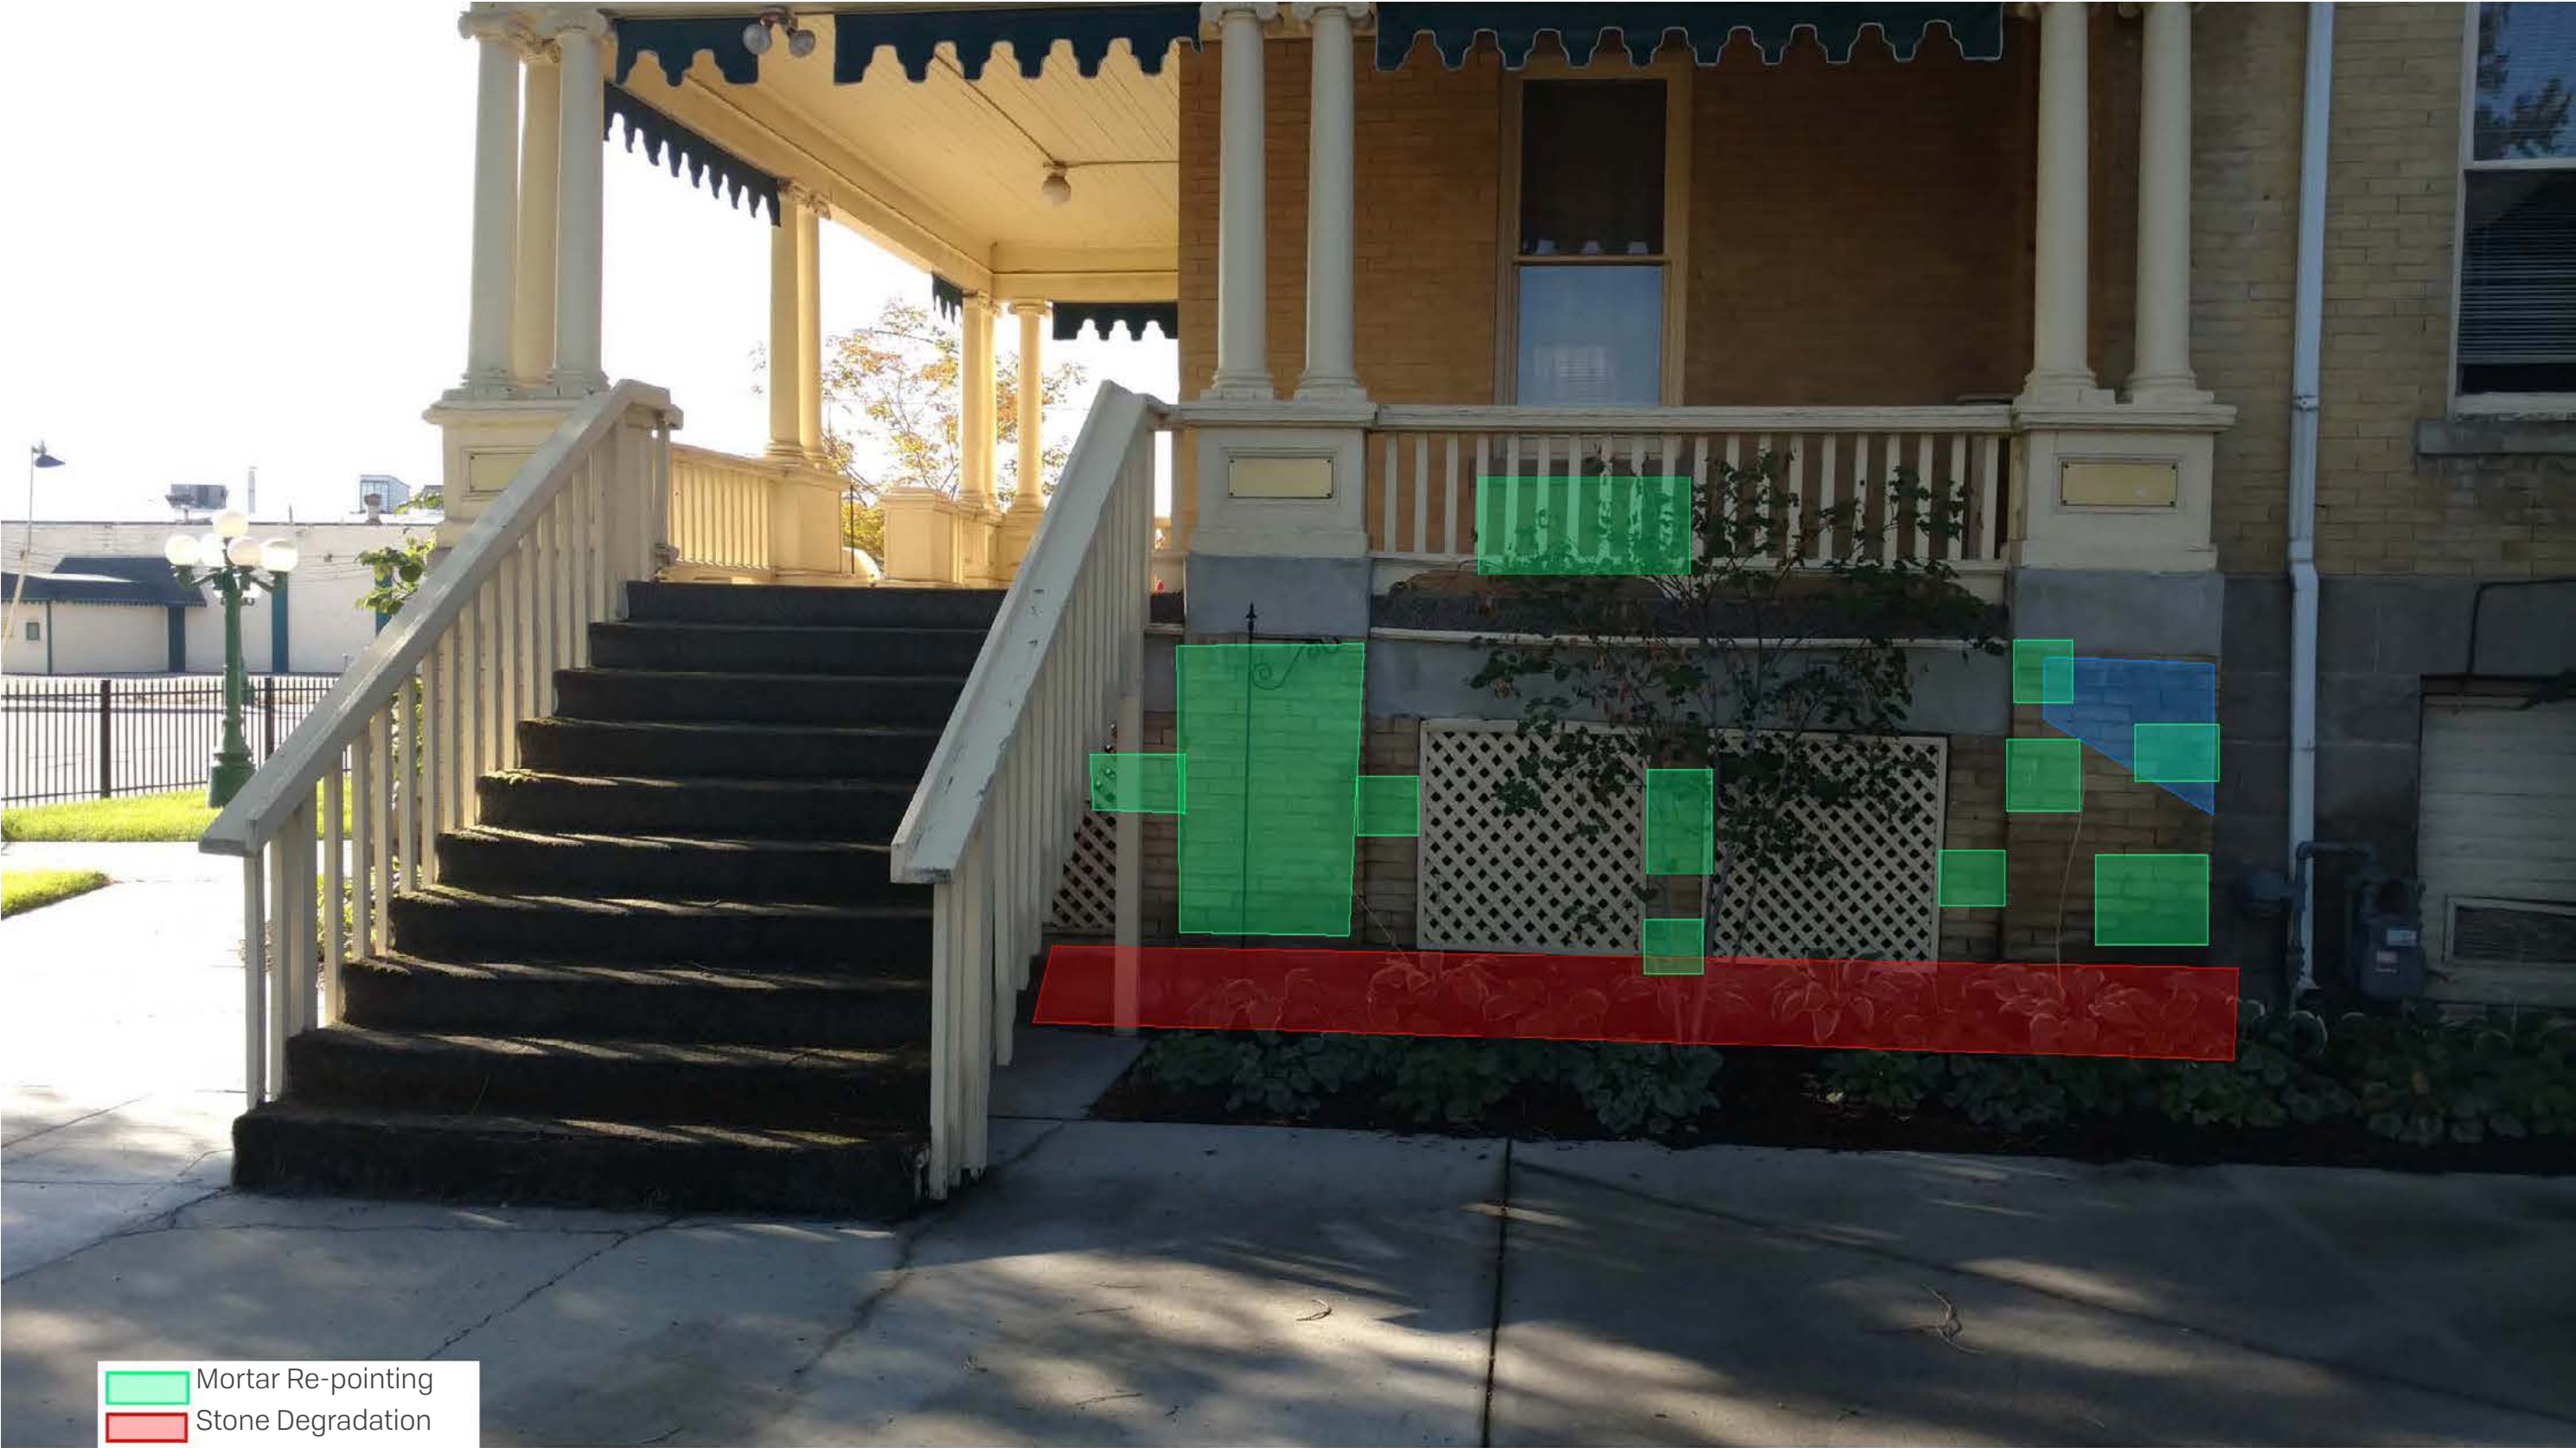
Mortar Re-pointing

Stone Degradation

Water Damage

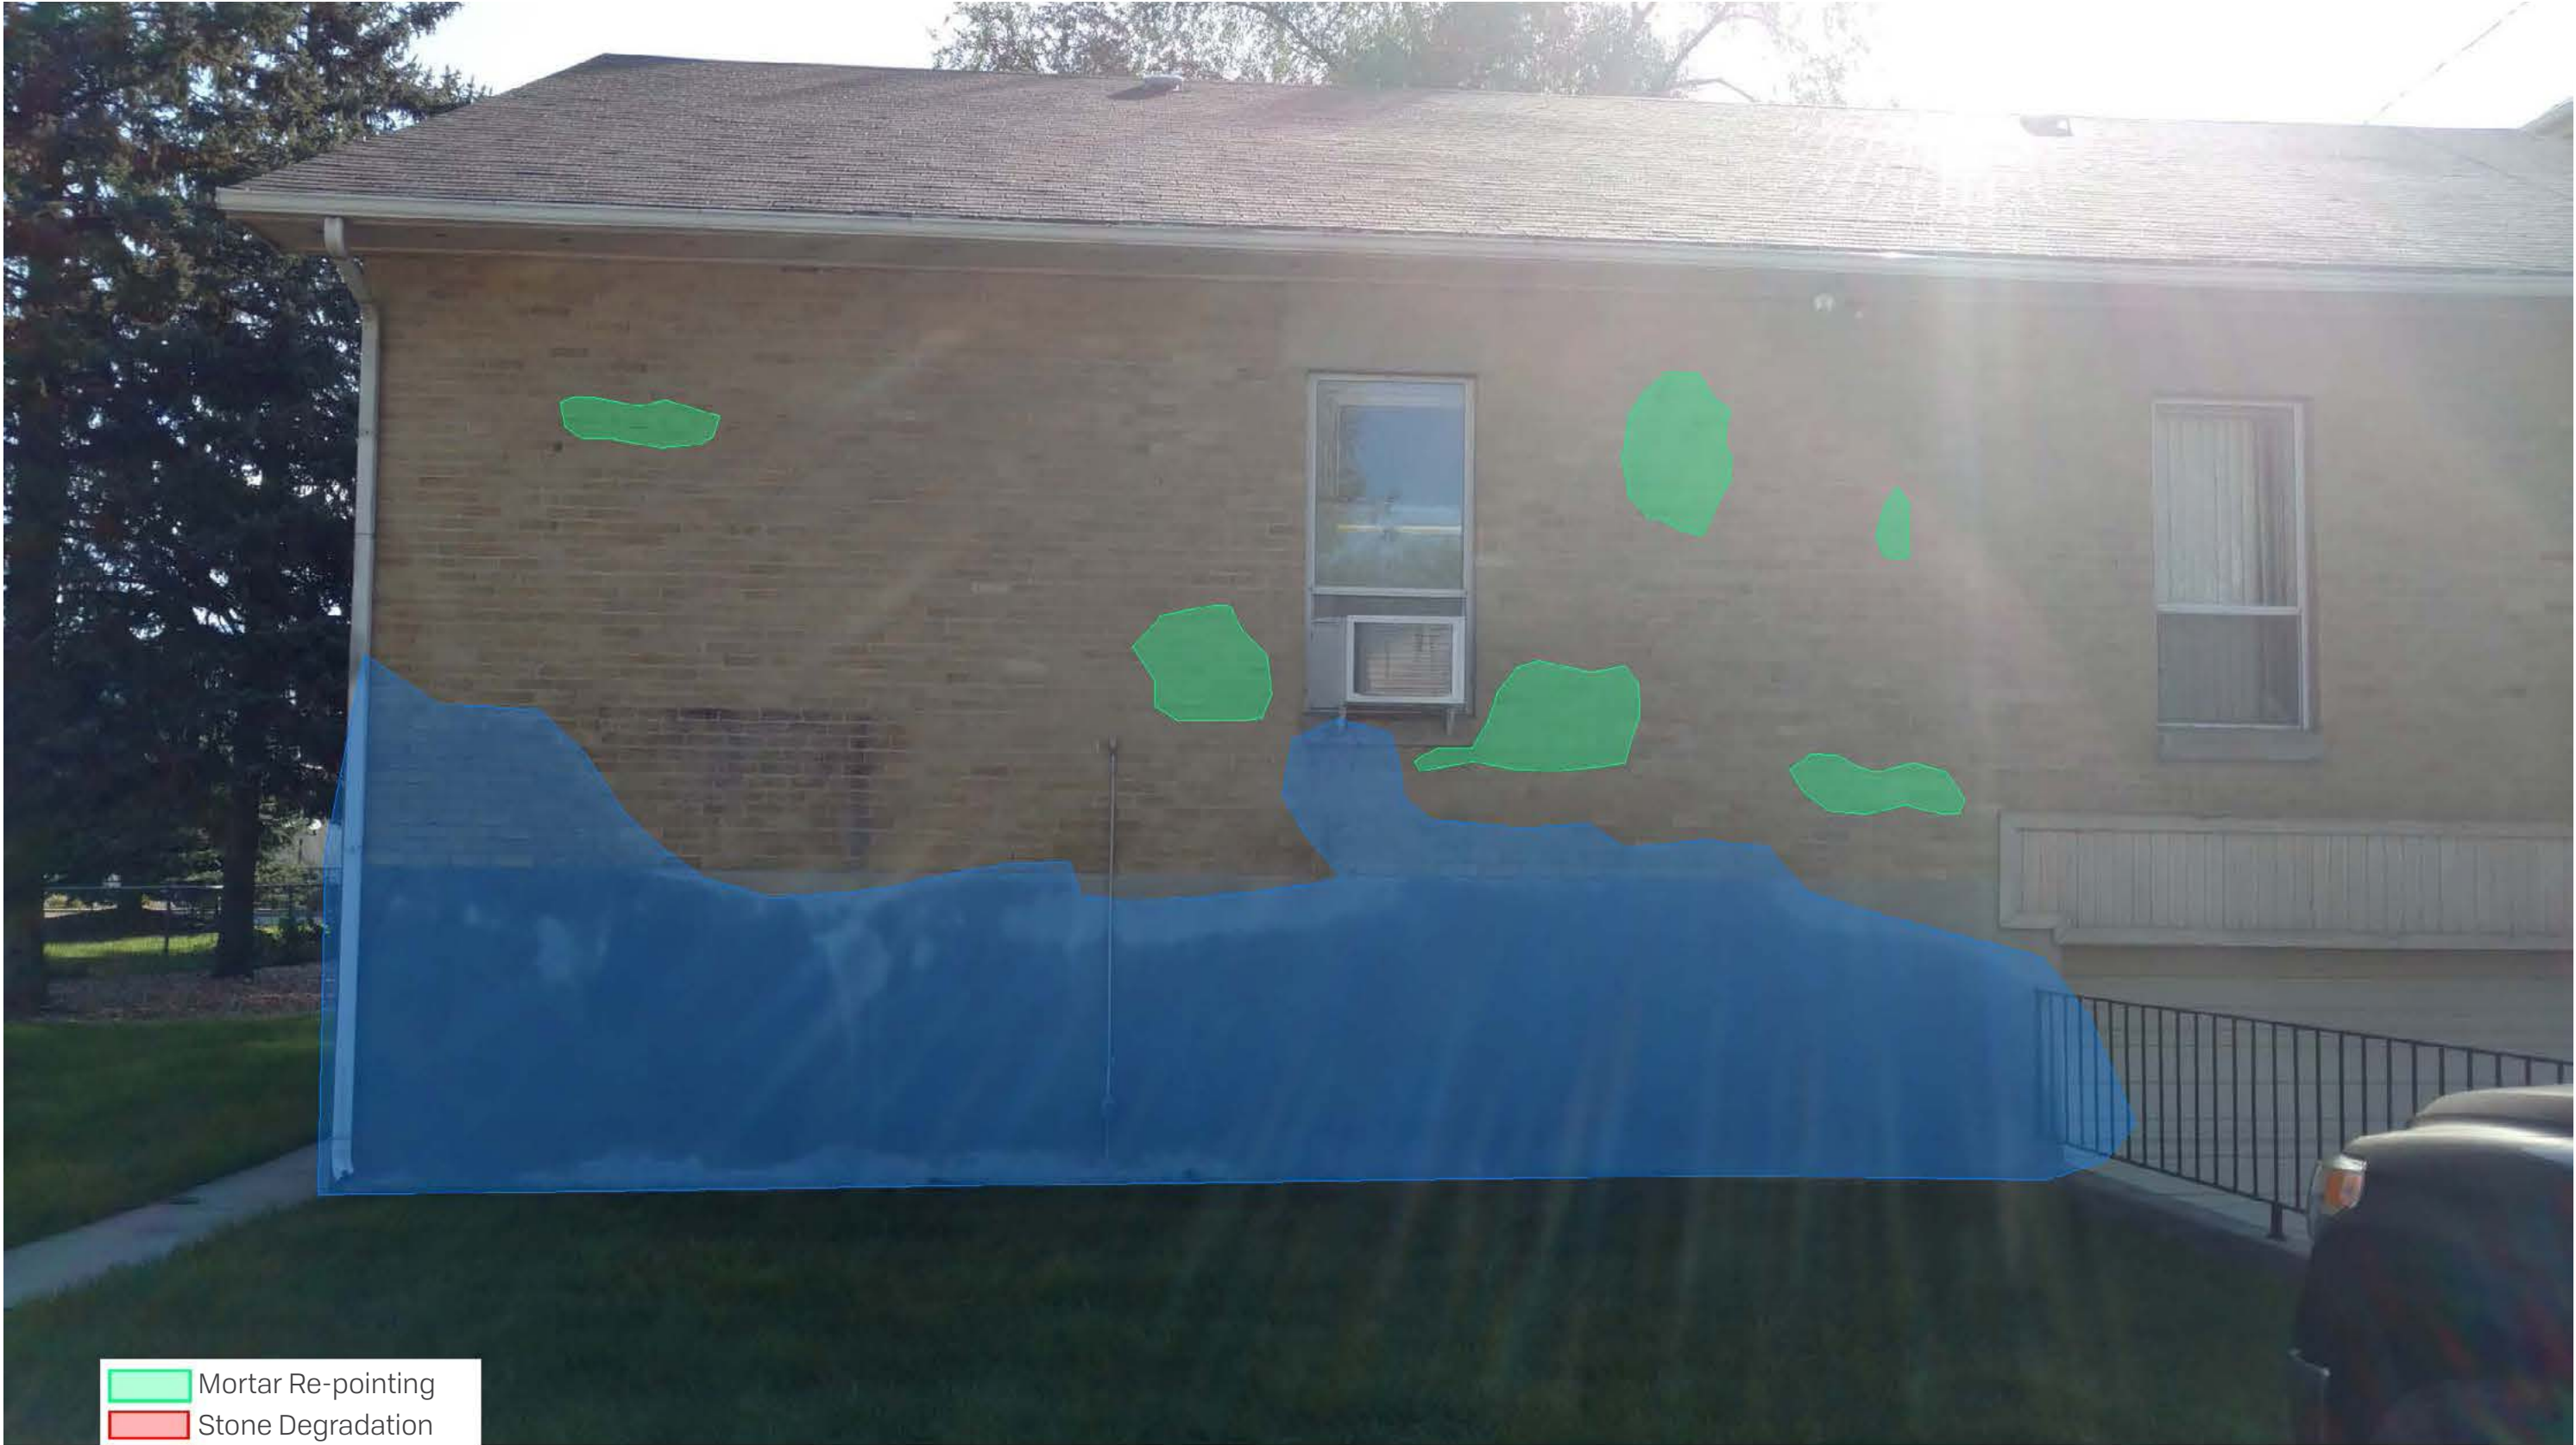
- Mortar Re-pointing
- Stone Degradation
- Water Damage

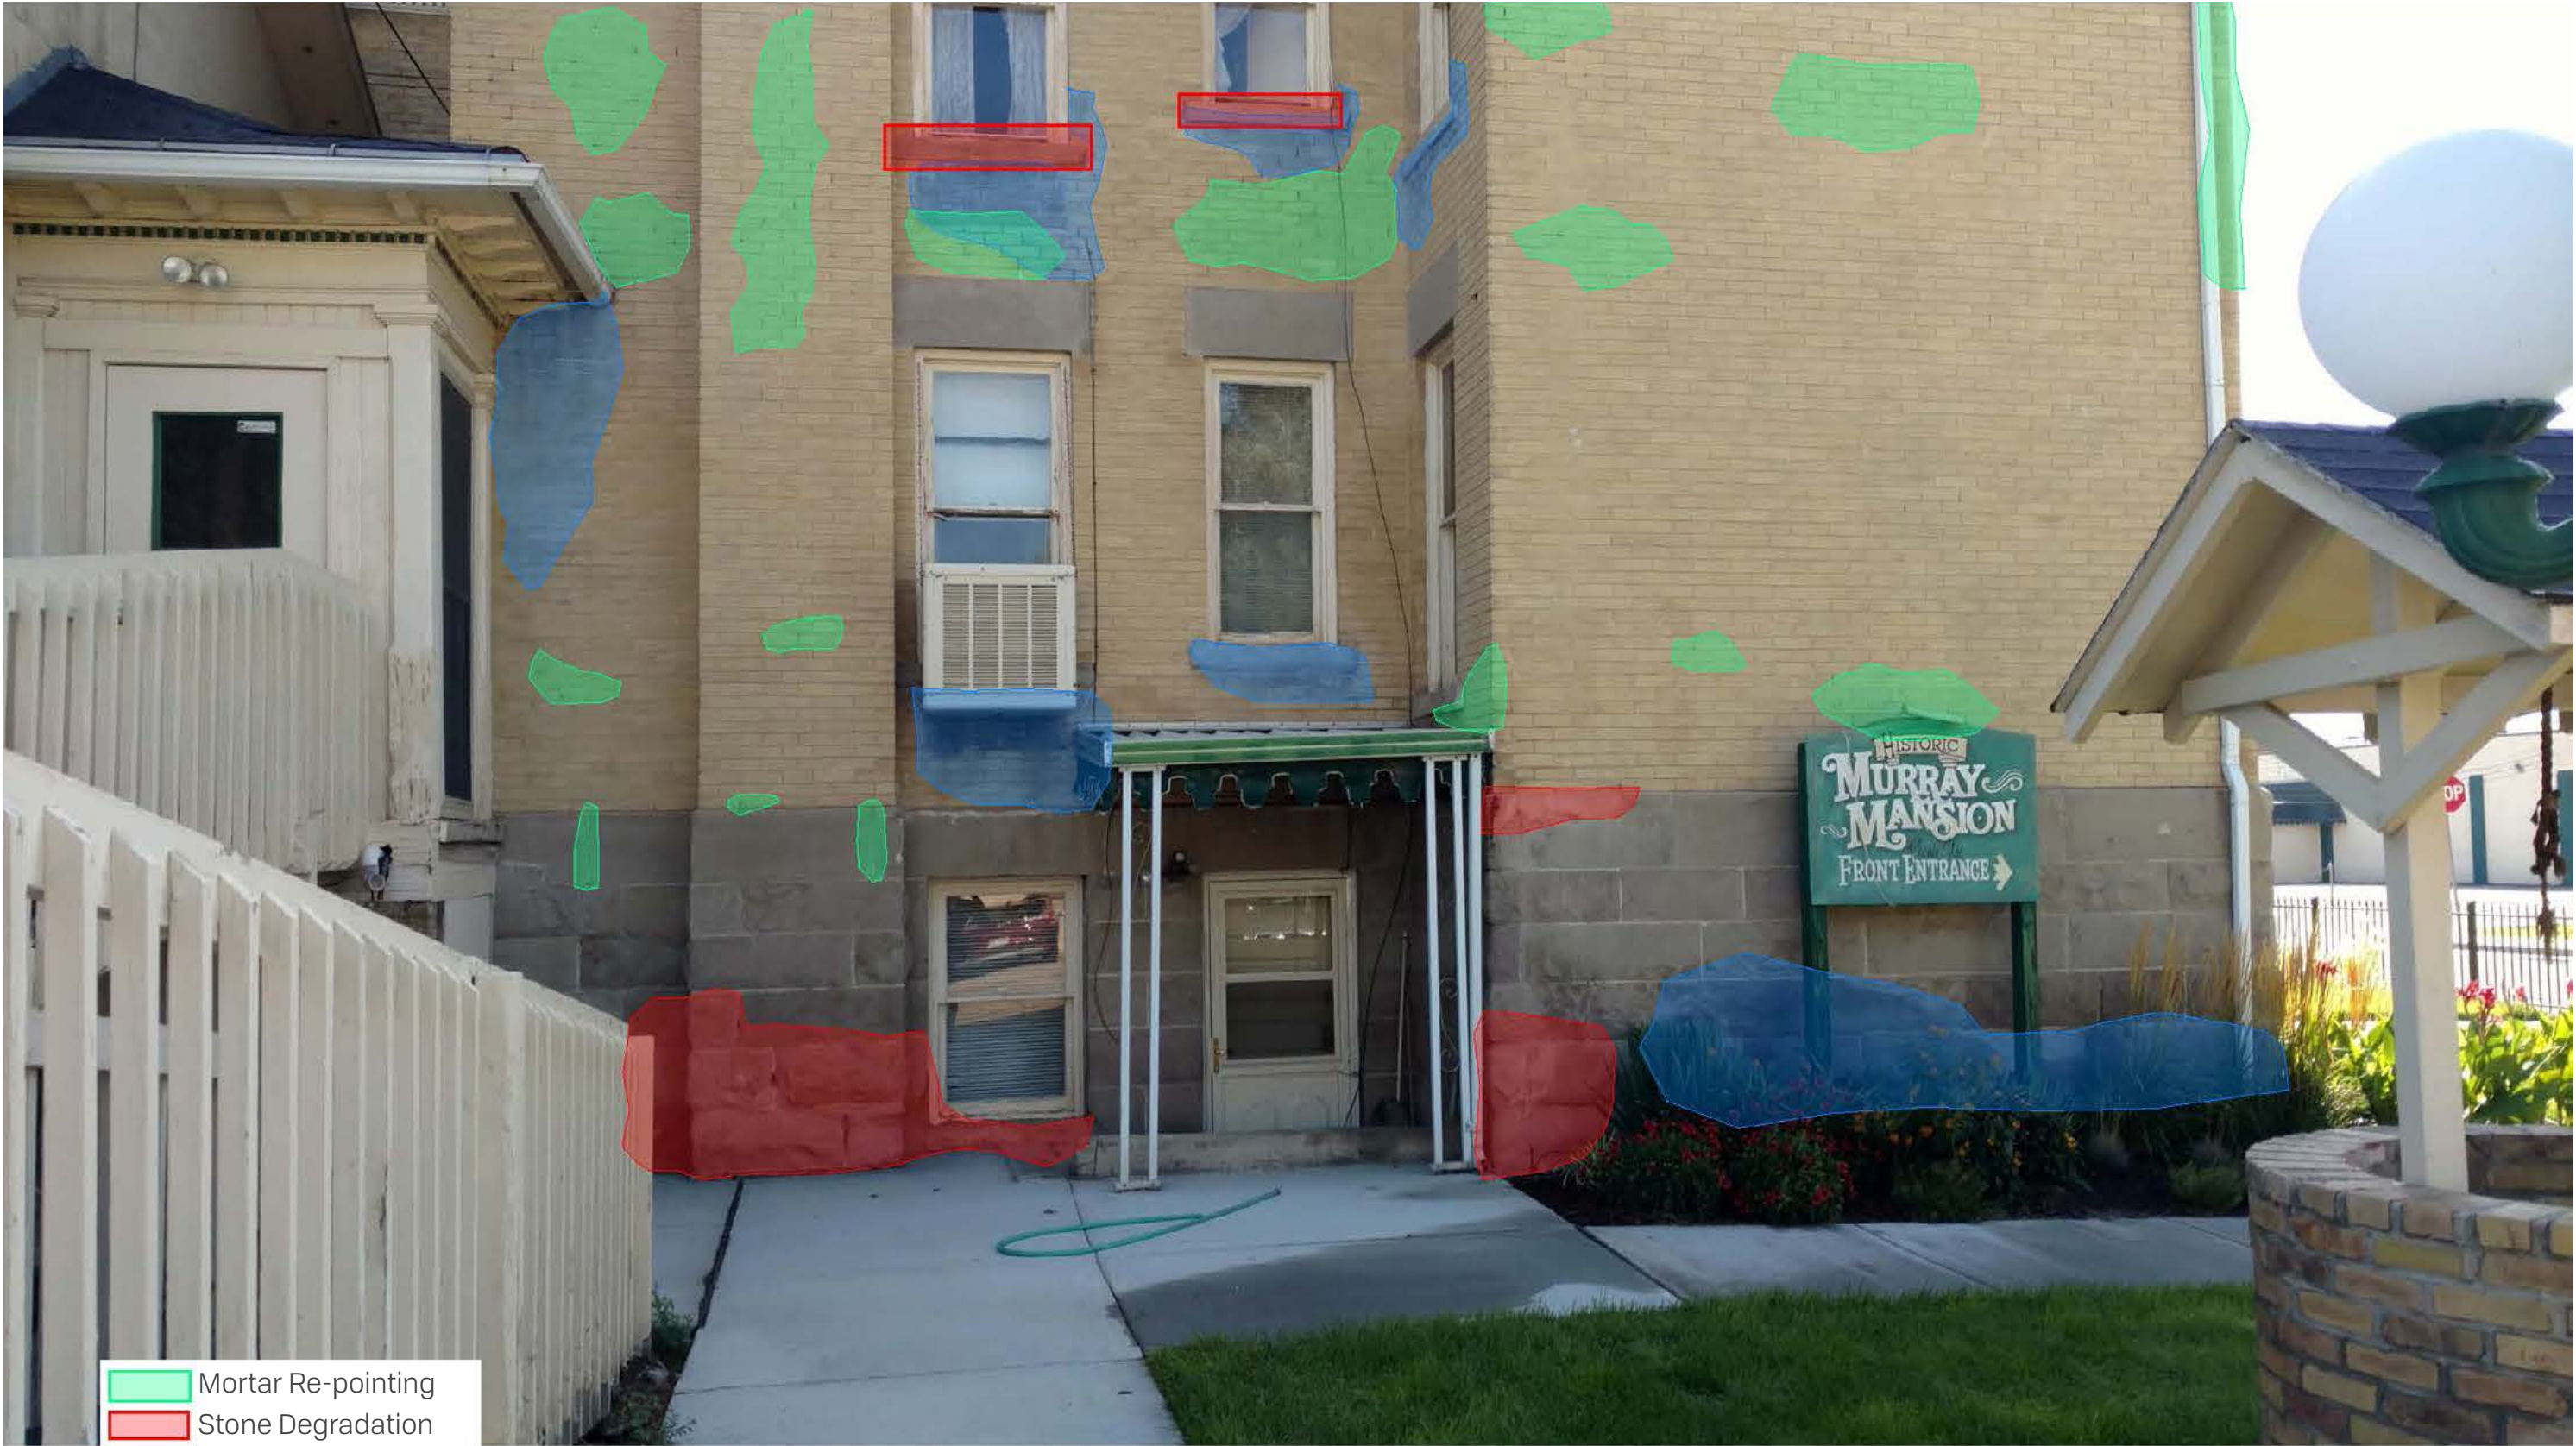
Mortar Re-pointing

Stone Degradation

Water Damage
