# CAHOON MANSION

## ENVELOPE STABILIZATION ASSESSMENT

Entelen Design-Build, LLC. + FFKR Architects

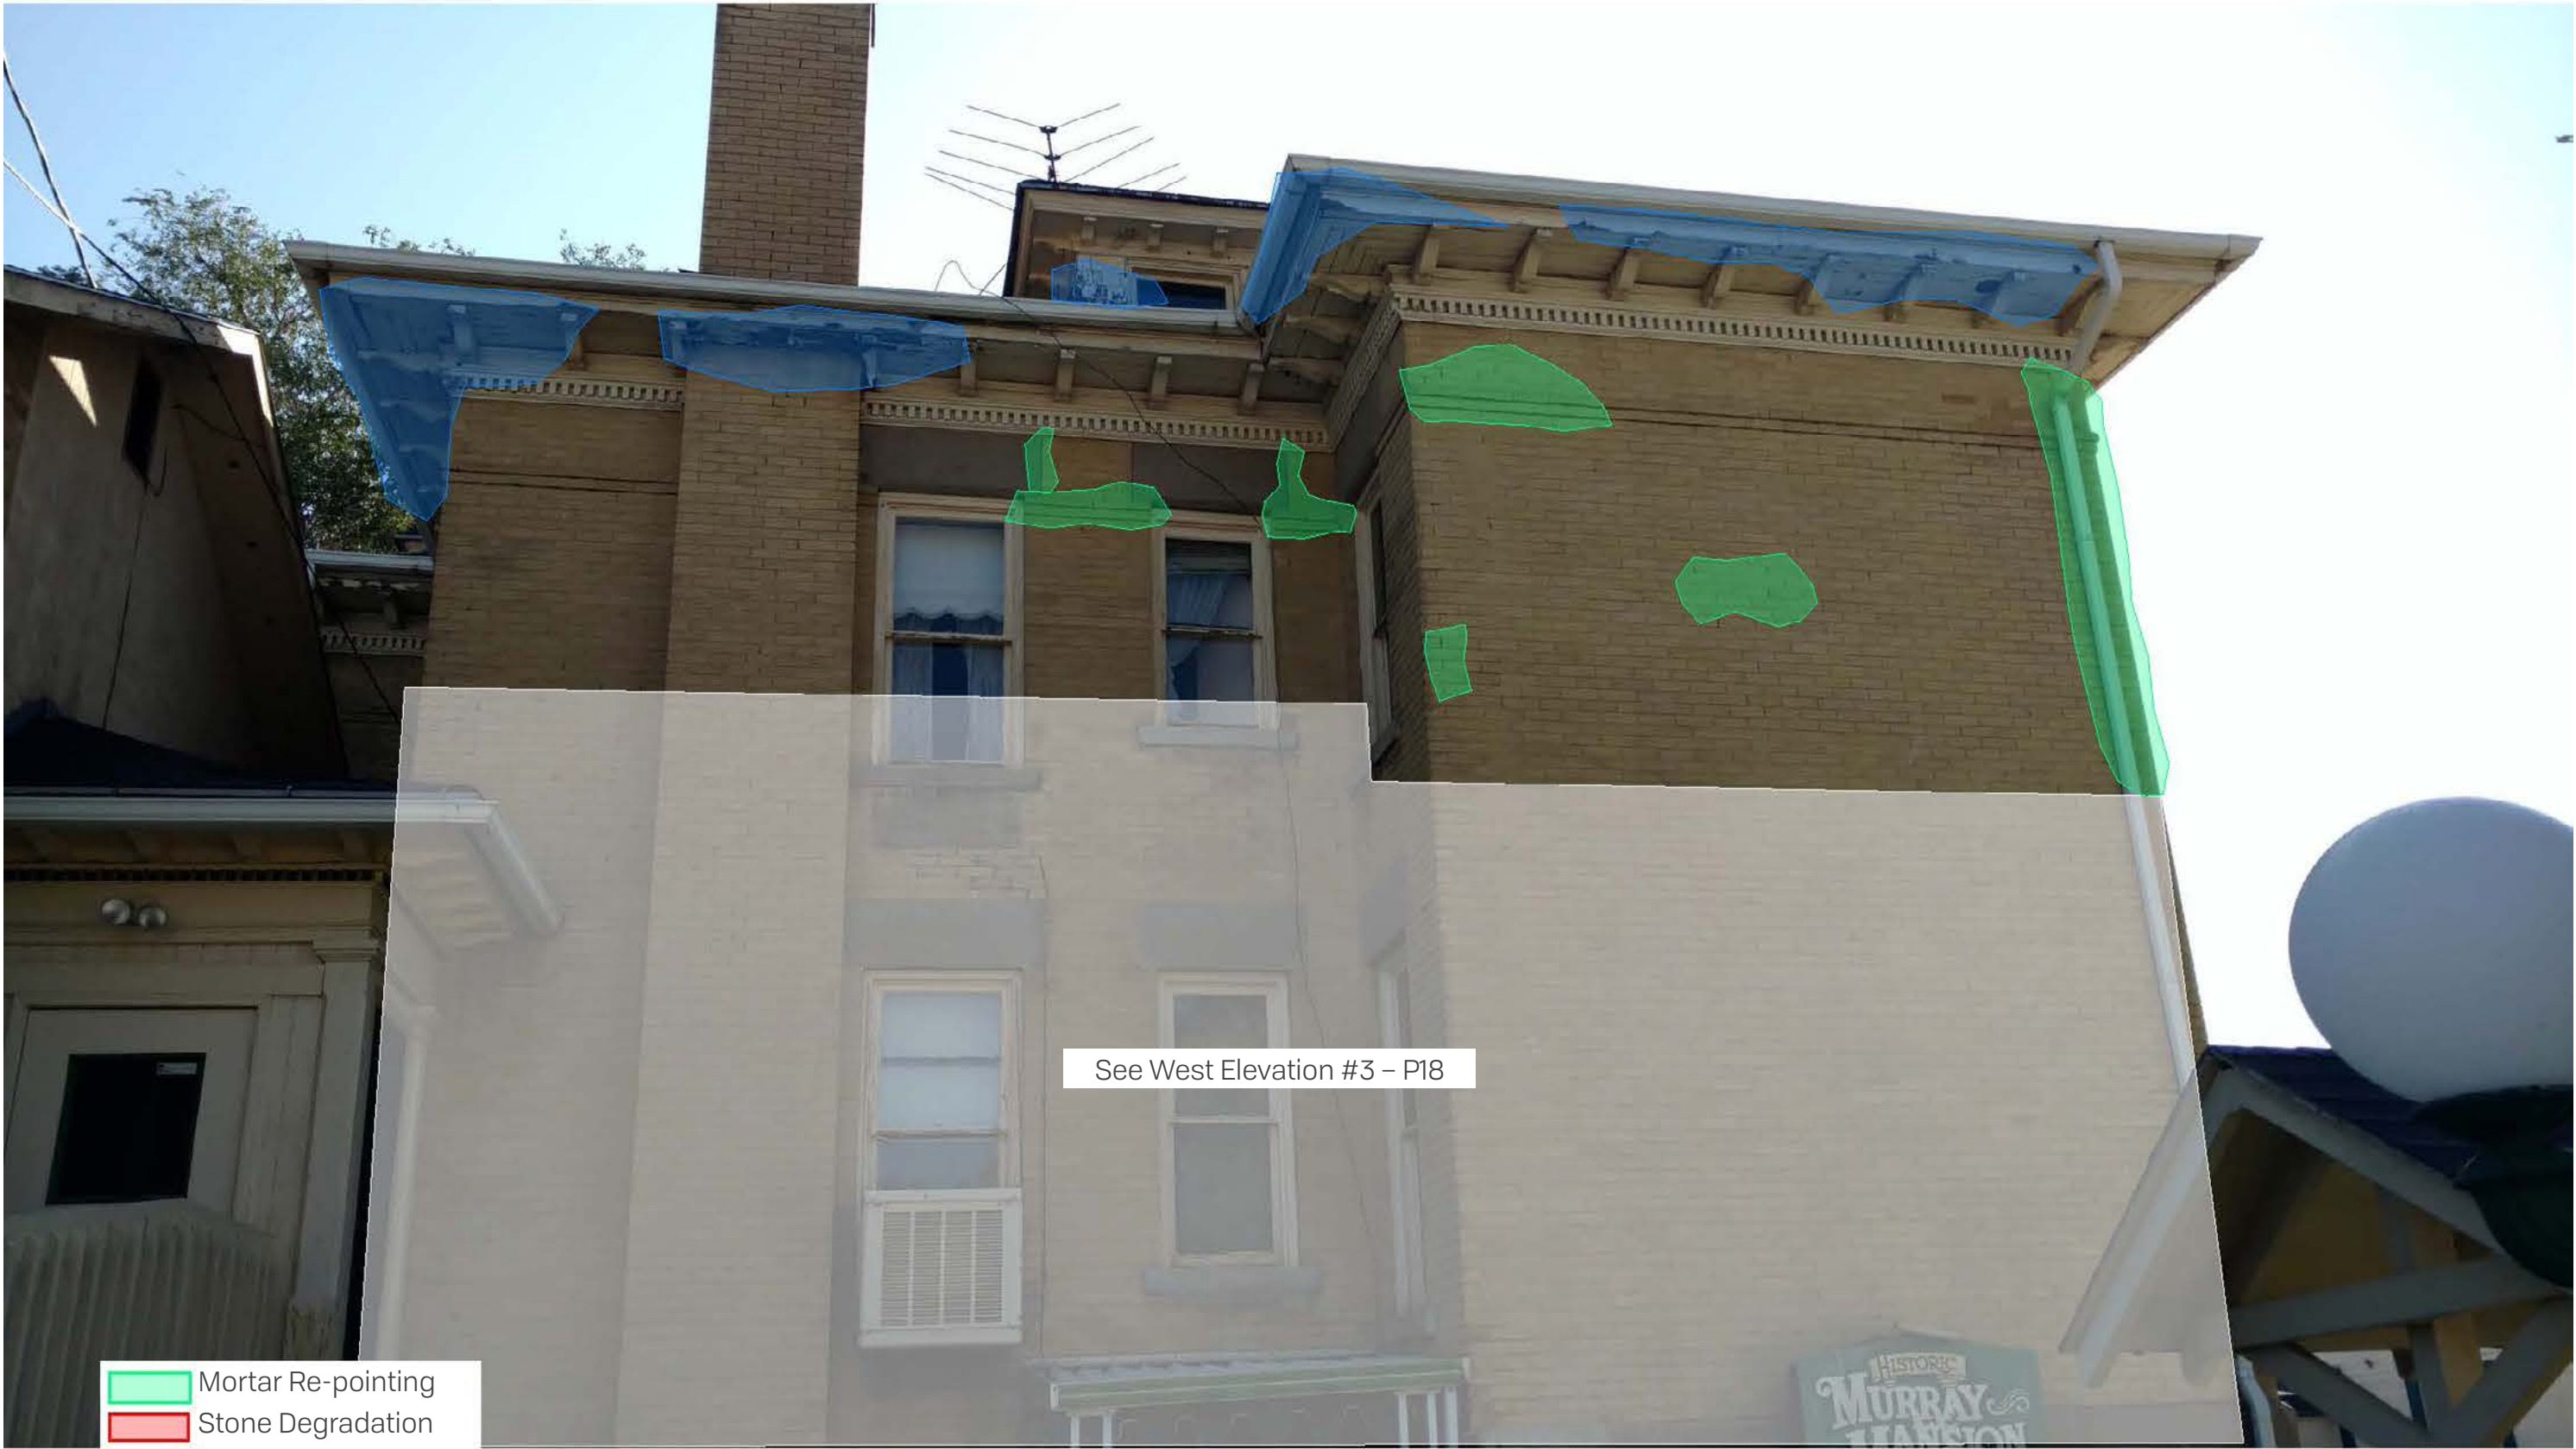
- █ Mortar Re-pointing
- █ Stone Degradation
- █ Water Damage

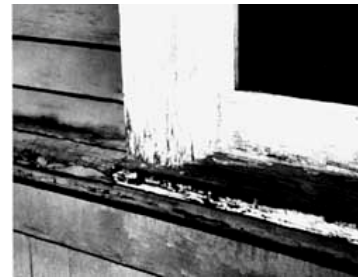
Deterioration of poorly maintained windows usually begins on horizontal surfaces and at joints, where water can collect and saturate the wood. Photo: NPS files.

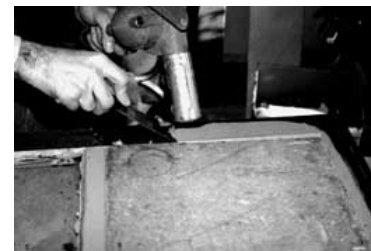
Sash can be removed and repaired in a convenient work area. Paint is being removed from this sash with a hot air gun. Photo: NPS files.
