# Historic Structure Report

March 2004

## Oakland Plantation South Tenant Cabin Cane River Creole National Historical Park Natchitoches, Louisiana

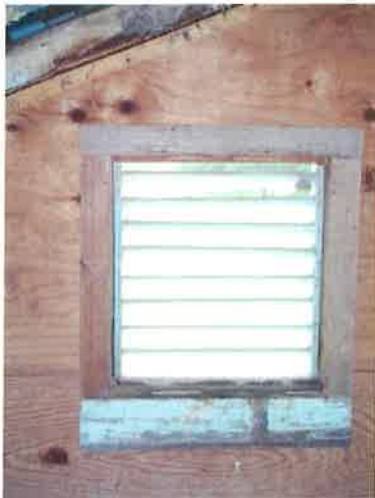
Interior of Window A

*Window A:* Window opening A measures 2'-1" by 2'-3". The jamb is a Type 3, and the sill is a Type 2 (see illustration). The HABS drawings suggest that a single 2/2 divided light sash was fixed in the casing.

- Treatment of the windows is important. Like those in the North Tenant Cabin, the windows are known to be a mid-twentieth century addition installed in a crude manner. It will be important for the windows to be repaired and sashes reinstalled in the same manner, based on existing conditions, while ensuring that they are watertight for continued use. This will require some careful attention to the existing construction details in order to replicate the historic configuration when restoring the windows.

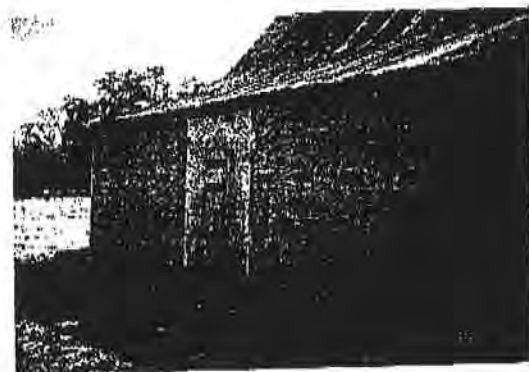
11-18. Work complete on the west elevation of the South Slave Quarter's.

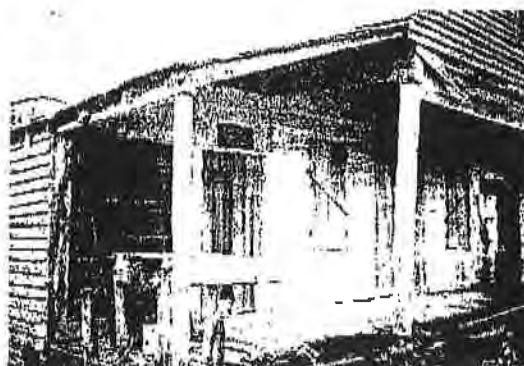
2-6. East elevation of Store/Post Office prior to work. Deck and columns same as back.

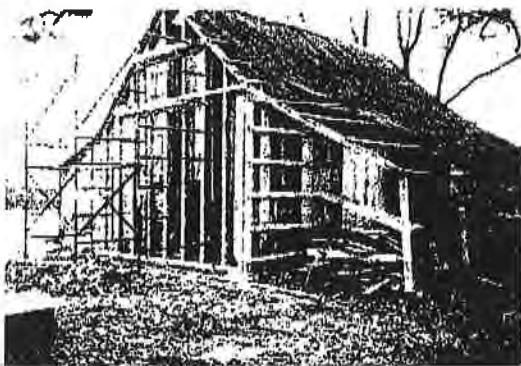
12-37. North Slave Quarter's. Chimney clean and stored, wall being framed in.

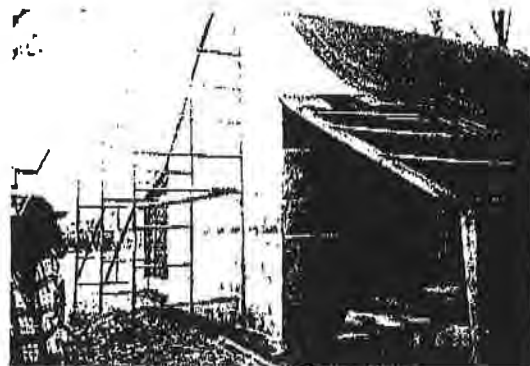
12-33. North Slave Quarter's. Wall framing, sheathing, vents and roof complete.

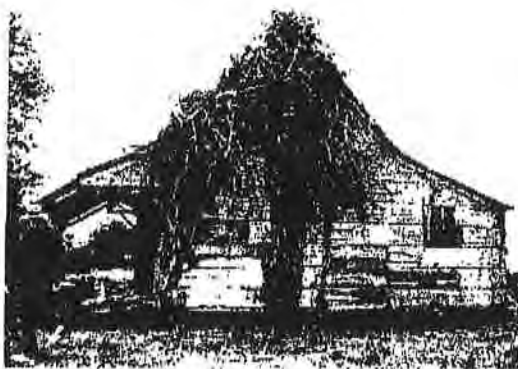
3-11. South Slave Quarter's showing the poison ivy growing on the north elevation.

- 2) *Poison Ivy.* The poison ivy, which encompassed the North side of the building, was removed. It actually came off easier than we thought but it had migrated behind much of the asphalt siding and that came off with it. We installed a temporary stud and plywood wall as previously stated to cover and protect the exposed wood sheathing.
- 3) *Roof Cover.* The corrugated metal roofing was refastened where it had become loose. Overall it was in good condition.
- 4) *East Porch.* Some of the porch decking was missing and/or decayed. The floor framing members in contact with grade were lifted and placed on pressure treated pads. Temporary columns were installed to prop up and secure the porch roof.

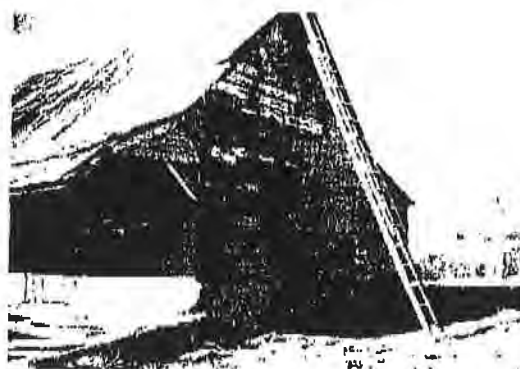
6-20. South Slave Quarter's showing poison ivy removed and stabilization in progress.

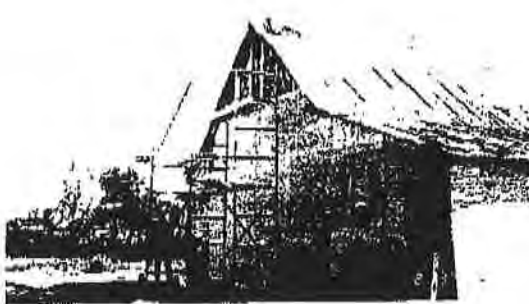
8-11. South Slave Quarter's, north elevation wall studded and plywood being applied.

framed wall was installed which we extended to cover the remaining side. We covered the wall with our typical plywood and vent treatment. The West wall received the same treatment and we installed extra vents over the windows for light and ventilation. A temporary 2x4 and plywood door was built and installed over the West side existing door.

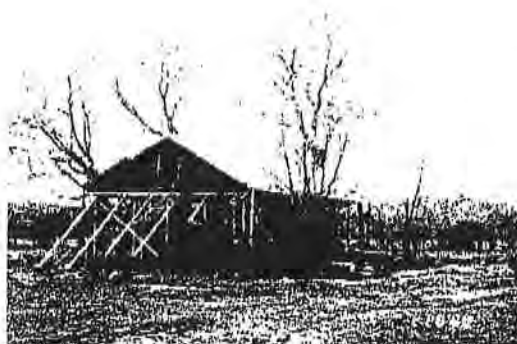
10-14. The Wagon Shed. Plywood sheathing on the north slope ready for asphalt cover.

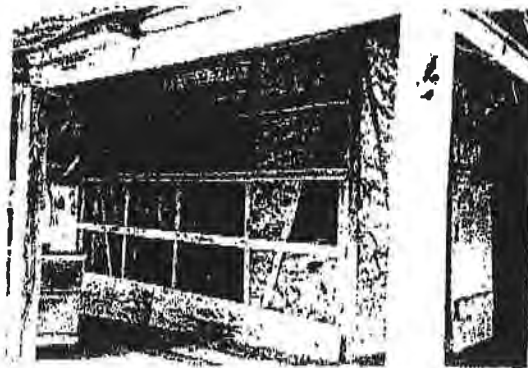
11-38. The Cook's House. Note temporary wall framing in progress.

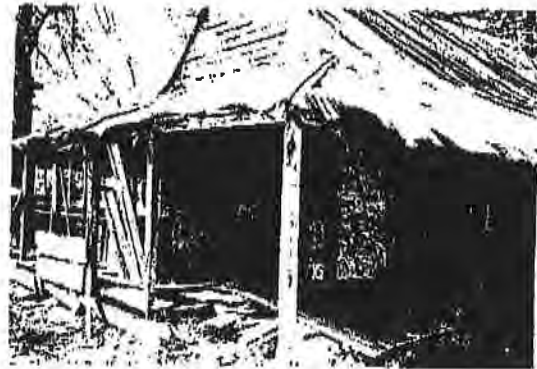
11-35. The Cook's House. Temporary plywood wall almost complete.

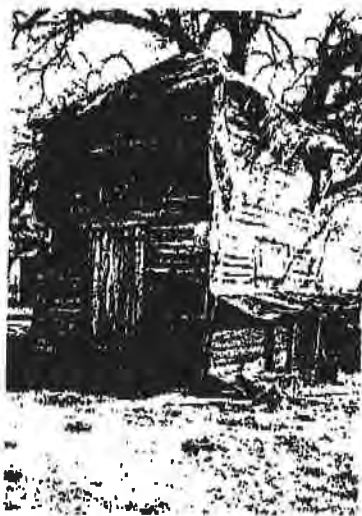
5-4. The East Pigeoneer prior to emergency stabilization.

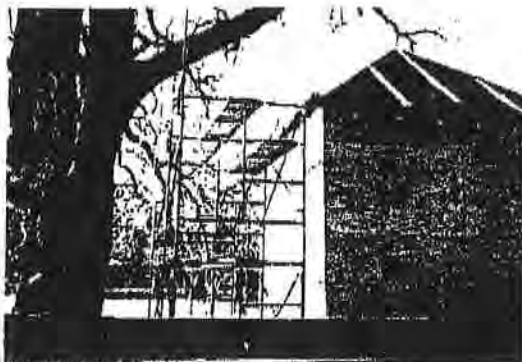
4-26. East Pigeoneer during installation of the wall sheathing. Note studs on roof.

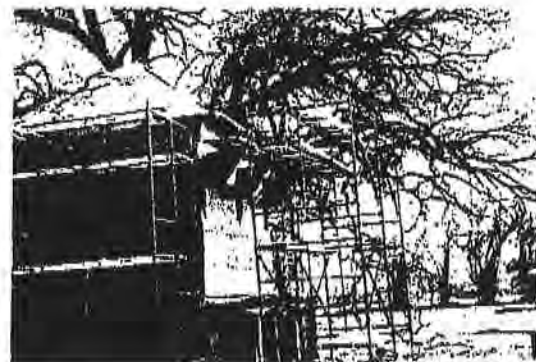
6-21. East Pigeoneer during installation of the roof sheathing. Note shed roof below.

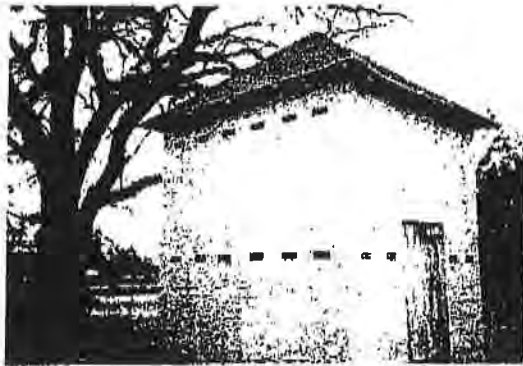
8-22. The East Pigeoneer. Complete except for the temporary plywood door.

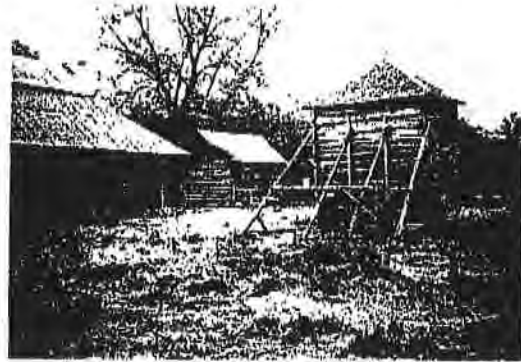
2-17. The West Pigeoneer prior to stabilization work. Note existing diagonal bracing.

- 1) *Exterior Walls.* The siding was loose and riddled with holes. It required the full 2x4, plywood and vent system as previously stated. The existing diagonal bracing on the West side of the structure was removed while we applied the wall treatment to this side. It was replaced when we were finished. 8x16" painted, aluminum louvered vents were installed into the walls between each of the new studs. A pair of 2x4 and plywood doors was constructed and

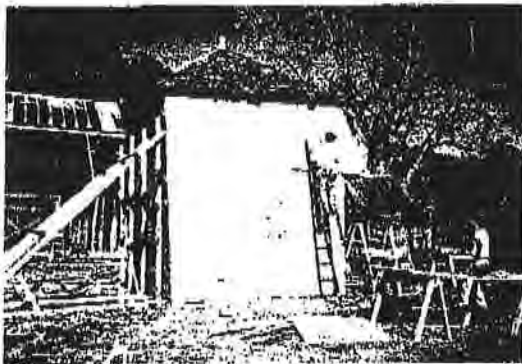
5-2. West Pigeoneer during installation of the wall studs and plywood sheathing.

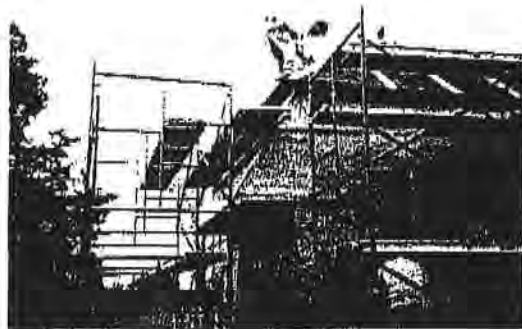
6-24. West Pigeoneer during installation of roof cover. Note cover over existing dr roof.

- 2) *Roof Cover.* The framing, sheathing, and wood shingles are decayed and have lost any of their structural integrity. We worked carefully on the roof and installed a temporary roof cover over the existing. It was constructed as stated above out of 2x4's, plywood, and 36" 90# mineral surface roofing. No venting was installed on the roofs but the eaves are all open and along with the wall vents should be adequate to ventilate the interior spaces of the structure. There was some sort of wood hip feature extending out of the top of the roof. It was not moved and a temporary enclosure was fabricated around it. The lower shed roof over the double doors on the East side of the structure was enclosed with a new temporary roof.

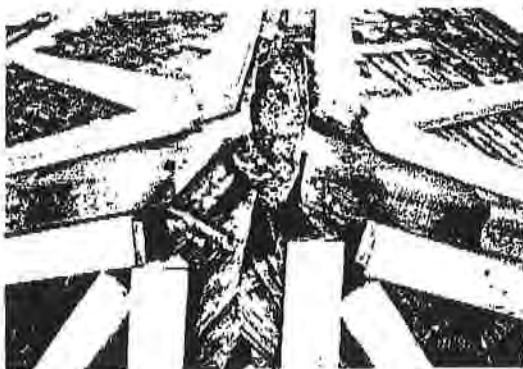
8-23. West Pigeoneer roof studs. Note finial remains. We build cover to protect it in situ.

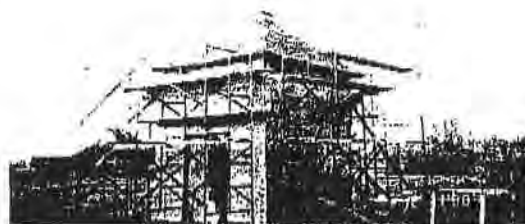
8-15. West Pigeoneer showing the completed temp. roof cover. Note finial cover.

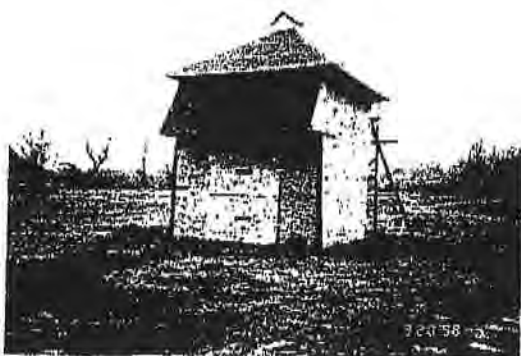
13-6. Complete West Pigeoneer. Notice asphalt, venting, and temp double doors.

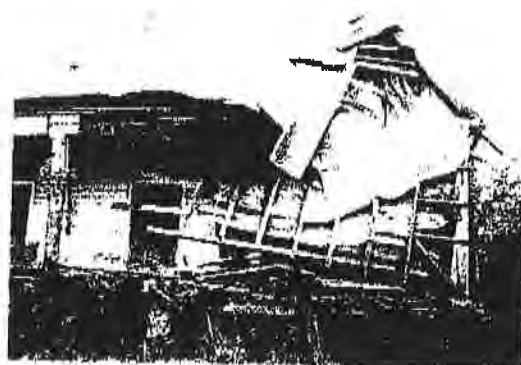
2-27. The Overseer's House. Prior to stabilization. Tree fell on NW corner of house.

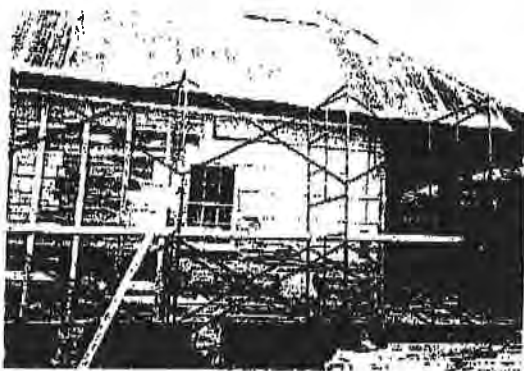
9-37. The Overseer's House during installation of wall studs to hold and vent plywood.

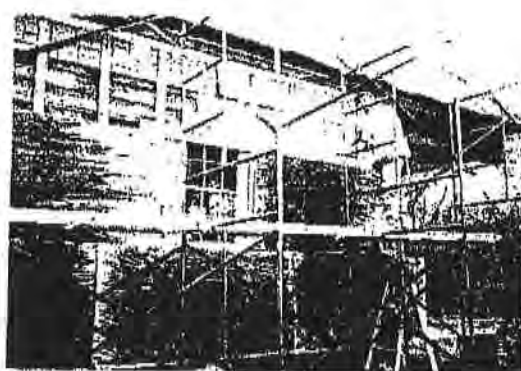
9-36. The Overseer's House during installation of the protective temporary wall covers.

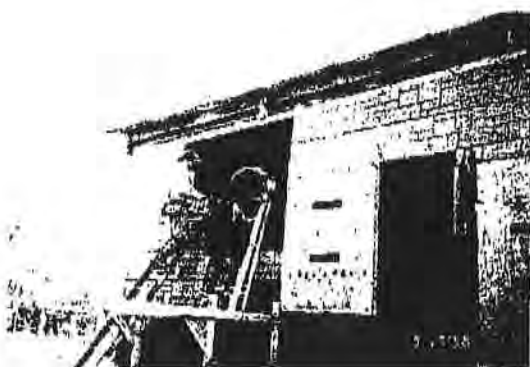
12-18. The west elevation of the Overseer's House during installation of temp wall cover.

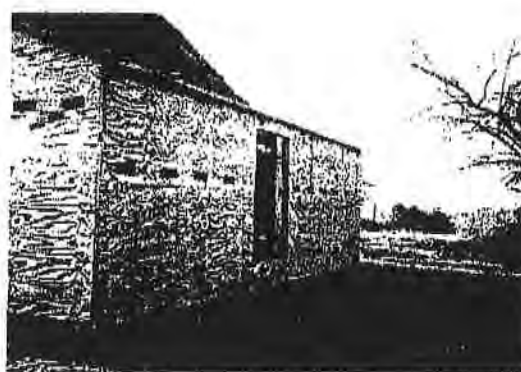
9-25. The Overseer's House showing completed west elevation wall enclosure less door.

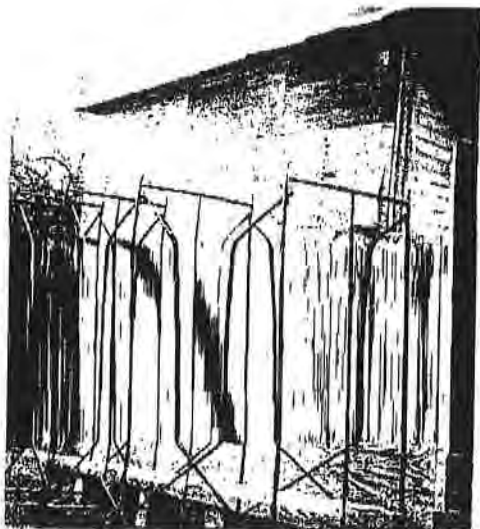
9-30. The Overseer's House, south elevation wall complete. Notice the louvered vents.

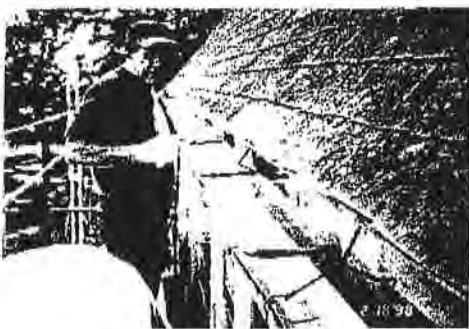
9-19. The wrap around gutter on the Main House during the patching process.

- 3) *Roof Drainage System.* The gutter was full of holes and leaking throughout its length. Many of the leaders were missing or disconnected. Aluminum Flashband, a product similar to Ice & Water Shield, was used to line the gutter where holes were present. Two applications of TopCoat Flexseal were applied over the Flashband product. The loose eave tubes were reset, one was replaced, and new 3x4" temporary aluminum leaders (downspouts) were installed to replace the missing ones. The existing units were re-secured. We extended the leaders at their bottom with an additional 10' length making sure the water shed away as far as possible.
- 4) *Windows.* We installed a louvered plywood blank over the window on the West side of the kitchen addition. The unit was failing. We left the window in place.

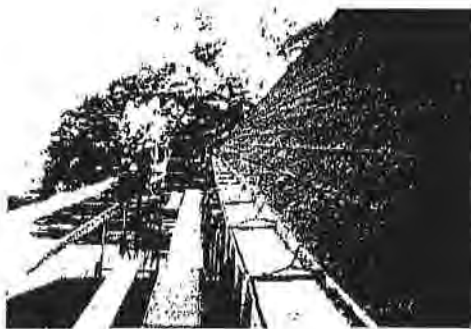
9-14. The wrap around gutter on Main House complete after final TopCoat application.

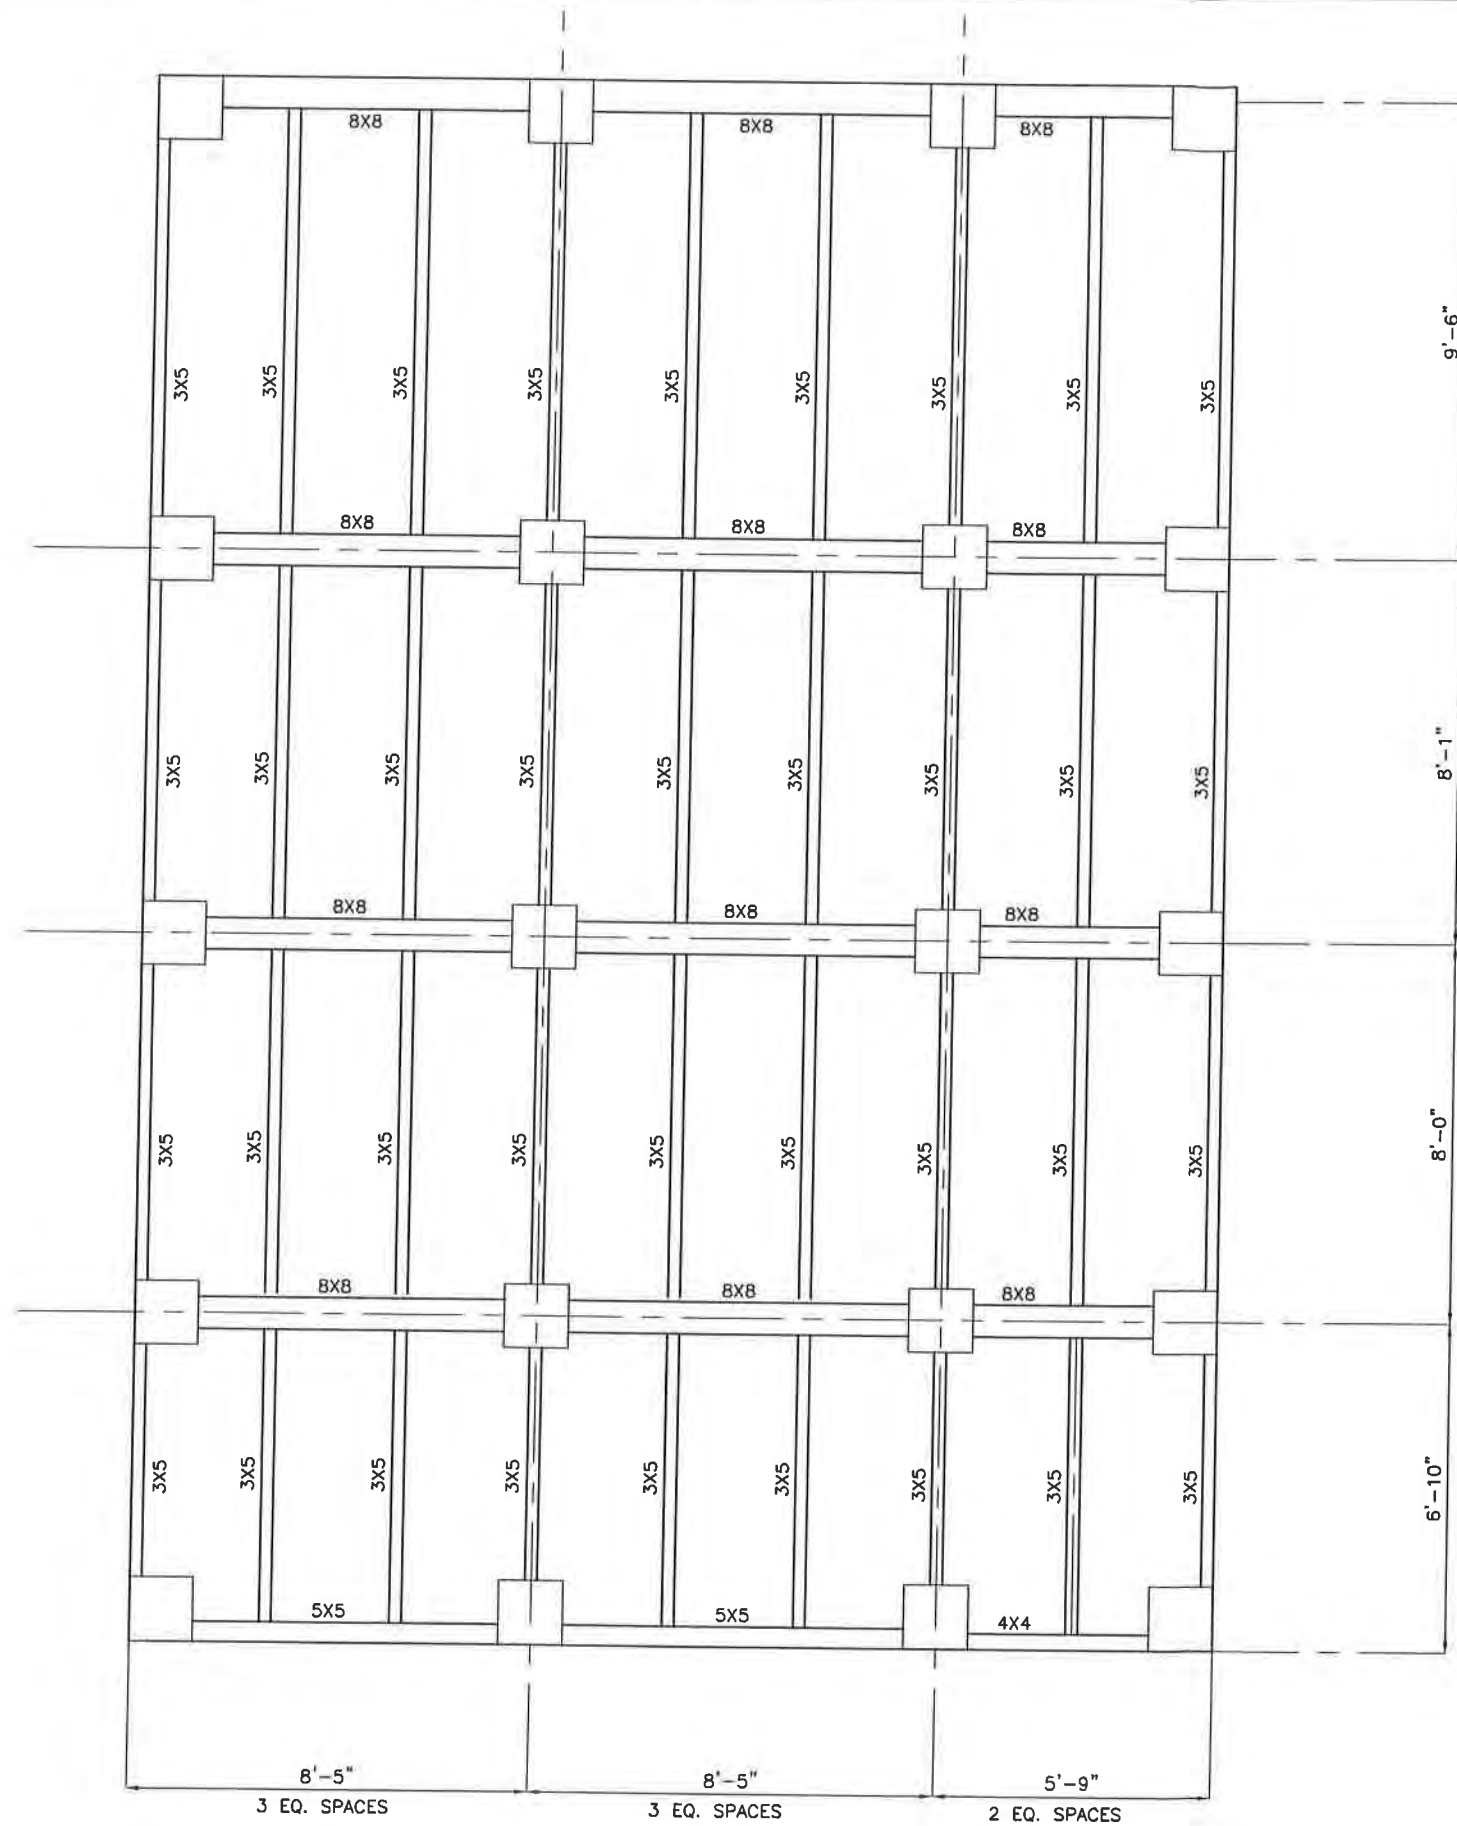
1  
S1 EXISTING FRAMING PLAN

Per the IBC, the roof would have to support a live load of 12 psf. The existing rafters are 2x6 spaced approximately 3'-0" o.c. Since the rafters are not in good condition, a 25% material reduction was taken to account for the deterioration of the material.

The existing roof rafters would not be able to support the required roof loads. Even if the rafters were in excellent condition, they would not be able to support the required roof loads because the spacing of the members are too far apart.

1. NEW WOOD SHALL BE CYPRESS OR PRESSURE-TREATED SOUTHERN PINE NO. 1 GRADE.
2. FIELD CUT NEW BEAMS. FIELD VERIFY DIMENSIONS PRIOR TO CUTTING.
3. FLOOR BOARDS ARE TO BE REMOVED AT LOCATIONS WHERE NEW BEAMS ARE TO BE INSTALLED. ONCE THE NEW BEAMS HAVE BEEN PLACED, BOARDS SHOULD BE PLACED IN THEIR ORIGINAL LOCATIONS & RE-NAILED TO JOISTS.
4. FURNISH & INSTALL NEW NEW 2X8 JOIST AT MIDWAY POINT BETWEEN EXISTING JOISTS. ATTACH TO EXISTING WOOD GIRDERS WITH SIMPSON STRONG TIE LUS 28 FACE MOUNTED HANGERS. SEE DETAIL A/S2.
5. REMOVE EXISTING PORCH SILL BEAMS AND REPLACE WITH NEW 6X6 BEAM WITH IN-KIND MATERIAL. ALL JOISTS FRAMING INTO PORCH SILL BEAMS ARE TO BE TEMPORARILY SUPPORTED WHILE CONSTRUCTION IS IN PROGRESS.

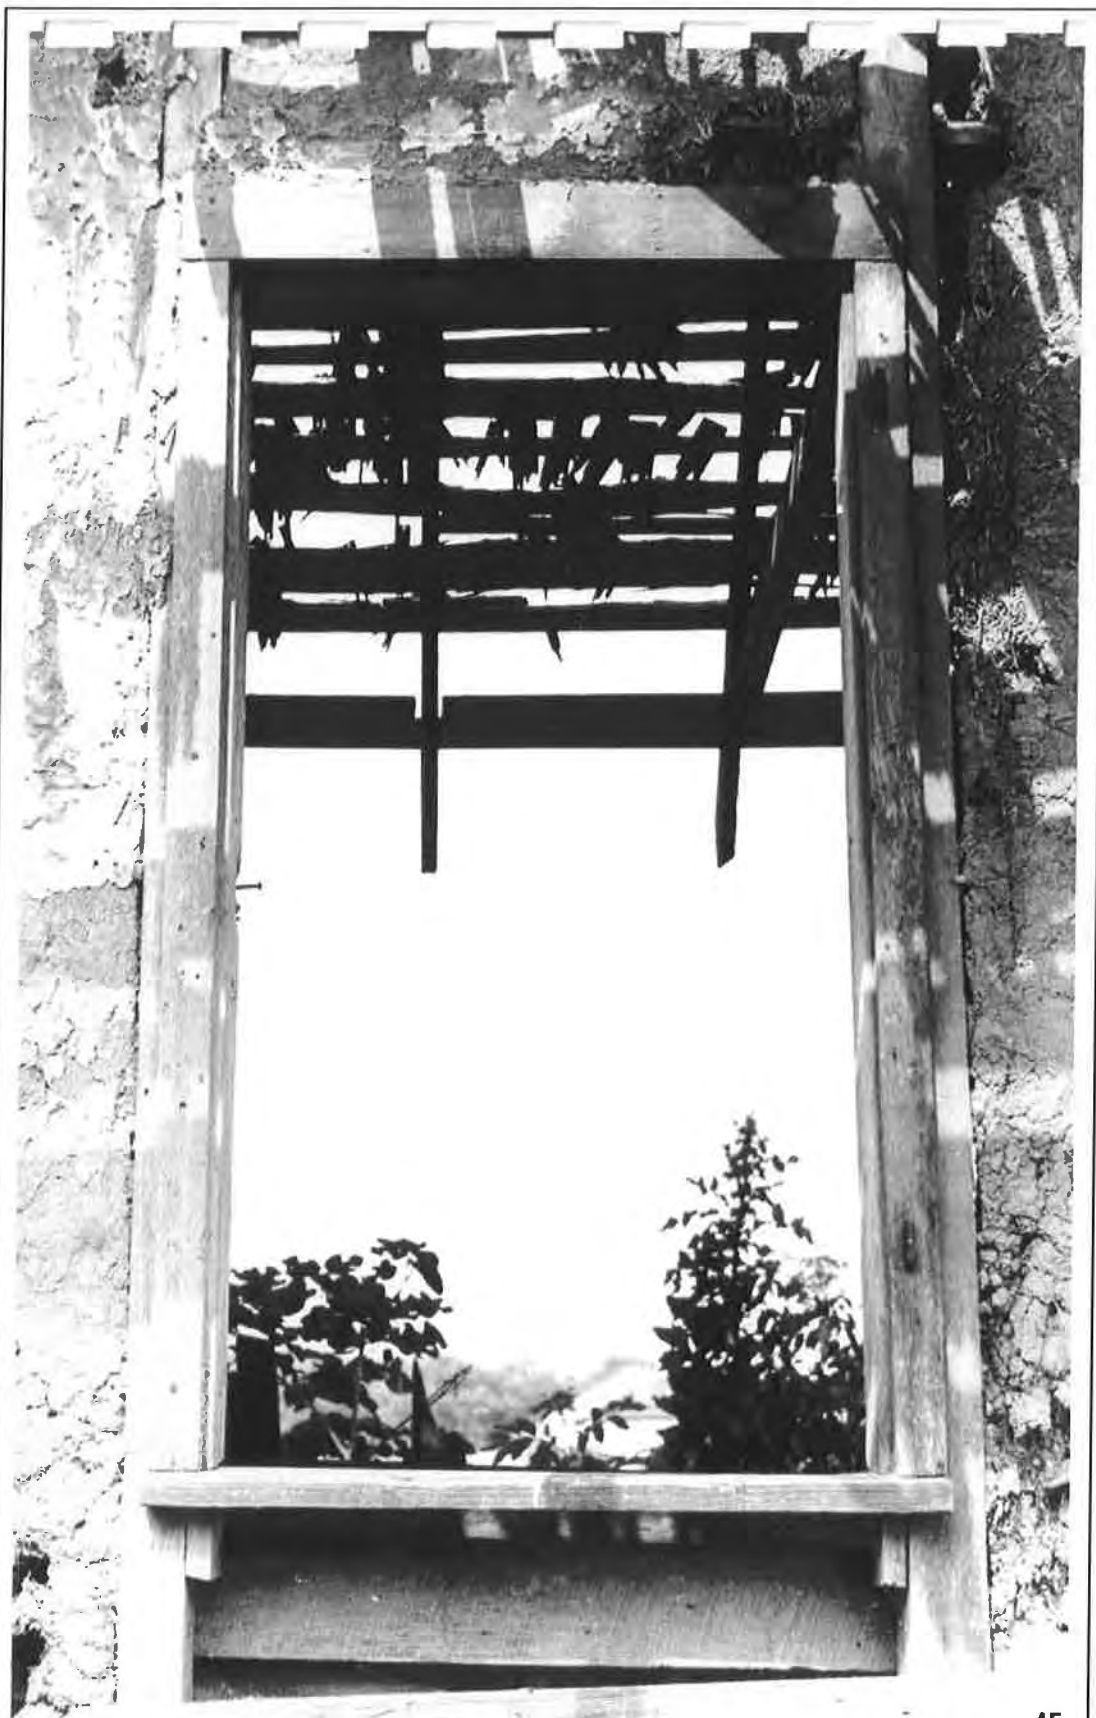
*Image 65: Oakland Plantation. South Tenant Cabin, date unknown (photograph courtesy of Cane River Creole National Historic Park Archives). The South Cabin as seen through the ruins of "Gabe Nargot's Cabin."*

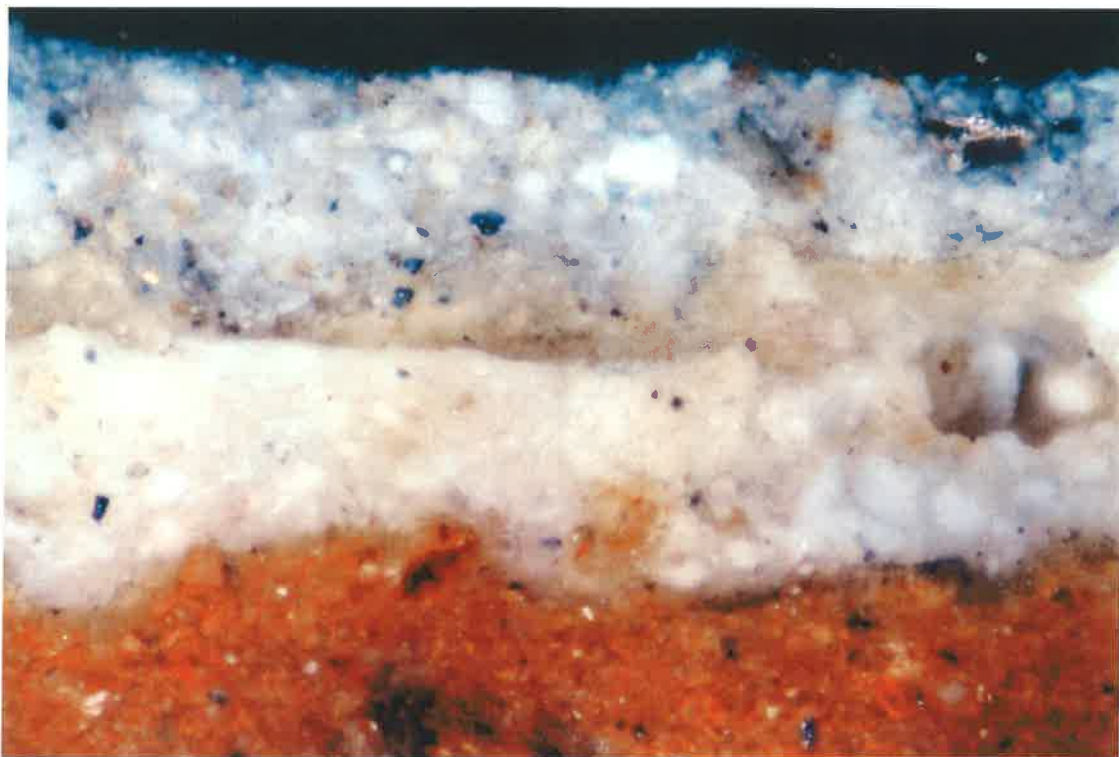
*Image 69:* Oakland Plantation. South Tenant Cabin, 2002. Photomicrograph of Sample #OPST.1 (10x mag.) showing the layers of limewash on the original *bousillage* on the east wall of Room 104.

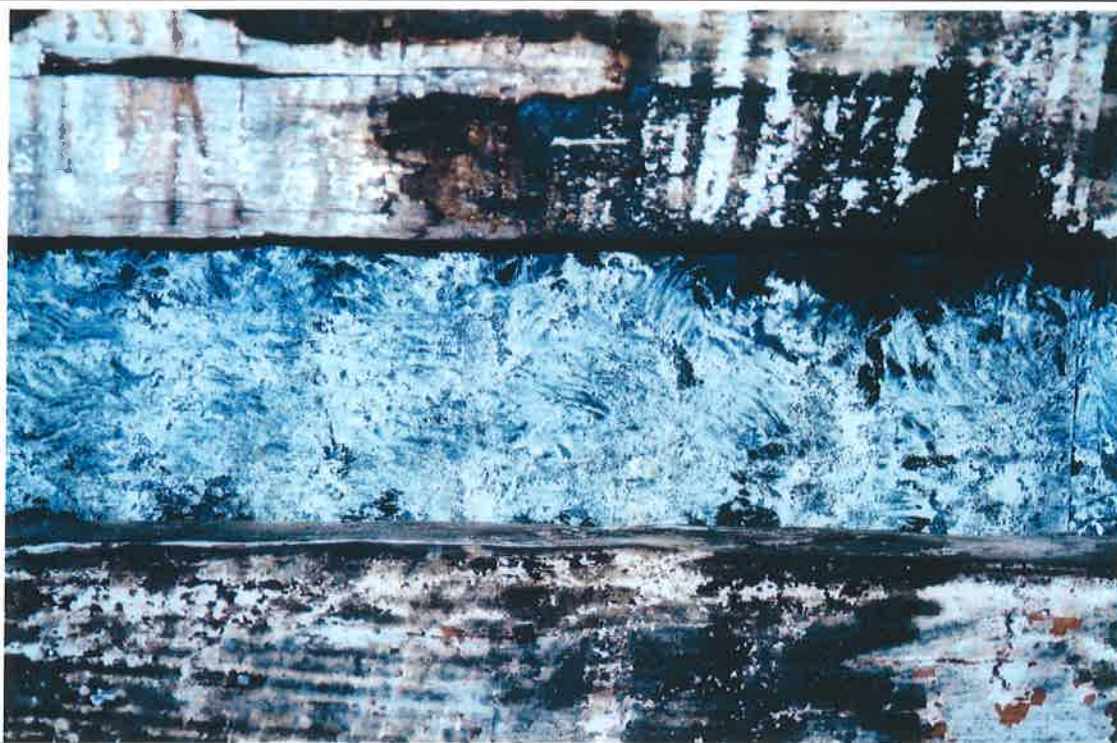
*Image 70:* Oakland Plantation. South Tenant Cabin, Room 104, 2002. The ceiling (or underside of the roof and rafters) of Room 104 was limewashed white.

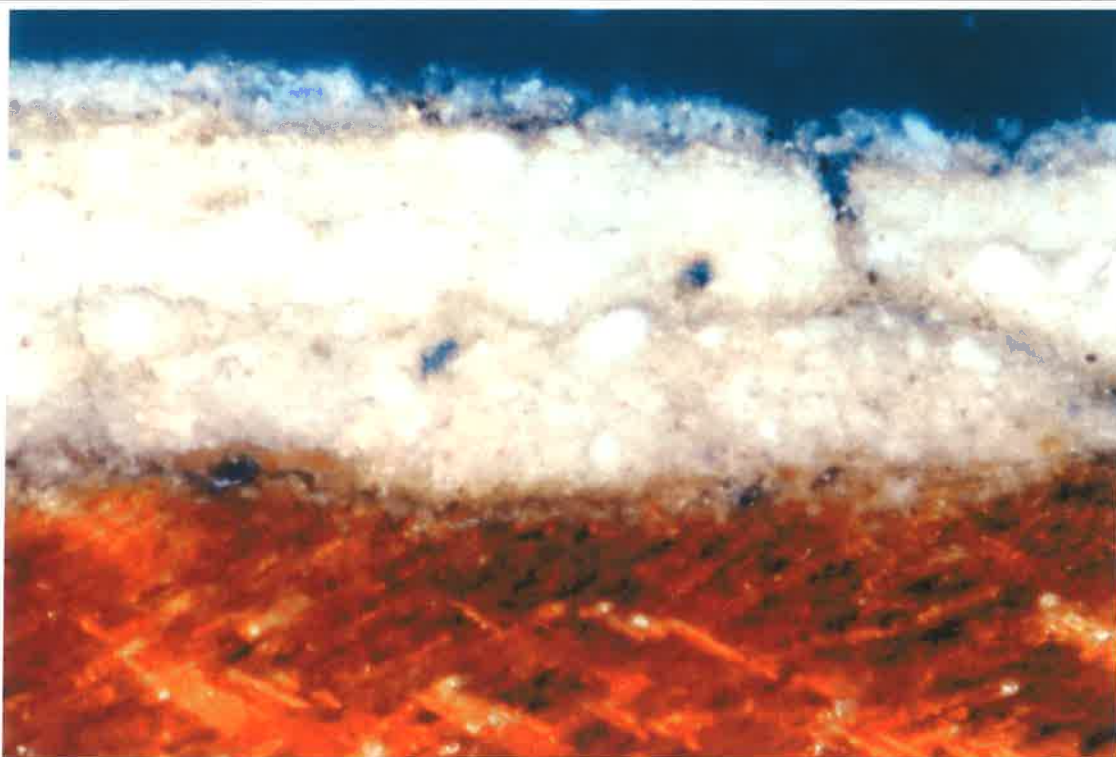
*Image 71:* Oakland Plantation. South Tenant Cabin, 2002. Photomicrograph of Sample #OPST.2 (10x mag.), which was removed from the ceiling rafter of Room 104, has two layers of whitewash on it.

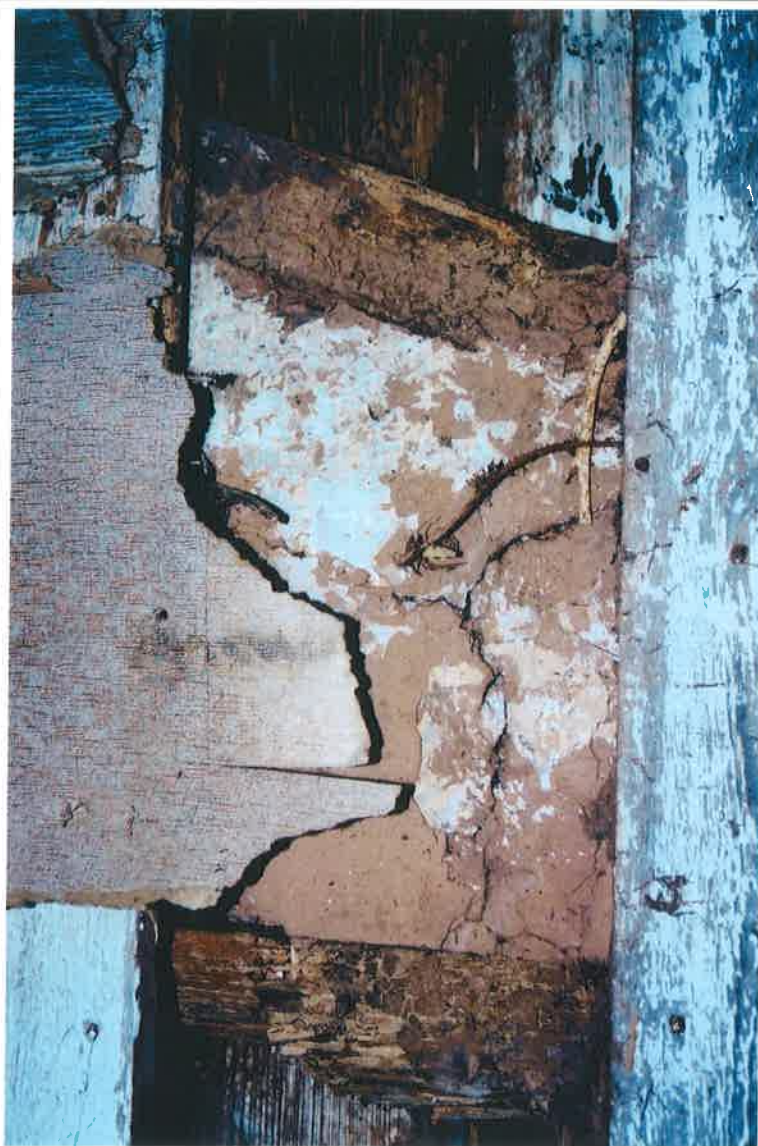
*Image 72:* Oakland Plantation. South Tenant Cabin, Room 102, north wall, 2002. The original whitewashed *bousillage* behind the sheathing and wallpaper.

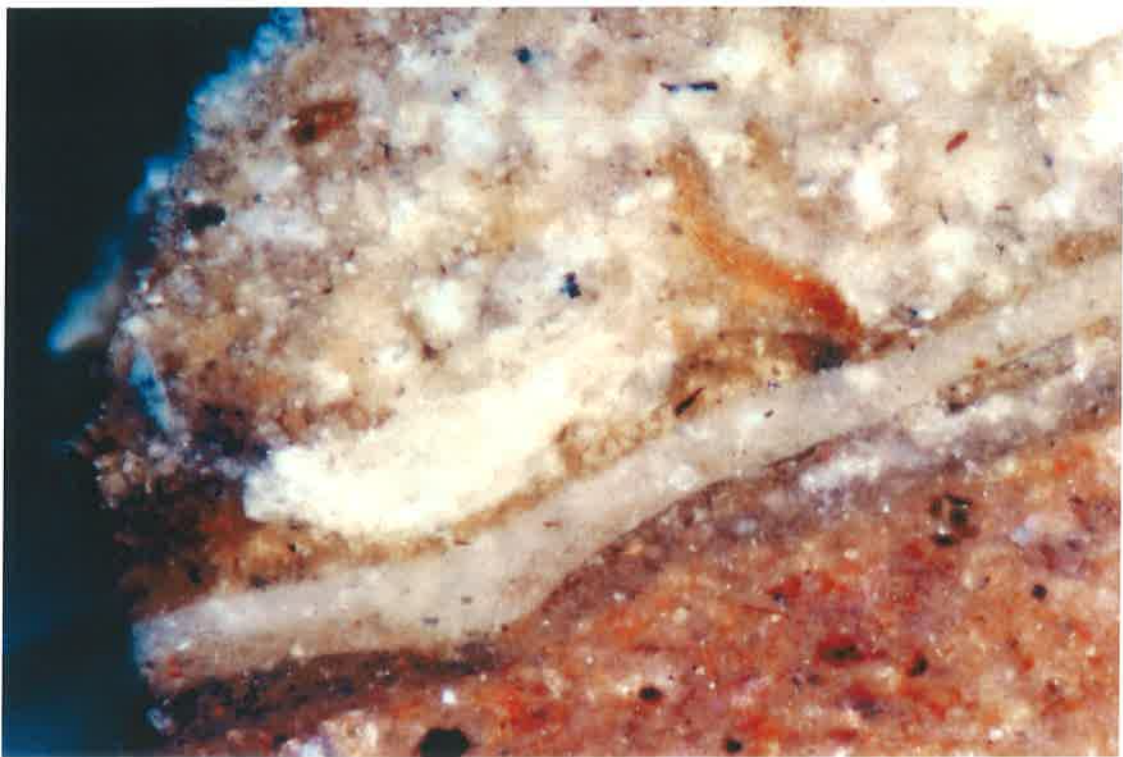
*Image 73:* Oakland Plantation. South Tenant Cabin, Room 102, 2002. Photomicrograph of Sample #OPST.14 (10x mag.) showing the whitewash layers on the *bousillage* of the north wall.

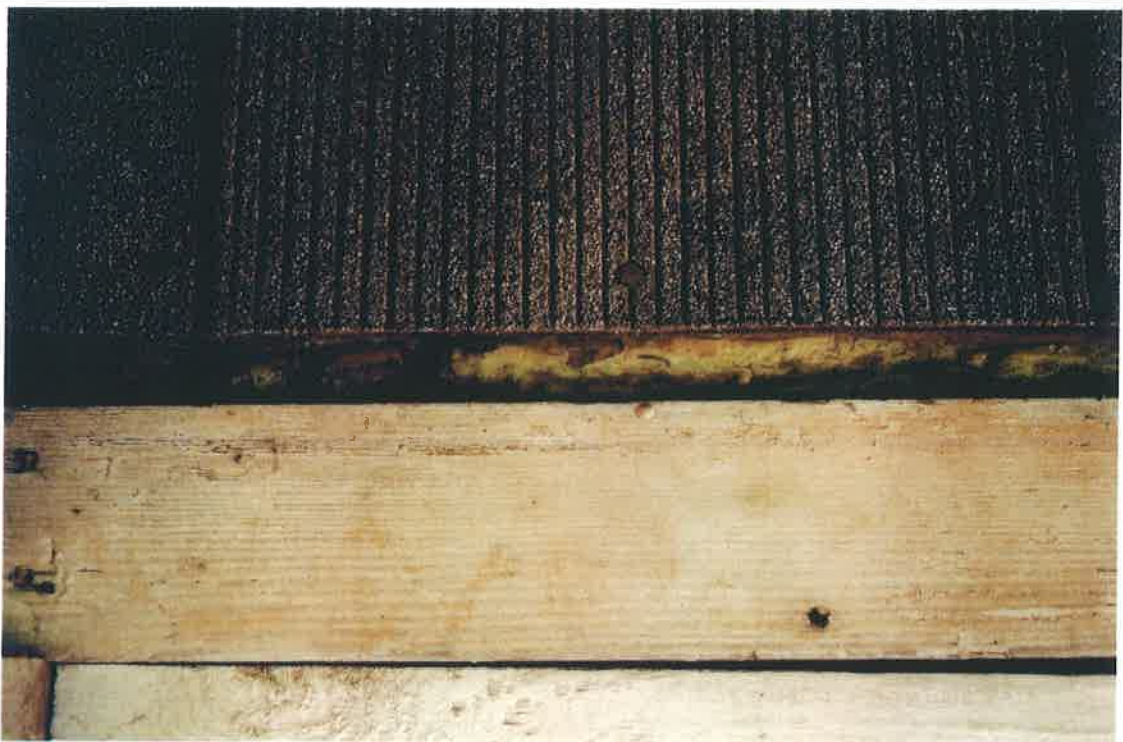
*Image 74:* Oakland Plantation. South Tenant Cabin, east elevation, 2002. *Bousillage* preserved behind sheathing and asphalt paper.

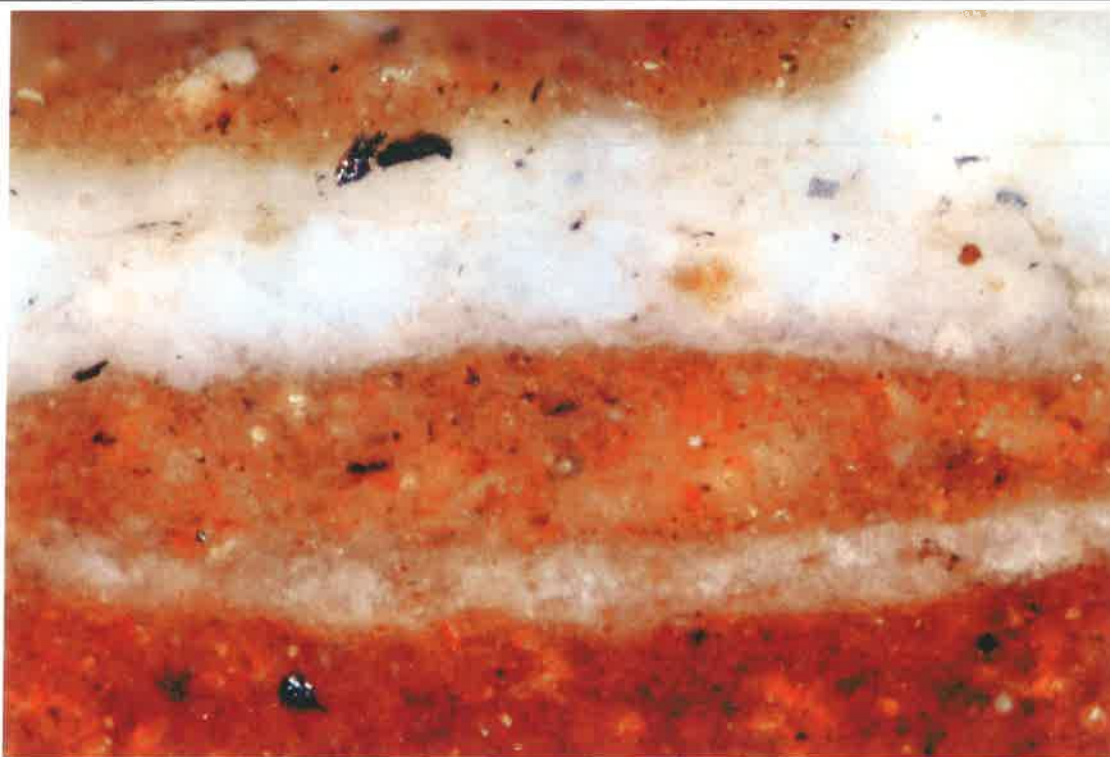
*Image 75:* Oakland Plantation. South Tenant Cabin, east elevation, 2002. Photomicrograph of Sample #OPST.49 (10x mag.) showing two campaigns of limewashed *bousillage* on the building's east elevation.

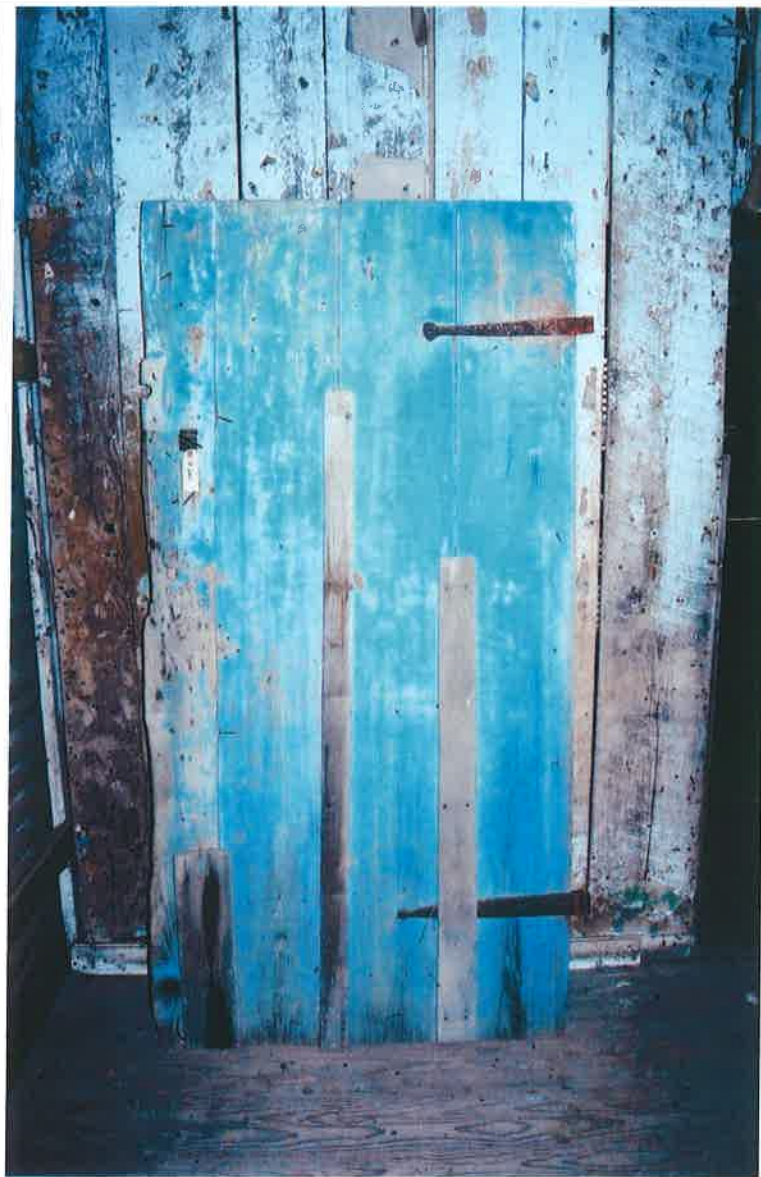
*Image 76:* Oakland Plantation. South Tenant Cabin, Room 102, 2002.  
Interior face of Door D1.

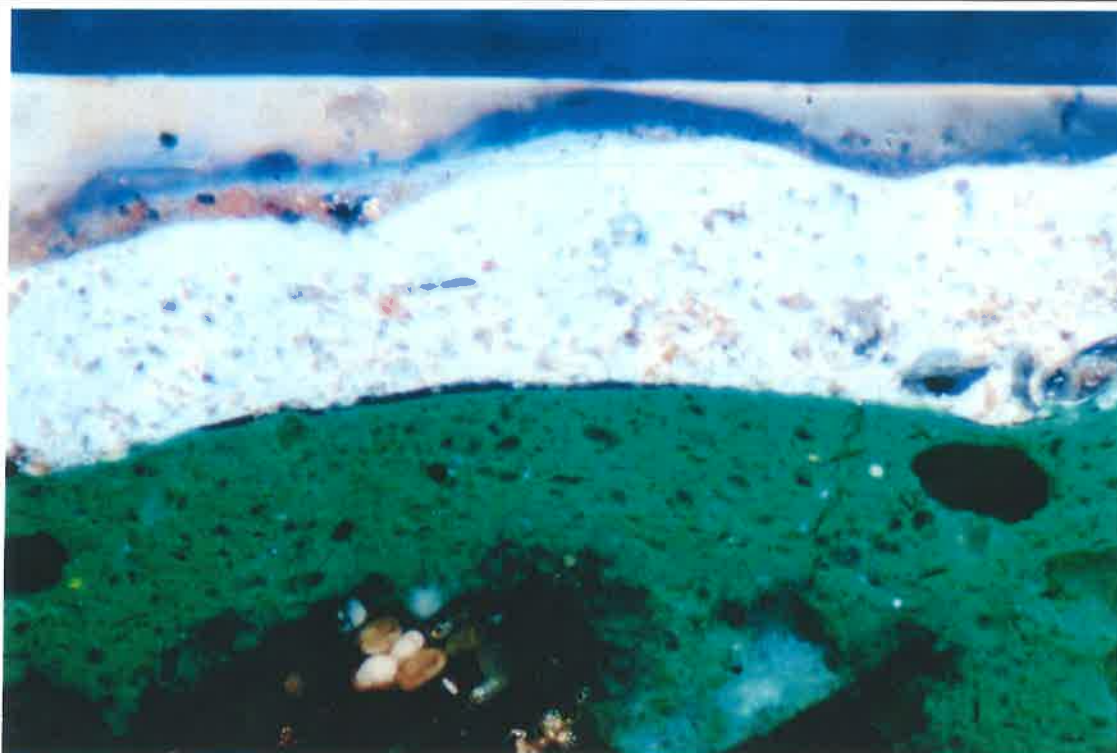
*Image 11:* Oakland Plantation. South Tenant Cabin, Room 102, 2002. Photomicrograph of Sample #OPST.24 (10x mag.) showing the painted finishes of the interior side of D1.

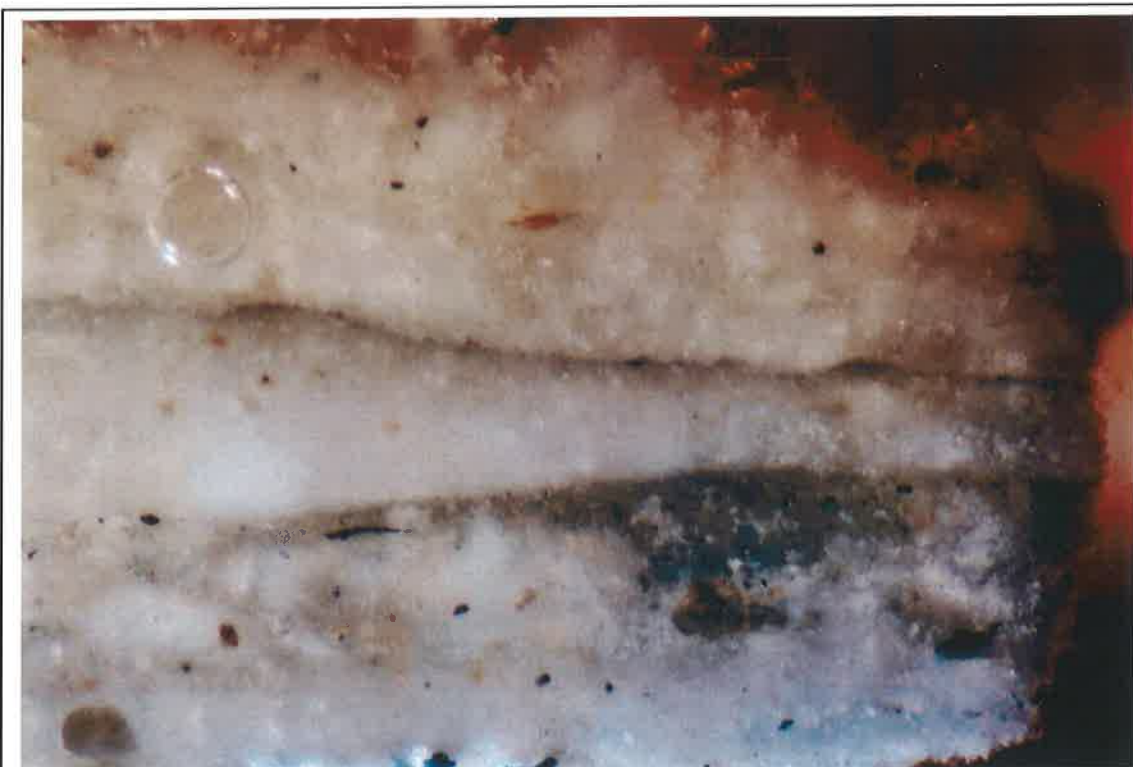
*Image 83: Oakland Plantation. South Tenant Cabin, west elevation. Photomicrograph of the three layers of limewash found on a fragment of Door D5. (Sample #OPST.57, 10x mag.).*

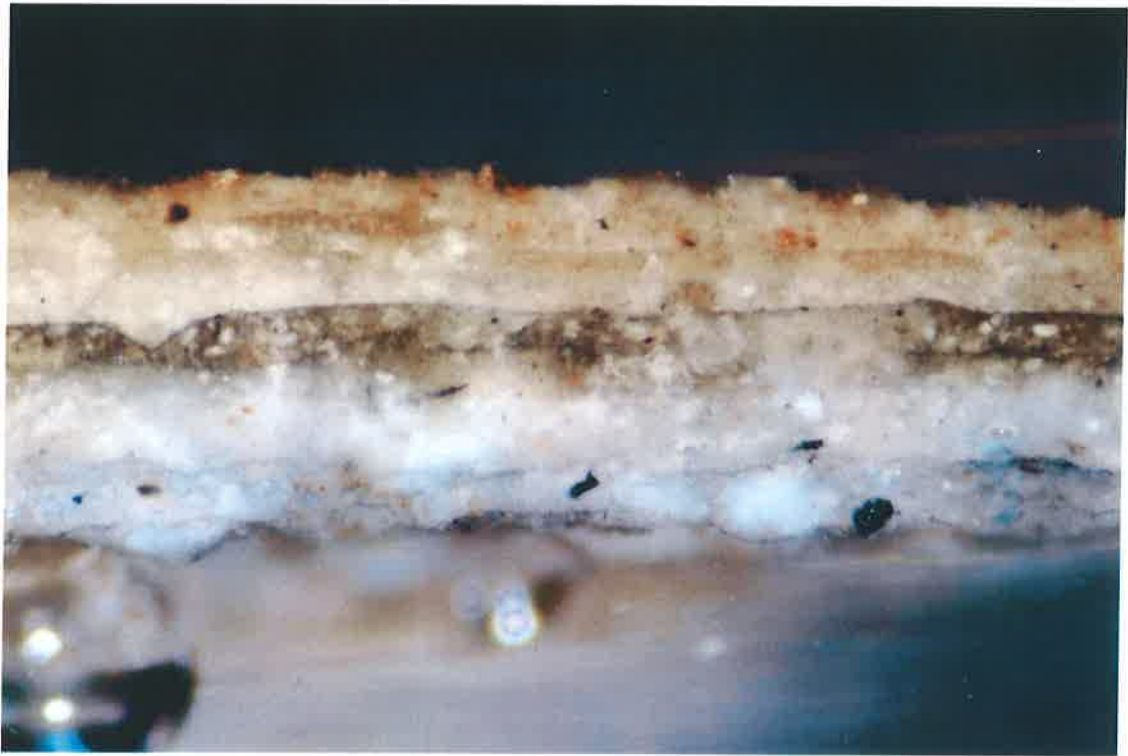
*Image 85:* Oakland Plantation. South Tenant Cabin, Room 103, 2002. Photomicrograph of Sample #OPST.38 (10x mag.), removed from window surround on east wall.

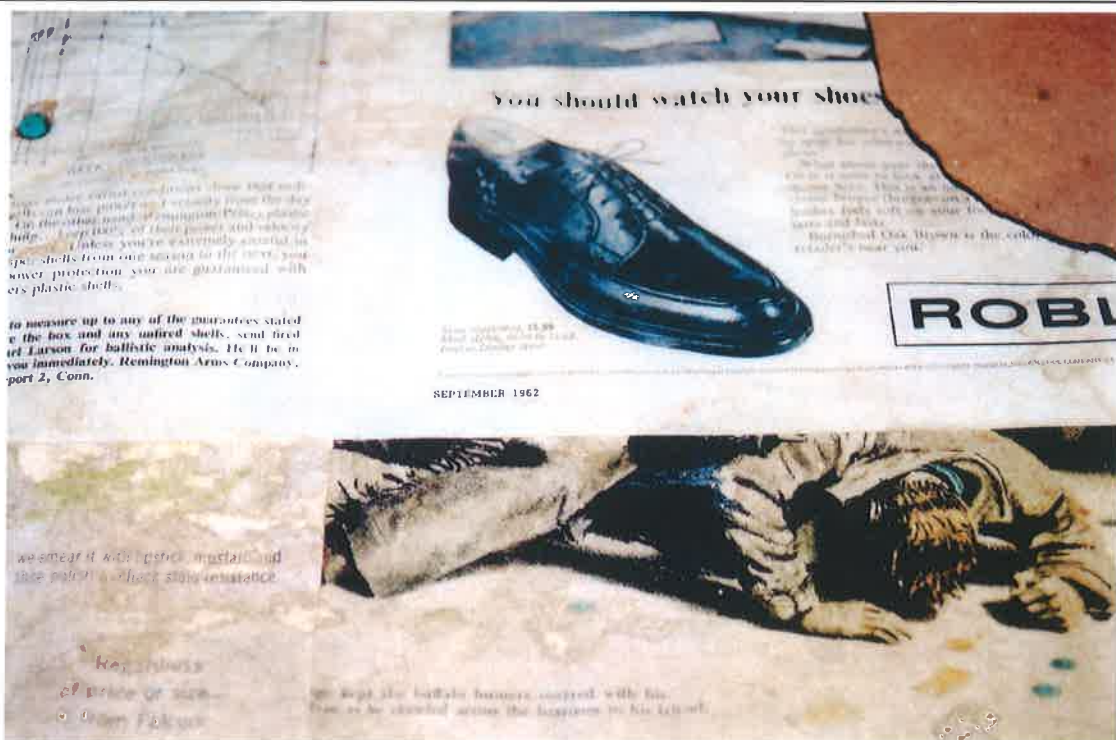
Image 89: Oakland Plantation. South Tenant Cabin, Room 103, 2002. A newspaper applied onto the wall provides a date (September 1962) for the wallpaper sequence.
