**PRE-RENOVATION  
LEAD-BASED PAINT INSPECTION REPORT**

**NIKE MISSILE SITE  
ADMINISTRATION AND CONTROL AREA  
AND  
LAUNCH AREA  
EVERGLADES NATIONAL PARK  
HOMESTEAD, FLORIDA**

March 4, 2010  
Revised August 27, 2010  
EE&G Project No. 2009-2333

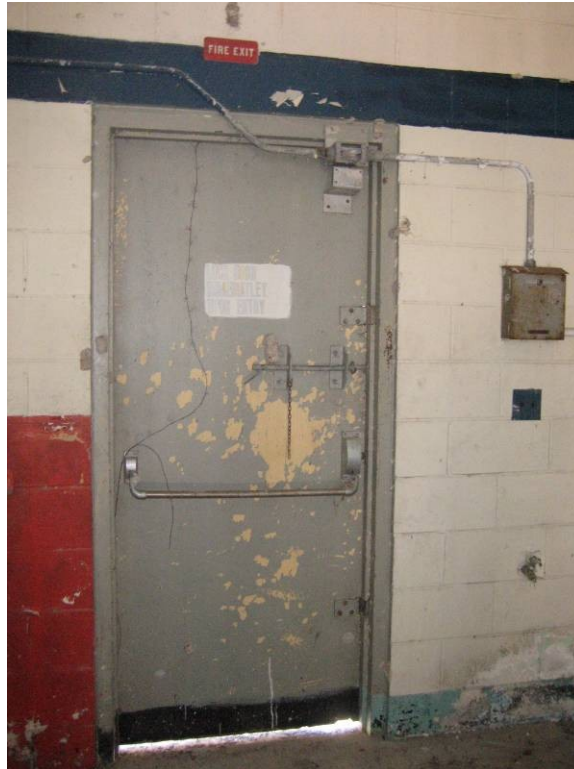
Missile Barn A: Chalking gray paint on interior metal exit door.

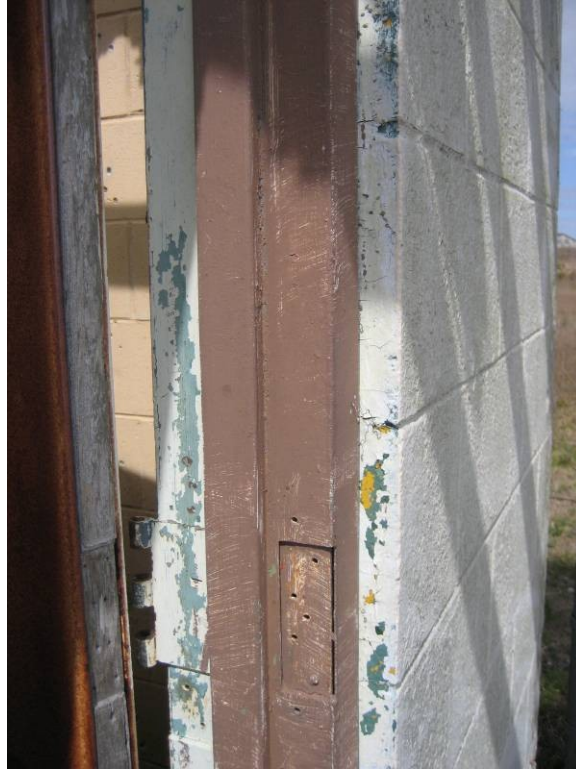
Kennel Building: Chalking brown paint on metal door casing.
