# NPS Wildfire Risk Assessments

### Theodore Roosevelt National Park

Theodore Roosevelt National Park-North Unit

# NPS Wildland Fire Risk Assessment - Facility Assessment

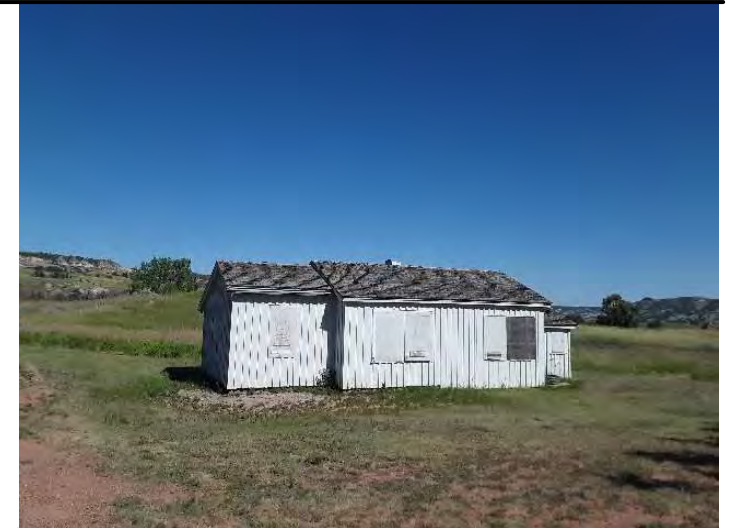
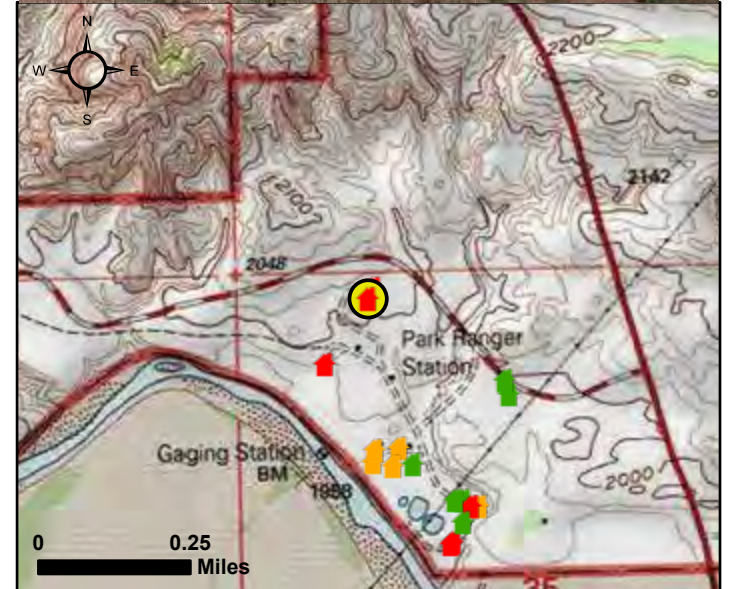
**Foundation:** Closed, Less than 6in masonry exposed

**Overhead Hazards:** No overhead hazards

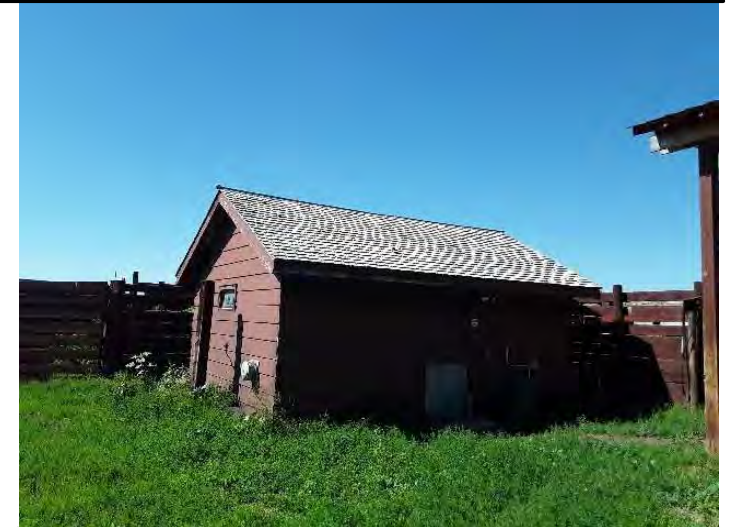
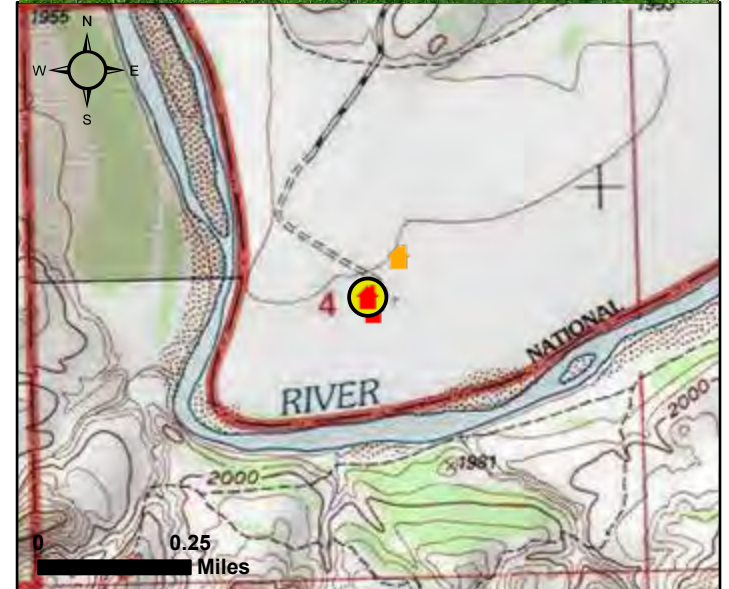
**Foundation:** Closed, Less than 6in masonry exposed

**Overhead Hazards:** No overhead hazards

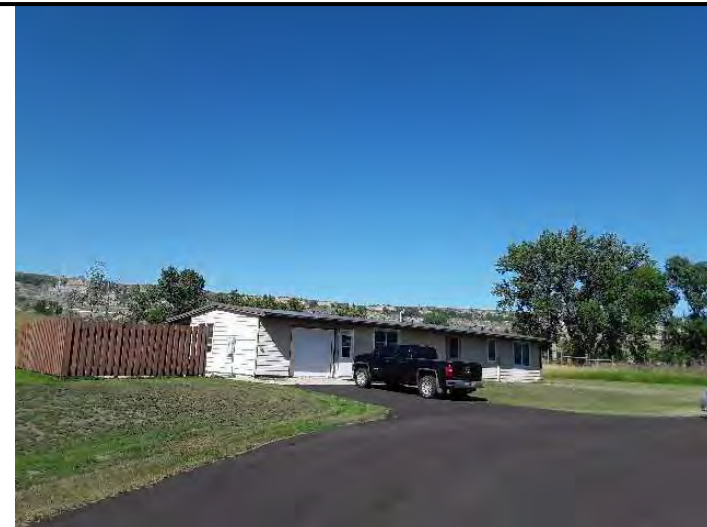
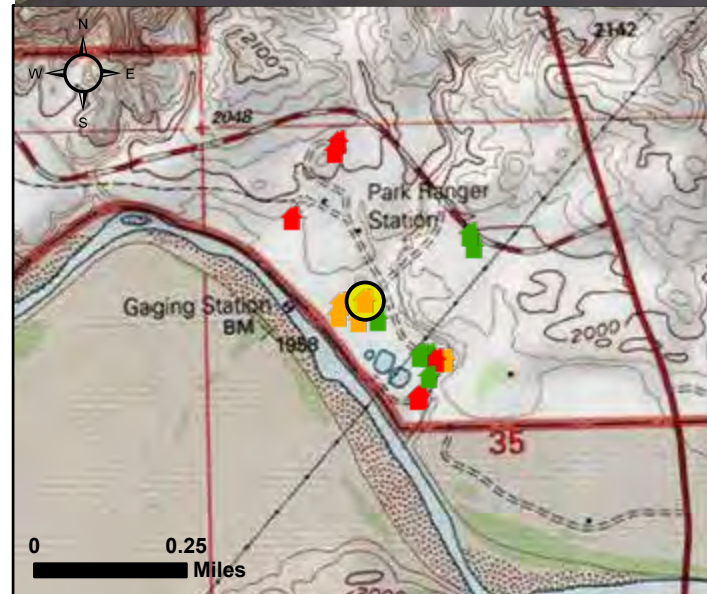
**Foundation:** Closed, Less than 6in masonry exposed

**Overhead Hazards:** Overhead hazards will limit aircraft

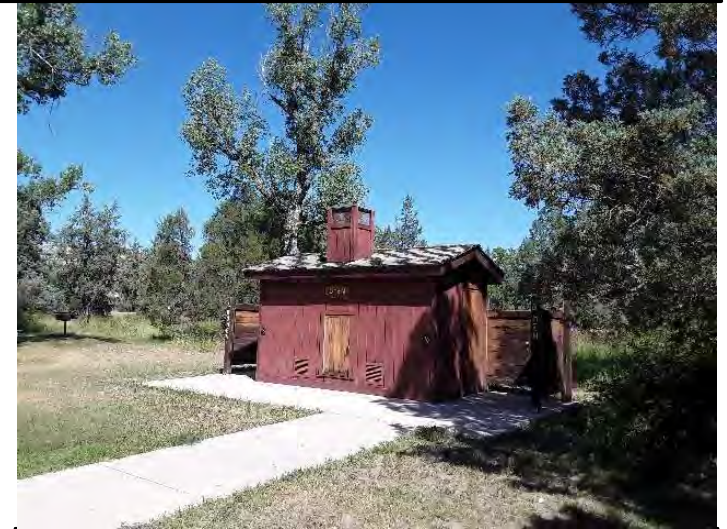
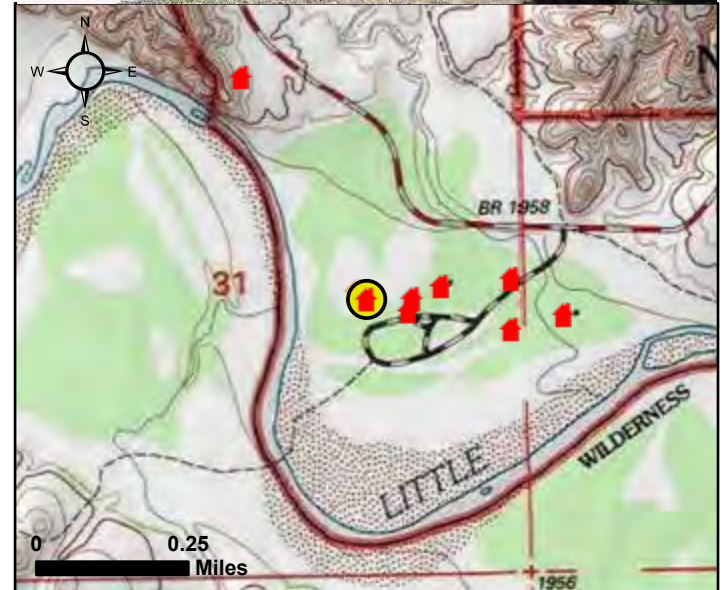
**Rating:** High  
**ProtectionLevel:** Full,  
**Resources of Concern:** Unknown  
**Occupied:** No  
**In Community:** No,  
**Revisit Interval:** 5 yrs  
**Map Label:** 4

**Primary Access:** Road  
**Ingress Egress:** 1 road in/out  
**Access Width:** 1.5 lanes (Greater than 18')  
**Access Condition:** Surfaced-paved, gradeLess than 5%  
**Bridge Condition:** Less than 300 ft with turnaround  
**Access and Turnarounds:** Less than 300 ft with turnaround  
**Facility Number or Sign:** Marked and clearly visible  
**Fuel Type:** Grass and shrub, hardwood litter  
**Fuel Load:** Moderate  
**Defensible Space:** Less than 30 ft treated  
**Topography:** Slope Less than 5%  
**Roof Material:** Combustible or no roof  
**Siding Material:** Wood or open sided  
**Foundation:** Closed, Less than 6in masonry exposed  
**Firewood:** None  
**Water Supply:** No reliable water source nearby  
**Propane:** None  
**Overhead Hazards:** No overhead hazards  
**Comments:**

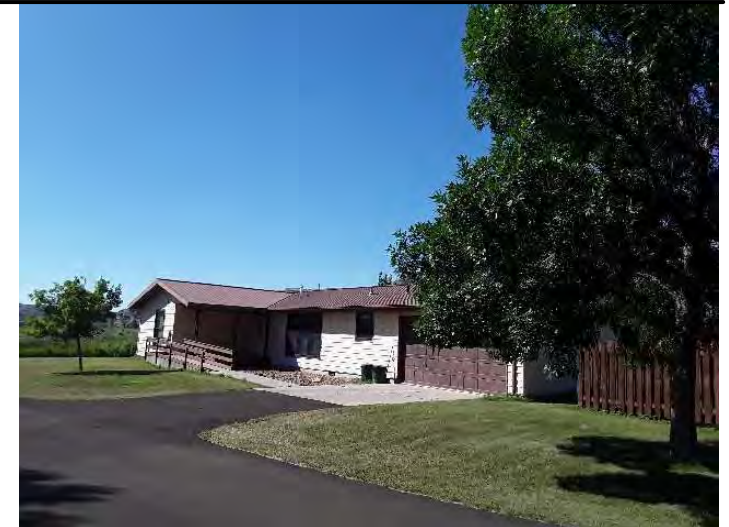
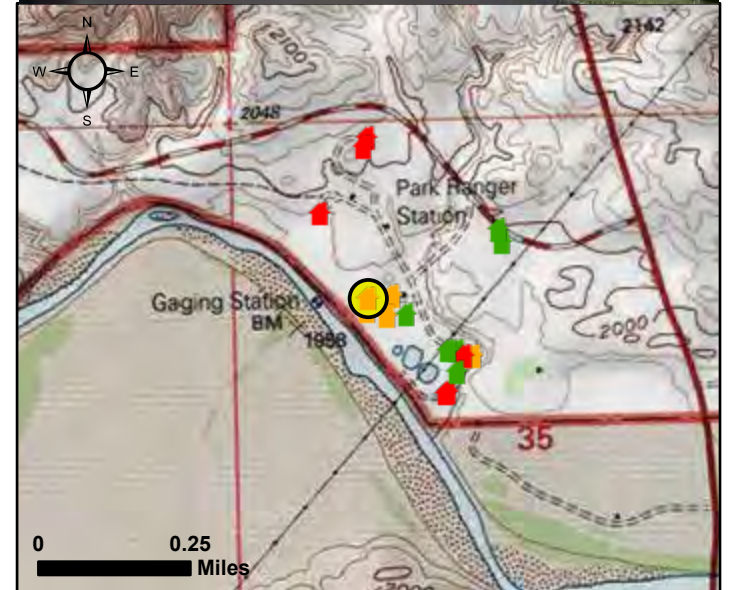
**Foundation:** Open or deck

**Overhead Hazards:** Overhead hazards will limit aircraft
