# NPS Wildfire Risk Assessments Assessment Locations

## CORO - Coronado National Memorial Overview

# NPS Wildand Fire Risk Assessment - Facility Assessment

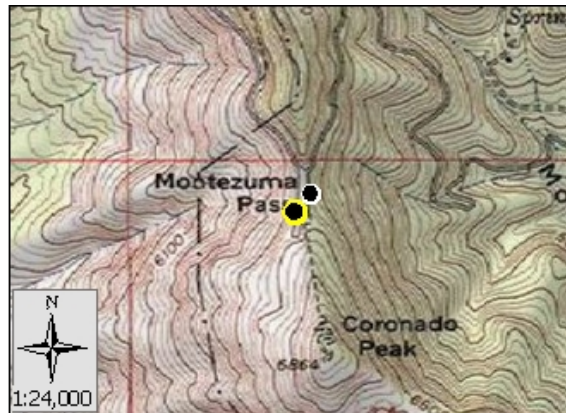
2021\_CORO\_79202\_MONTEFrontUMA PASS COMFORT STATION\_Front.jpg

**Score: 48** **Asset Priority Index (API): 36**  
**Rating: Moderate**

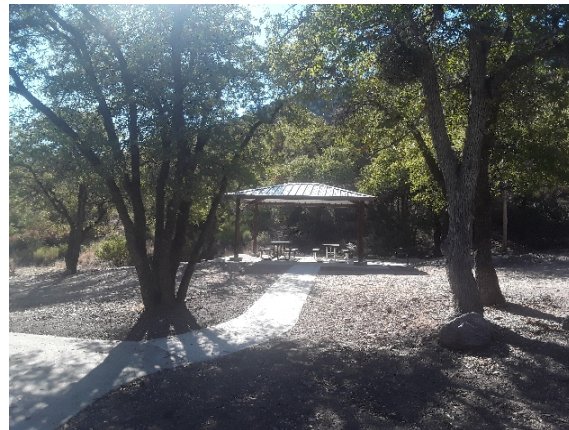
2021\_CORO\_not found \_PICNIC AREA shade\_Front.jpg

**Score: 38**  
**Rating: Low**

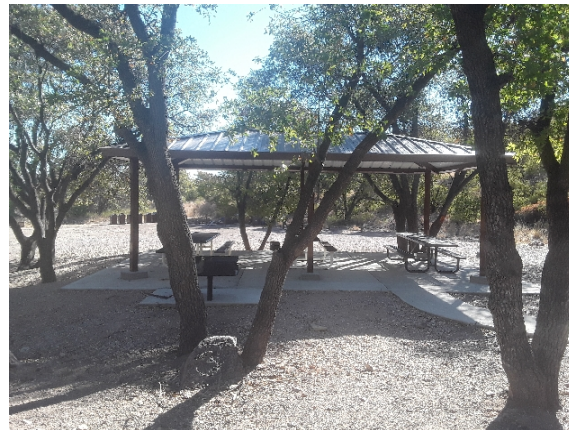
2021\_CORO\_not found \_PICNIC AREA shade\_Front.jpg

**Score: 38**  
**Rating: Low**

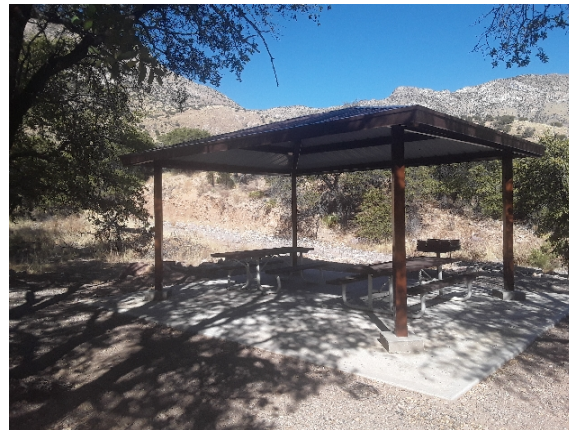
2021\_CORO\_not found \_PICNIC AREA shade\_Front.jpg

**Score: 38**  
**Rating: Low**

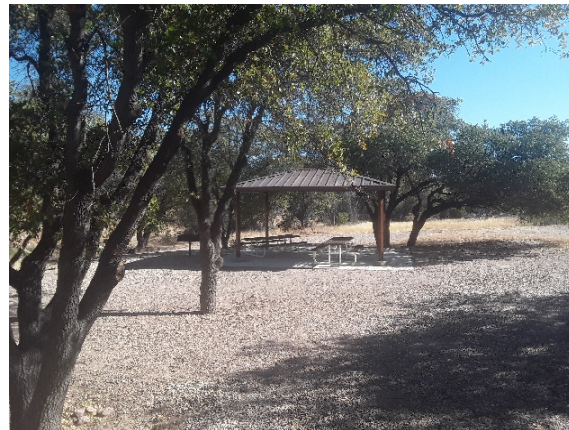
2021\_CORO\_not found \_PICNIC AREA shade\_Front.jpg

**Score: 38**  
**Rating: Low**

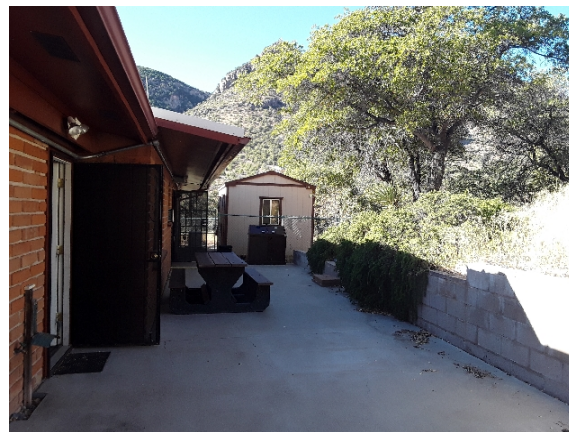
2021\_CORO\_not found \_shed\_Front.jpg

**Score: 45**  
**Rating: Moderate**

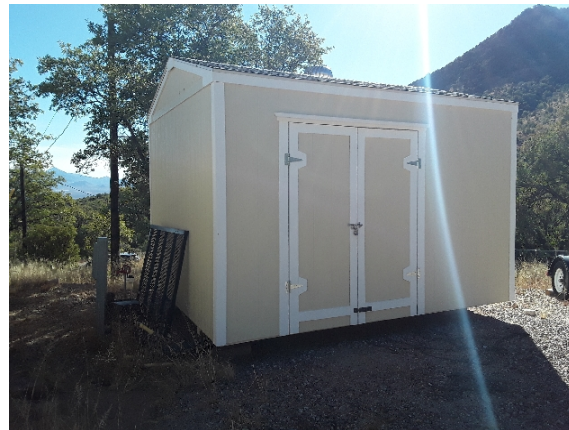
2021\_CORO\_not found \_Storage Shed\_Front.jpg

**Score: 45**  
**Rating: Moderate**

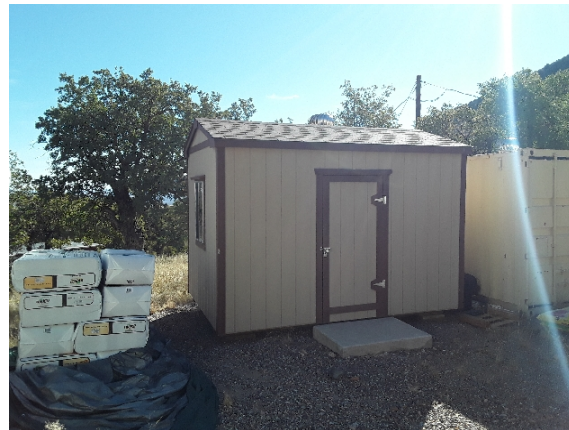
2021\_CORO\_not found \_Storage Shed\_Front.jpg

**Score: 58**  
**Rating: Moderate**

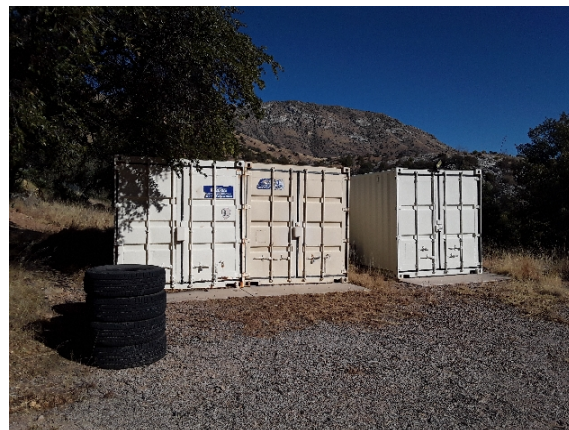
2021\_CORO\_not found \_Storage Shed\_Front.jpg

**Score: 50**  
**Rating: Moderate**

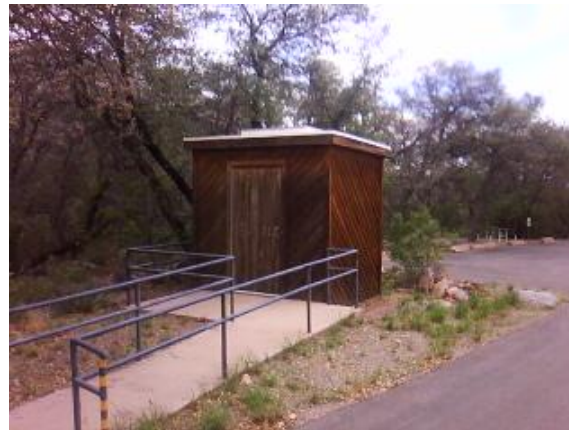
2018\_CORO\_CORO\_Unknown002\_Unknown Picnic Area Comfort Station\_Front.jpg

**Roof Material:** Noncombustible or not applicable  
**Siding Material:** Wood or open sided  
**Foundation:** Closed, < 6in masonry exposed  
**Fences/Decks:** None or noncombustible

**Firewood:** None  
**Propane Tanks:** None  
**Water Supply:** Limited or dependent on electricity  
**Overhead Hazards:** Overhead hazards will limit aircraft

**Score: 52**  
**Rating: None**

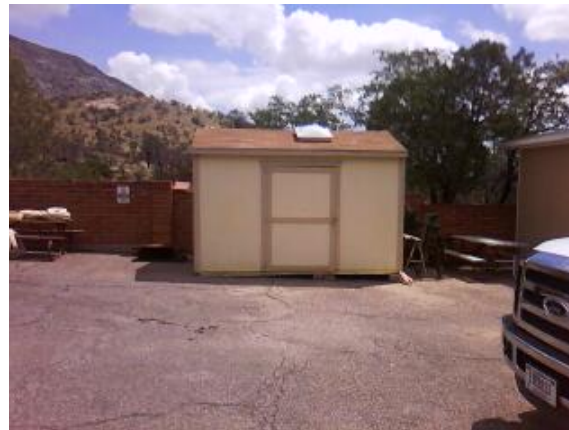
2018\_CORO\_CORO\_Unknown001\_Unknown Storage Shed\_D.jpg

**Roof Material:** Noncombustible or not applicable  
**Siding Material:** Wood or open sided  
**Foundation:** Closed, < 6in masonry exposed  
**Fences/Decks:** Combustible, adjacent, clear of veg/debris

**Score: 50**  
**Rating: None**
