# NPS Wildfire Risk Assessments Assessment Locations

## Mojave National Preserve - Overview

# NPS Wildland Fire Risk Assessment - Facility Assessment

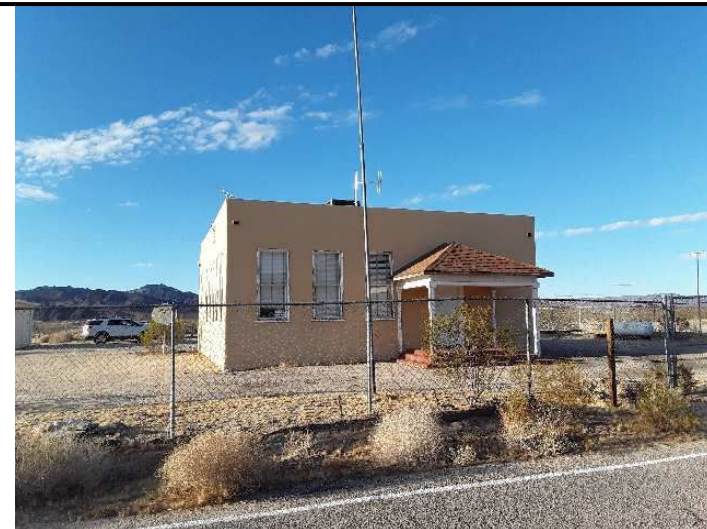
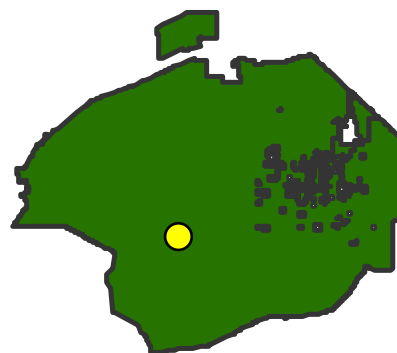
**Comments:** building behind locked fence, limited view

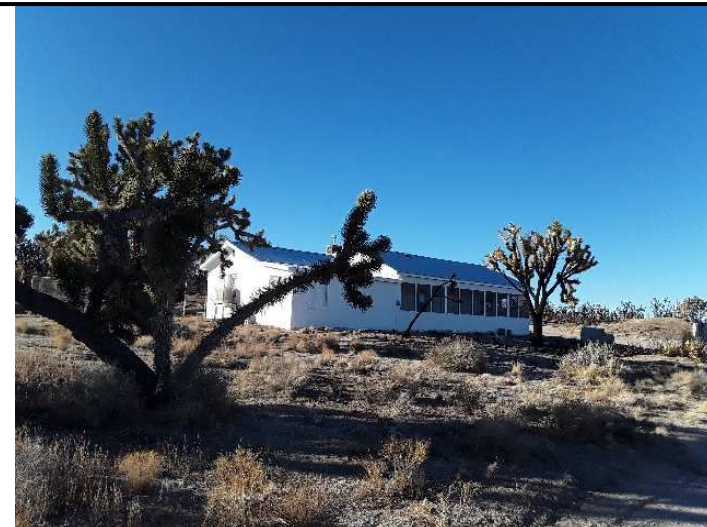
**Comments:** in 2020 Dome fire area

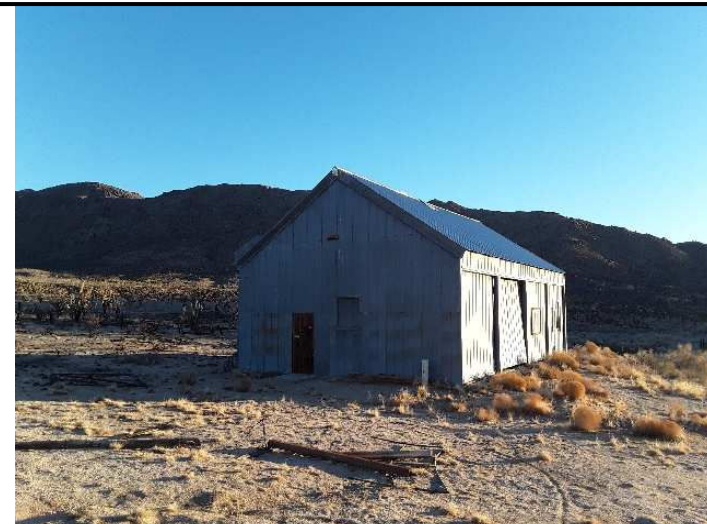
**Comments:** in the 2020 Dome fire area

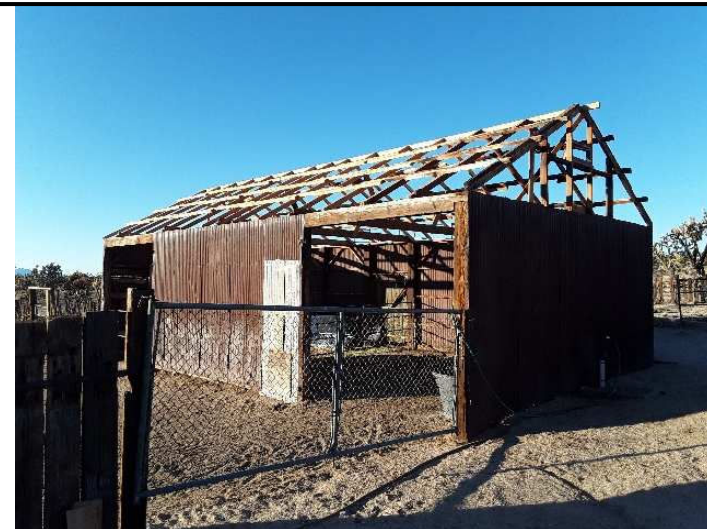
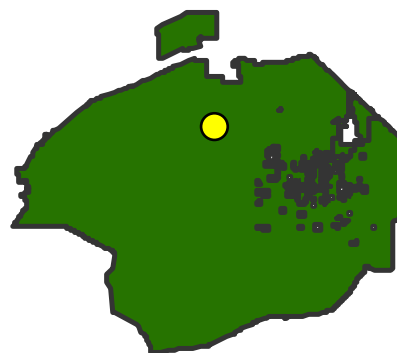
**Comments:** being rebuilt/repaired following 2020 Dome fire damage

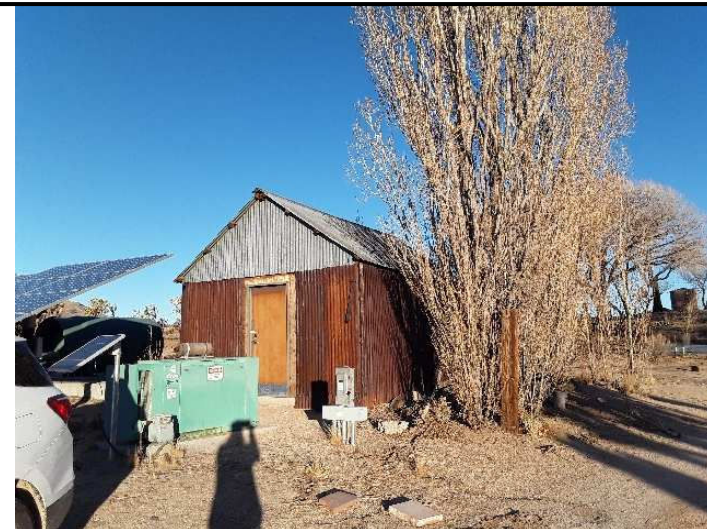
**Comments:** in 2020 Dome fire area

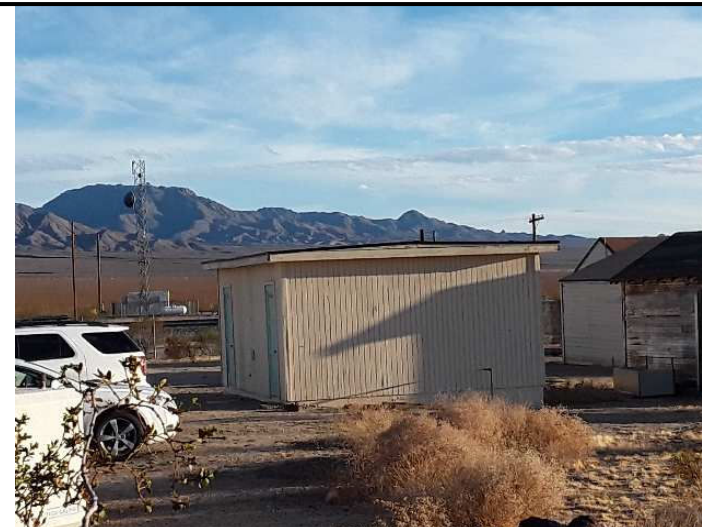
**Comments:** buildings behind locked fence, limited view

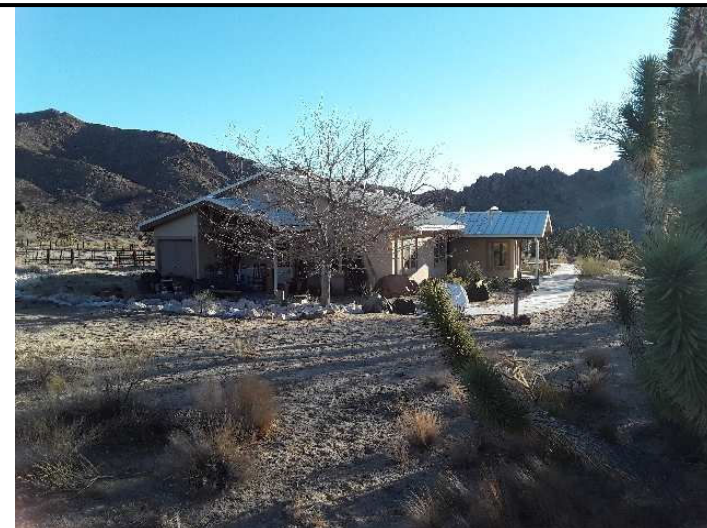
**Comments:** building is on edge of 2020 Dome fire area.  
other photos not taken due to dog

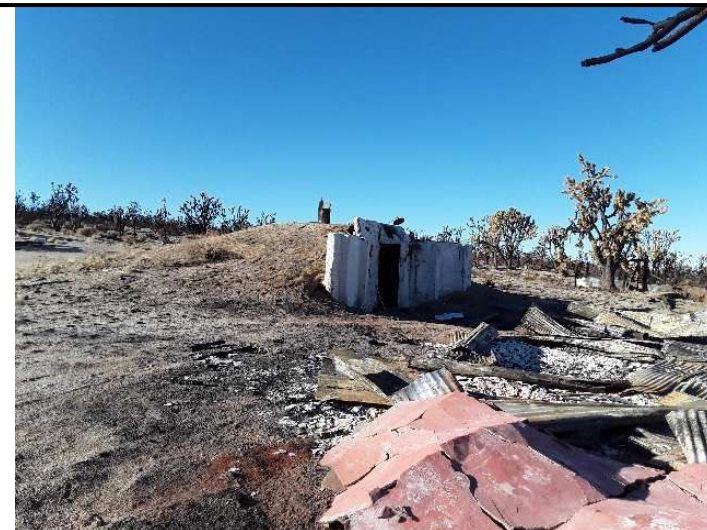
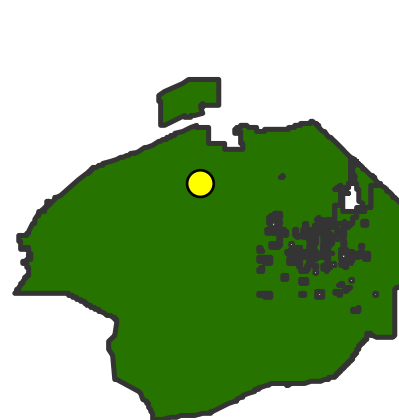
**Comments:** building damaged in 2020 Dome fire

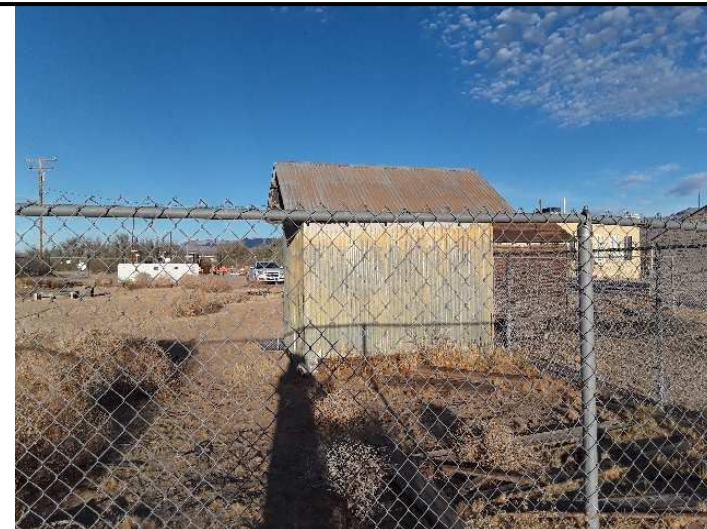
**Comments:** building behind locked fence, limited view

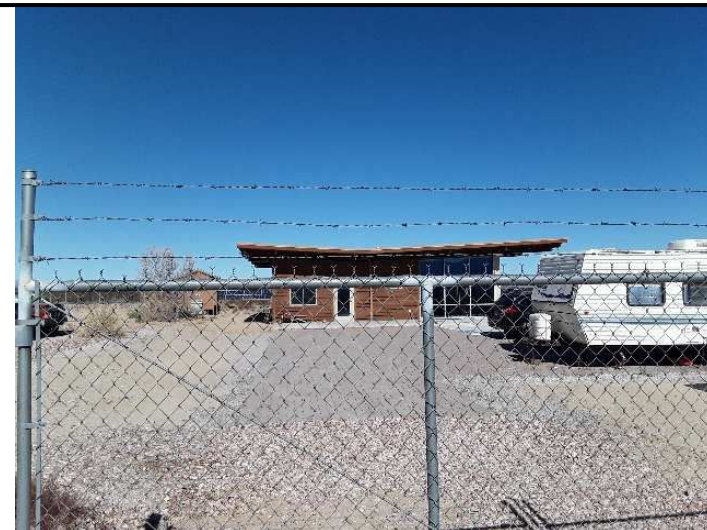
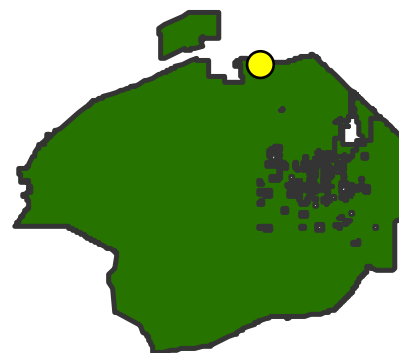
**Comments:** Desert tortoise research facility with creosote. facility enclosed in fence with locked gate

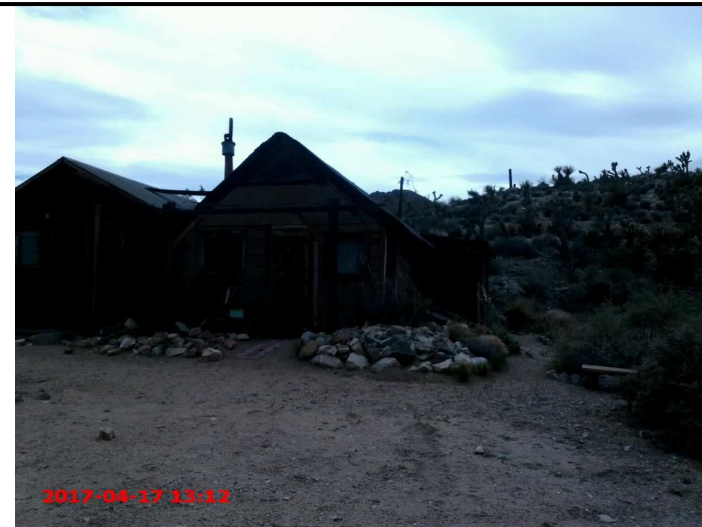
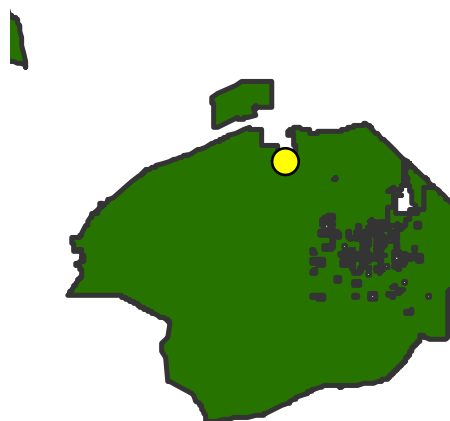
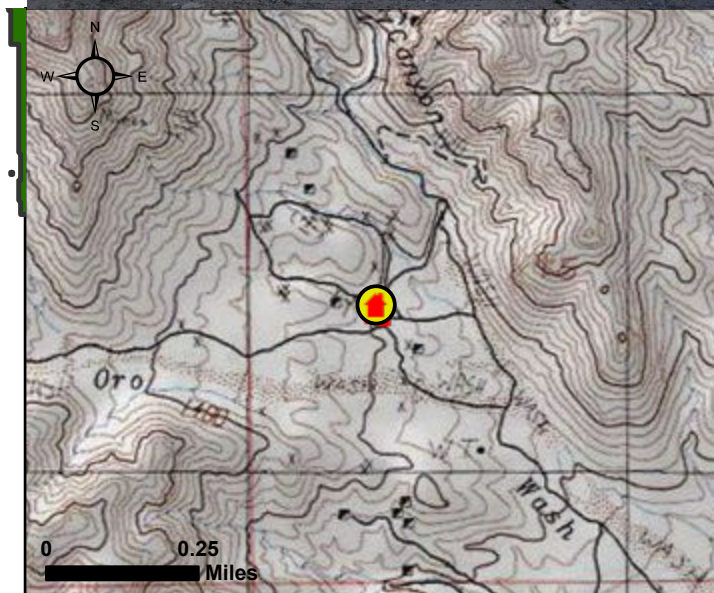
**Comments:** Historic

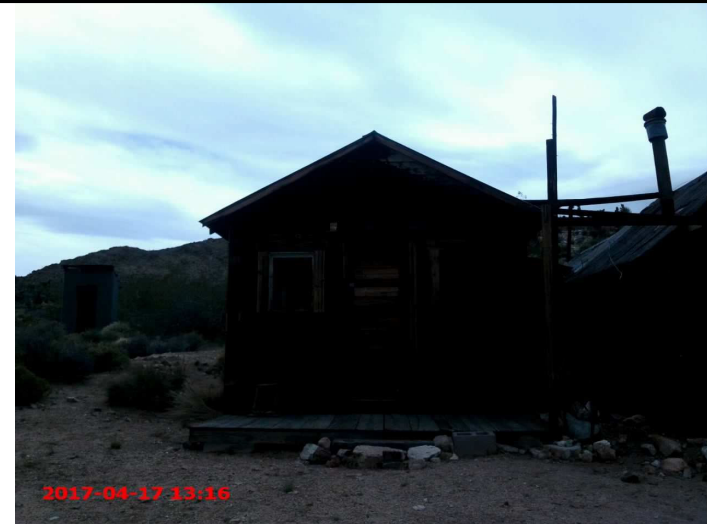
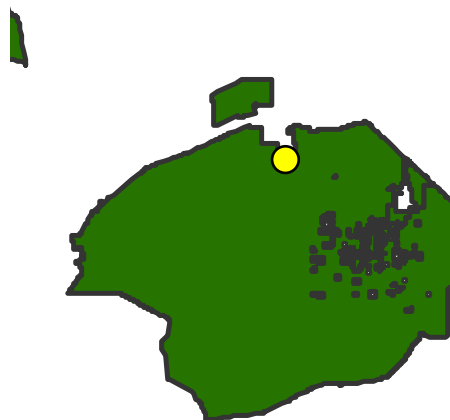
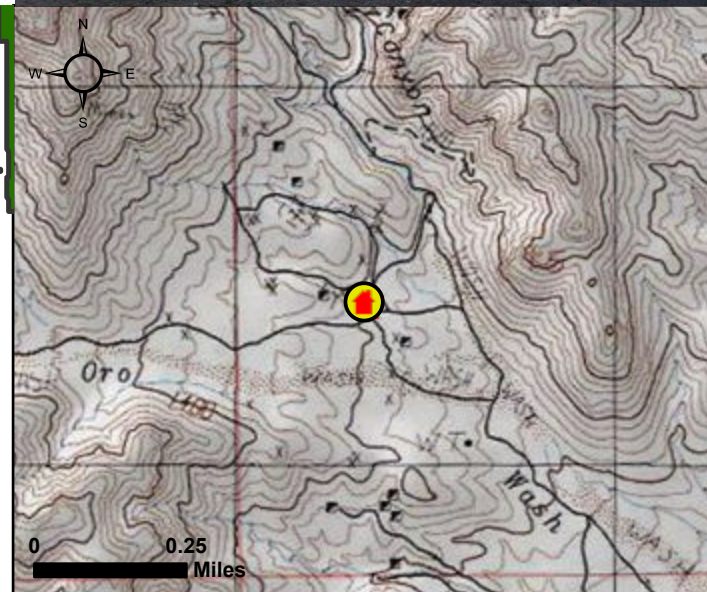
**Comments:** Historic

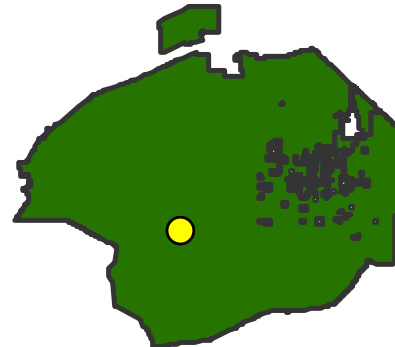
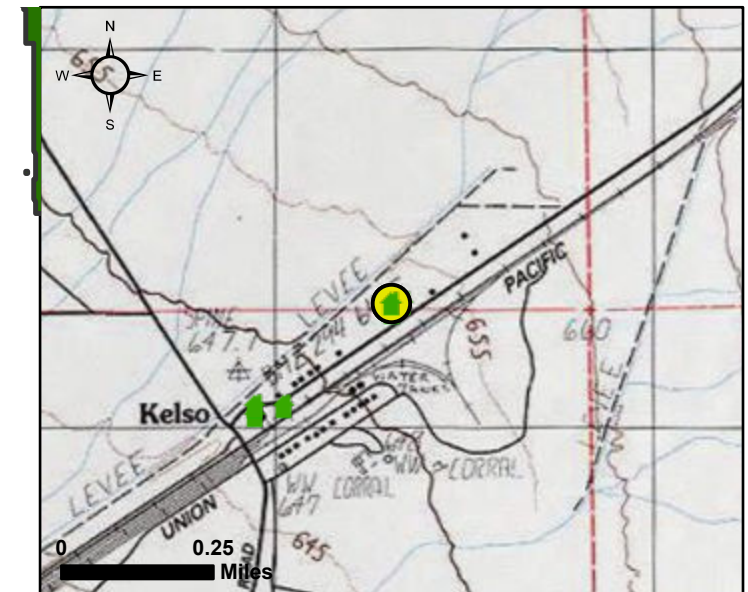
**Propane:** Present and fuels clearance Present and fuels clearance  
**Comments:** buildings behind locked fence- only one view visible buildings behind locked fence- only one view visible

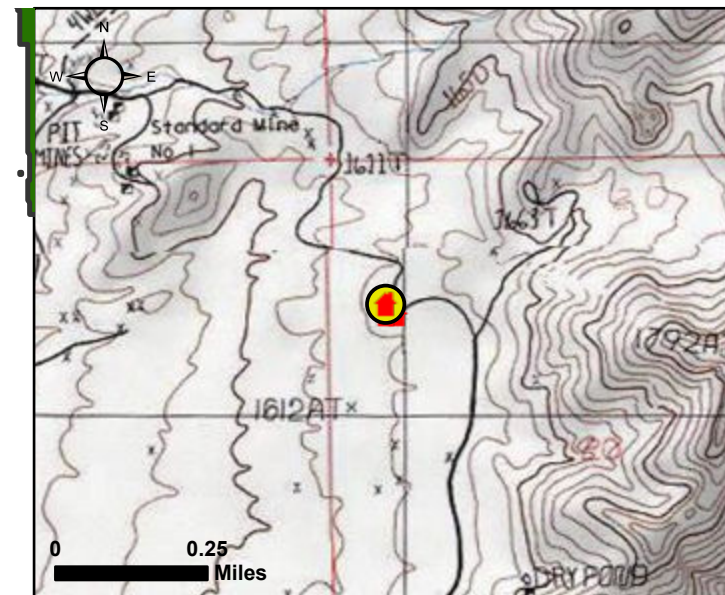
**Comments:** buildings behind locked fence- only one view  
visible buildings behind locked fence- only one view visible
